High Lakes Stabilization Construction Report

Uinta Basin Replacement Project

Garfield Basin

Five Point Lake, Bluebell Lake, Drift Lake, Superior Lake

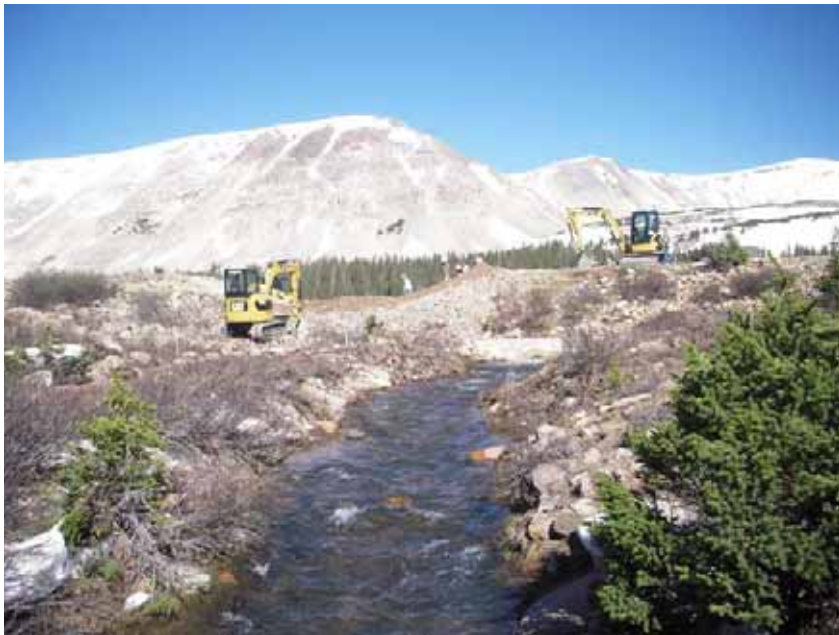
Figure 5: Crew clearing snow from spillway at Five Point.

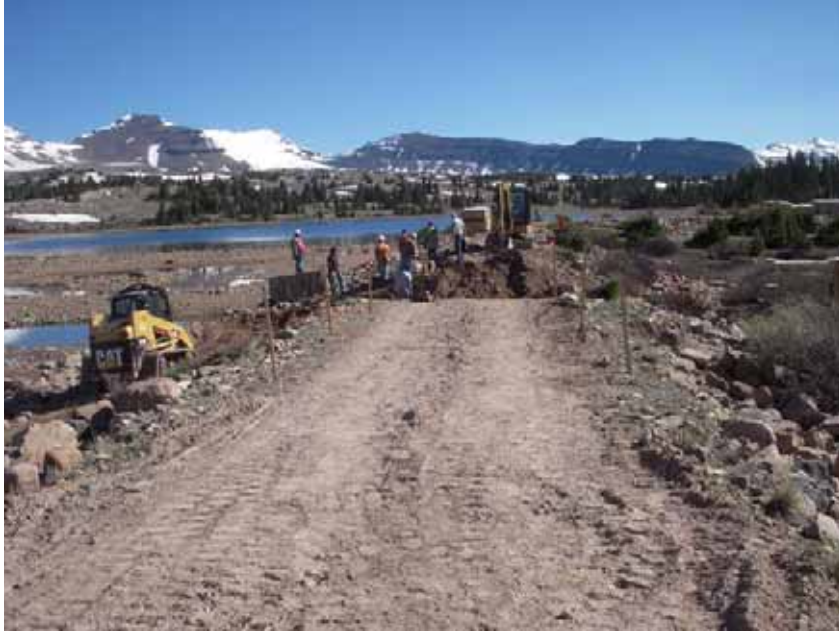
Figure 6: Crew cutting the breach through the Five Point dam.

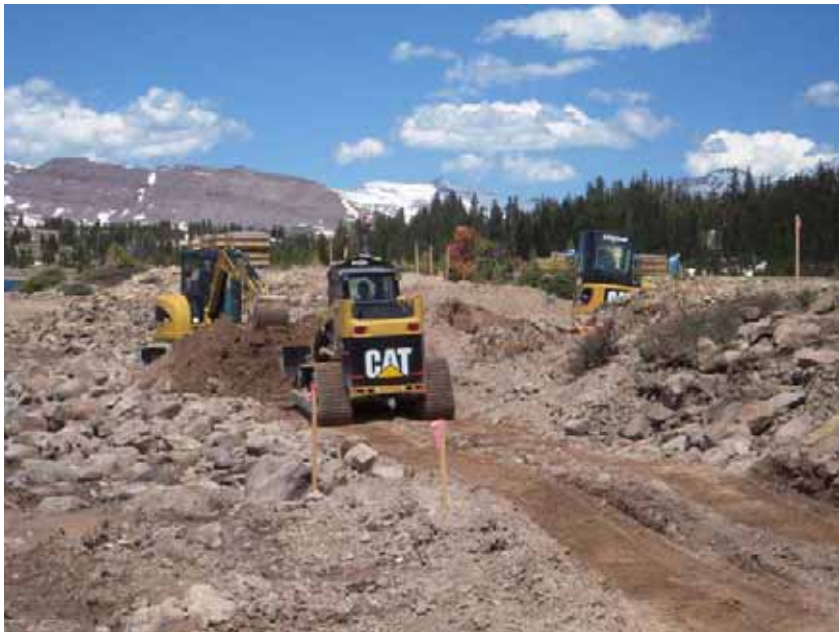
Figure 7: Skid Steer and trackhoe used to make the cut.

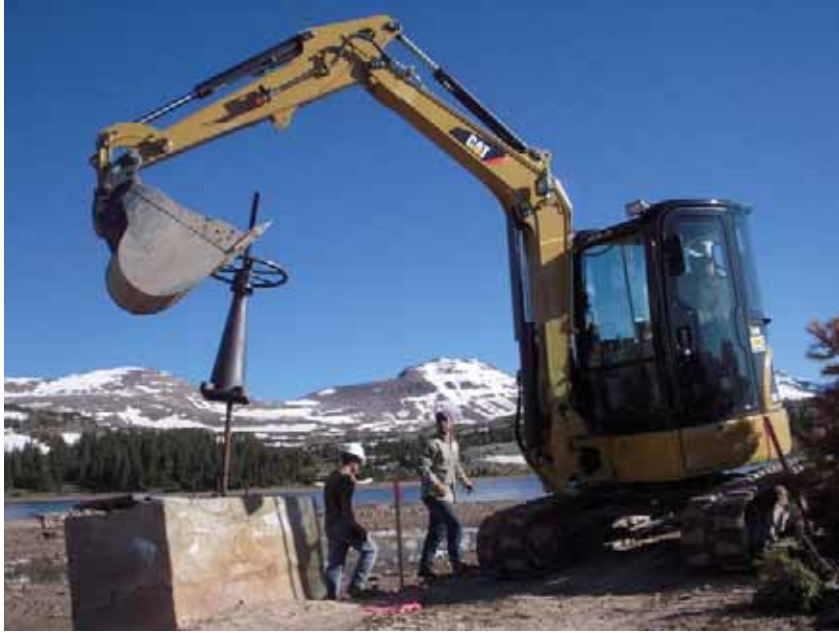
Figure 8: Crew using trackhoe to remove outlet works at Five Point.

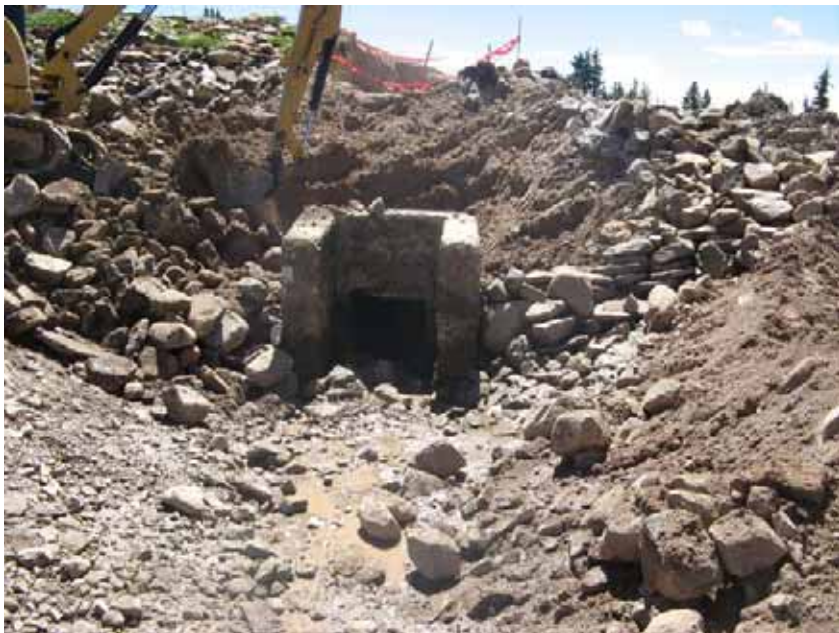
Figure 9: Removing inlet structure at Five Point.

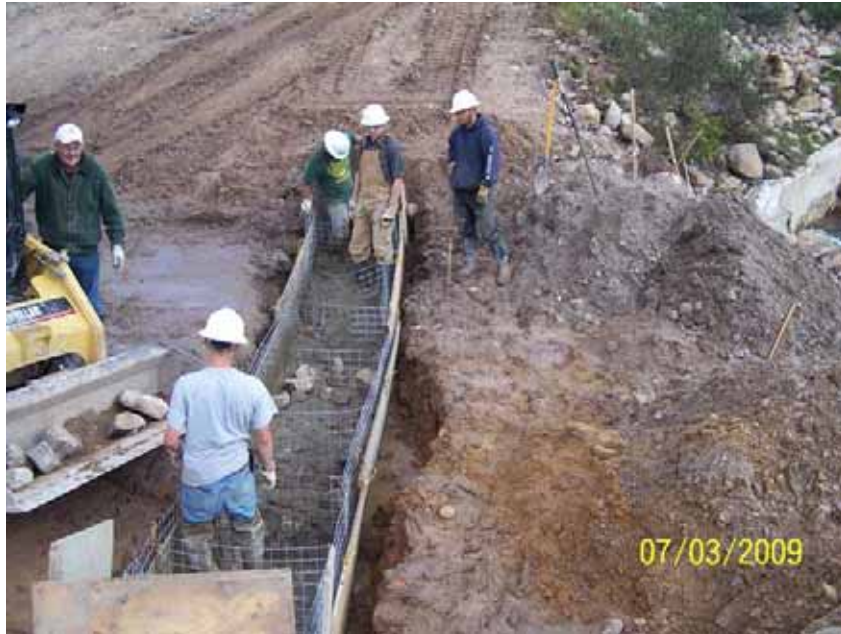
Figure 10: Installation of the middle cutoff wall at Five Point.

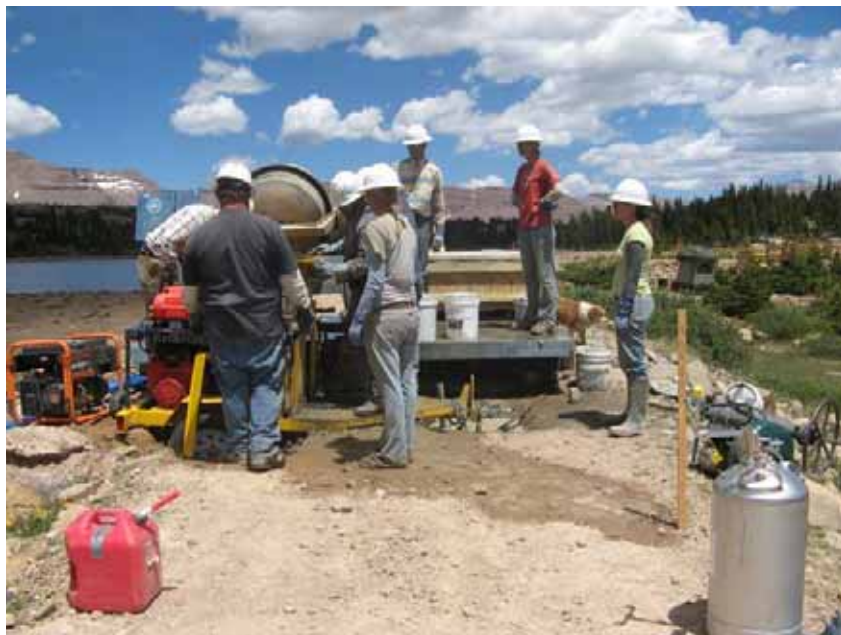
Figure 11: Grouting operation with DCWCD hand crew for cutoff walls.

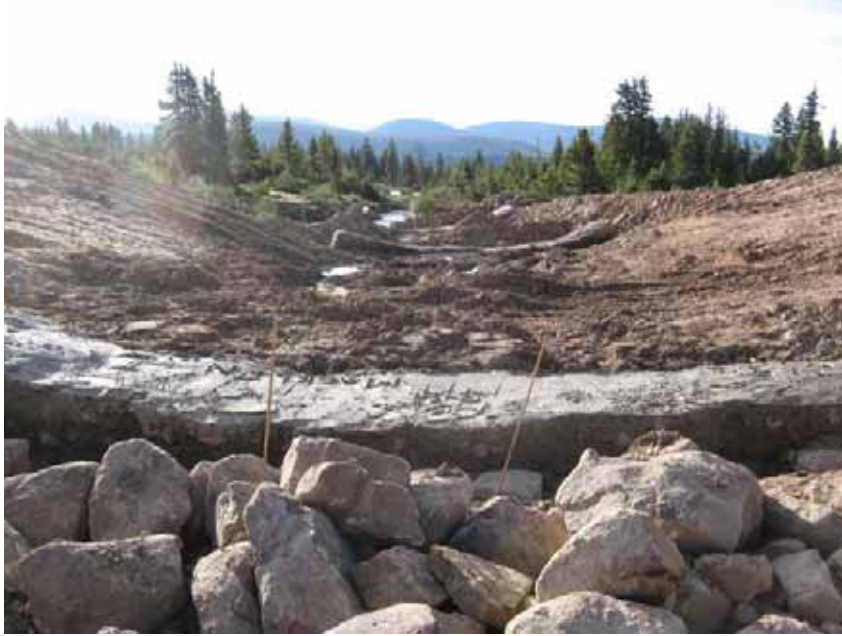
Figure 12: Five Point Lake Dam breach looking downstream with the gabion cutoff walls in place.

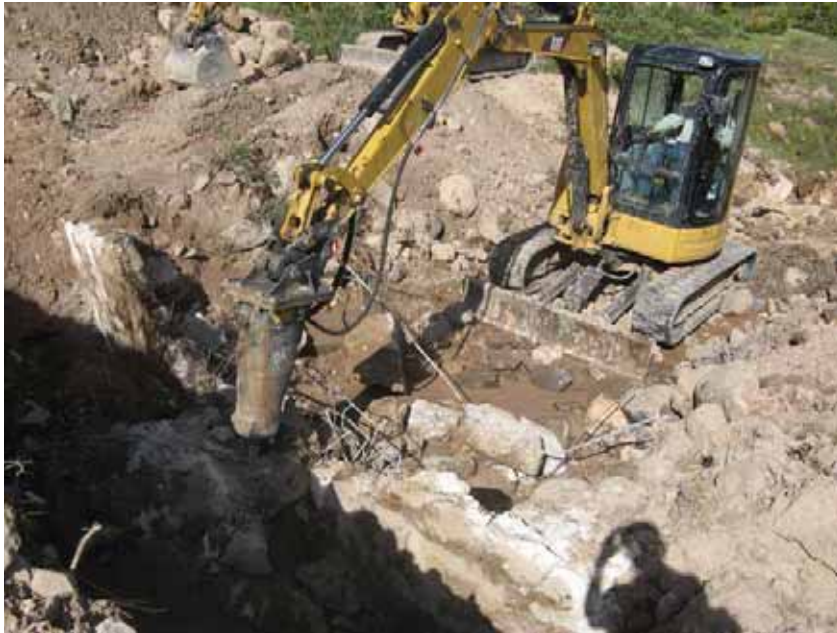
Figure 14: Inlet structure being removed using a stinger attachment.

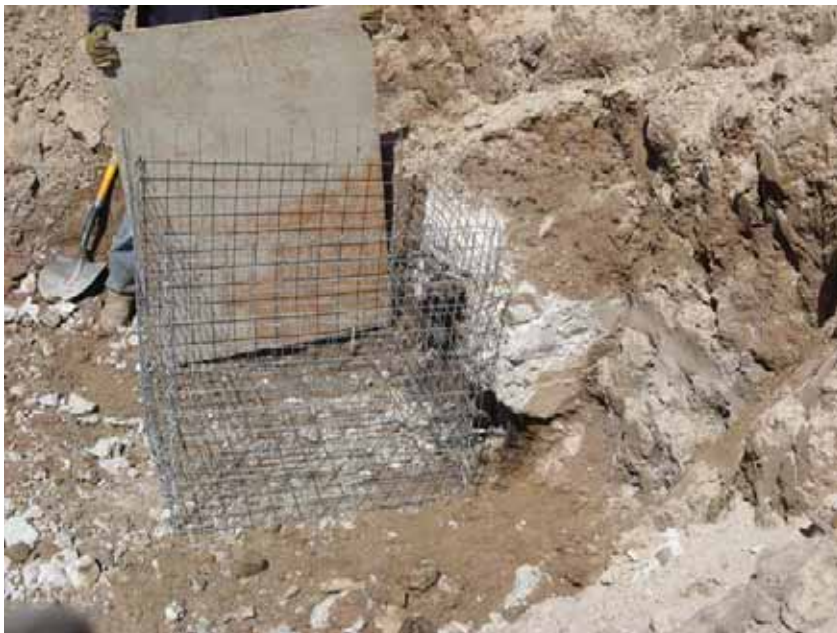
Figure 15: Installing gabion basket at outlet pipe prior to grouting.

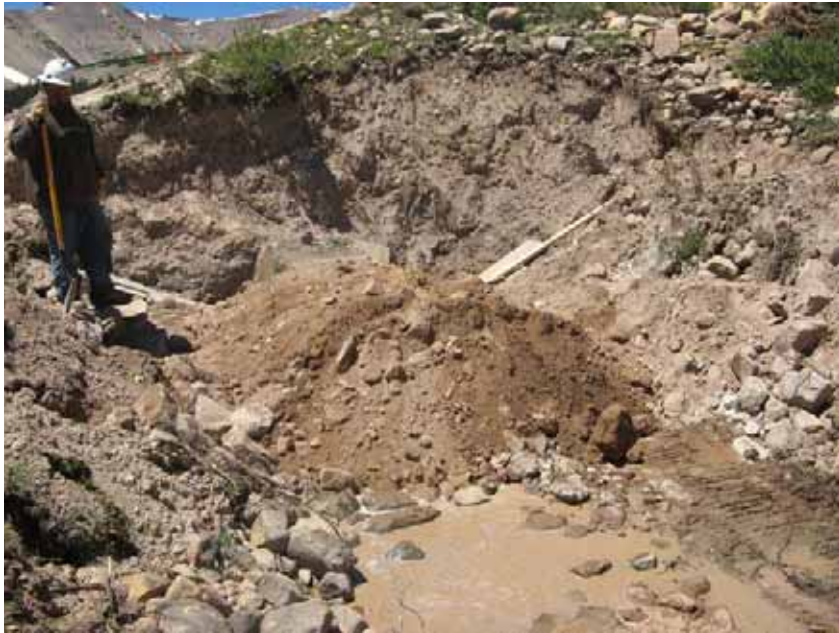
Figure 16: Grouted outlet pipe with sand filter in place.

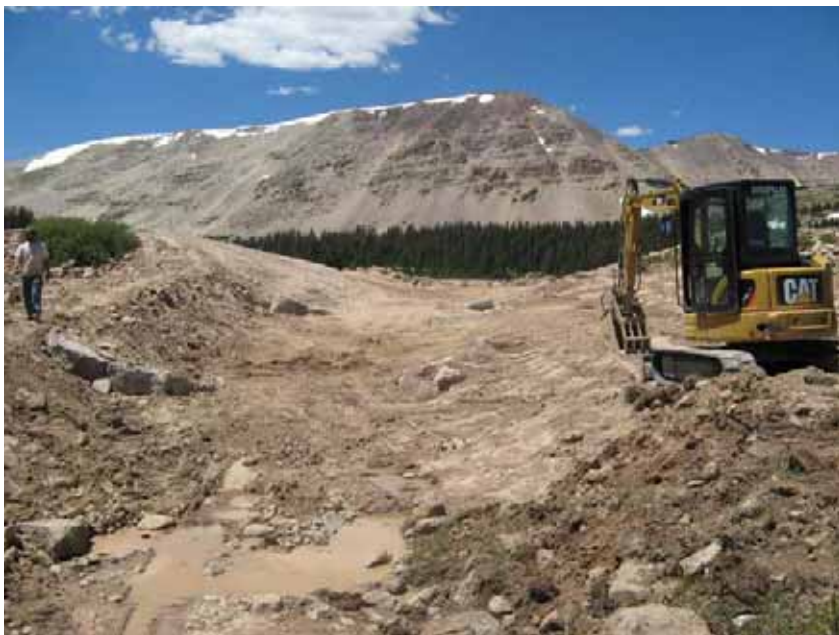
Figure 17: Breach channel prior to placing riprap.

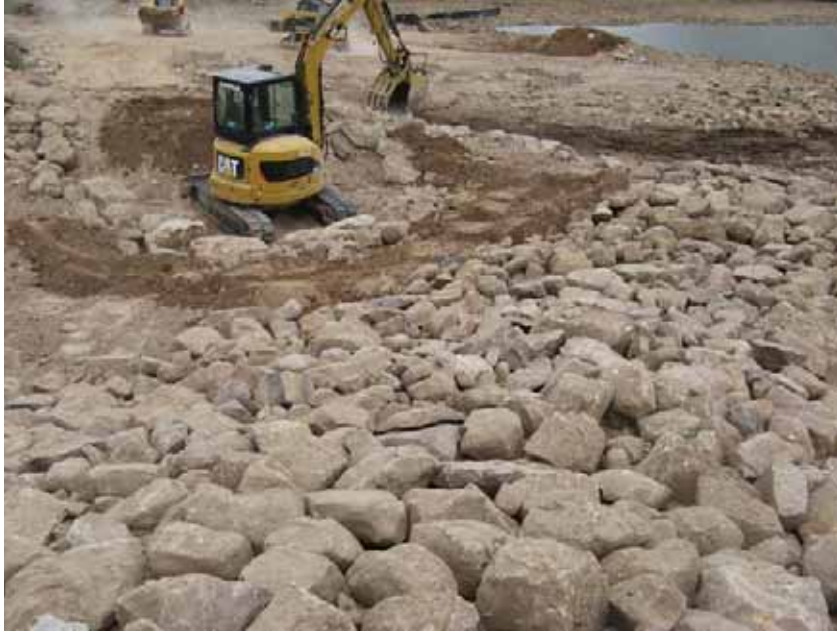
Figure 18: Crew placing riprap in the channel using mini-excavator.

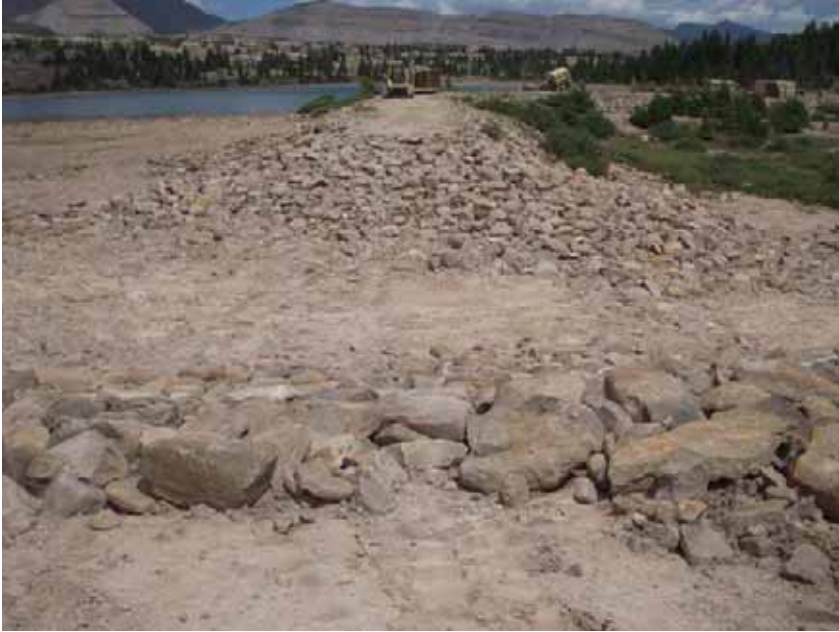
Figure 21: View of finished channel at Five Point graded and lined with riprap.

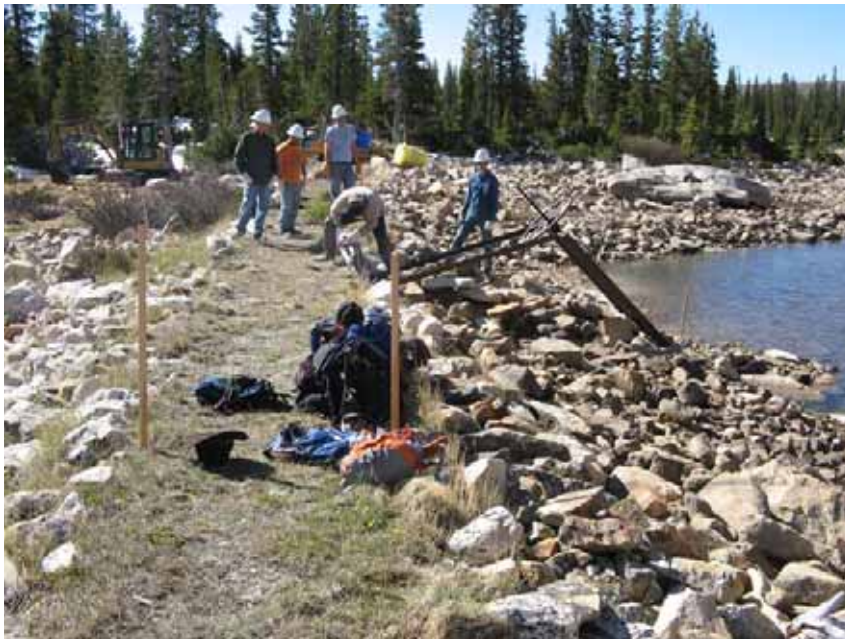
Figure 23: DCWCD crew removing headgate.

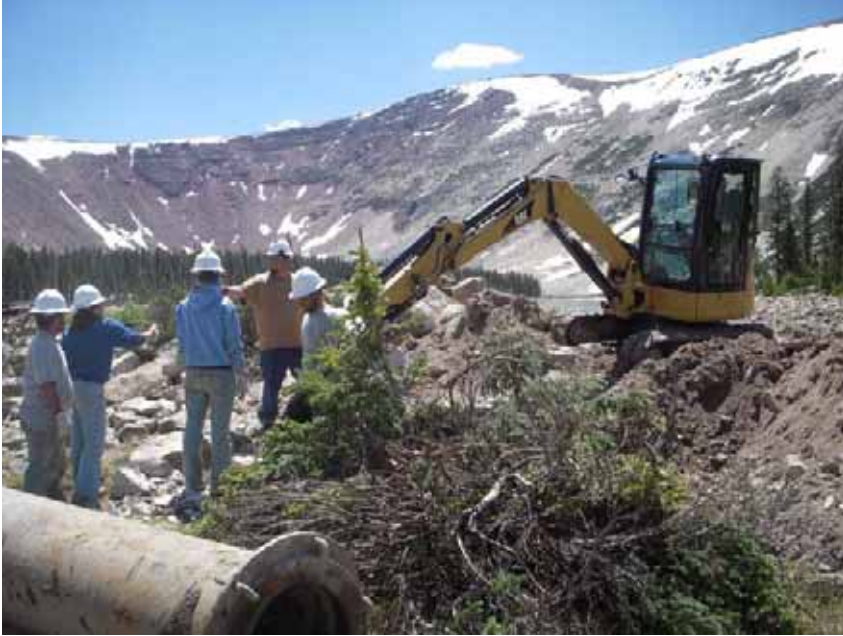
Figure 24: Crew removing outlet pipe.

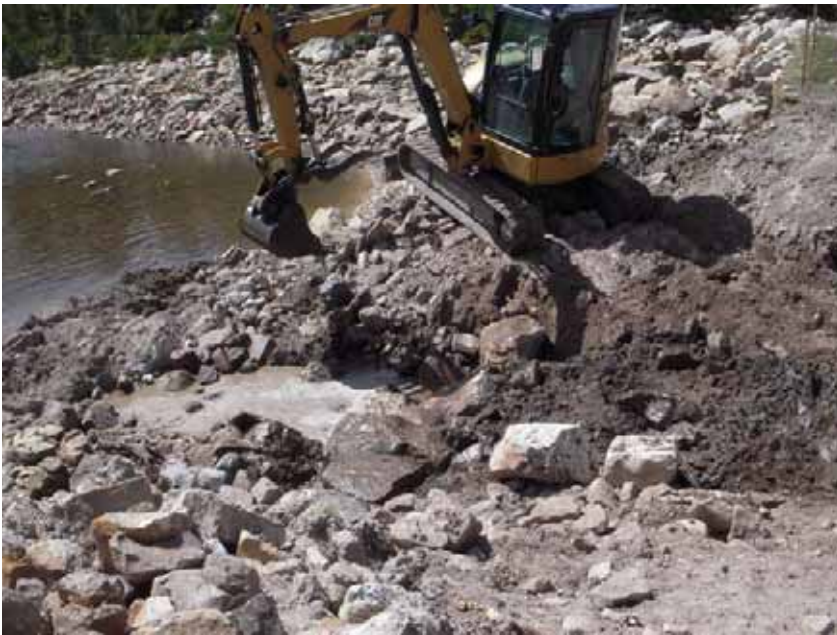
Figure 25: Crew installing rock sills at Bluebell Lake.

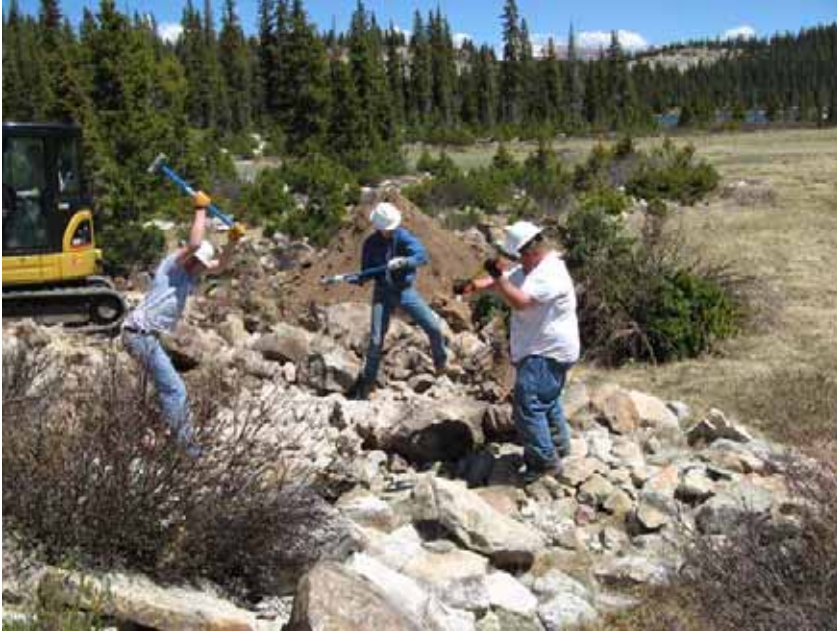
Figure 26: Hand crew assisting with breaking up concrete structure with sledge hammers which was proven ineffective, so they used the stinger attachment to get the job done. Bluebell Lake.

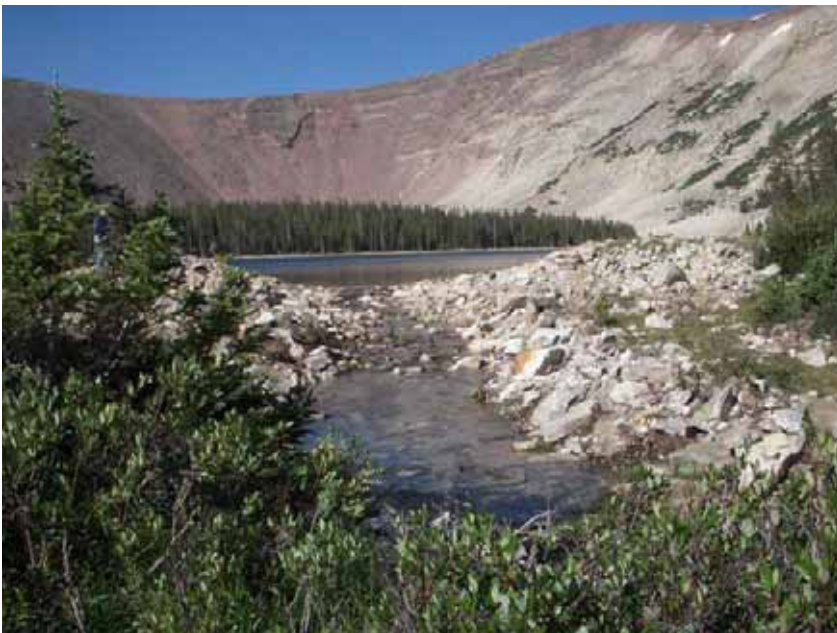
Figure 27: Looking upstream to the finished channel w/ riprap in place.

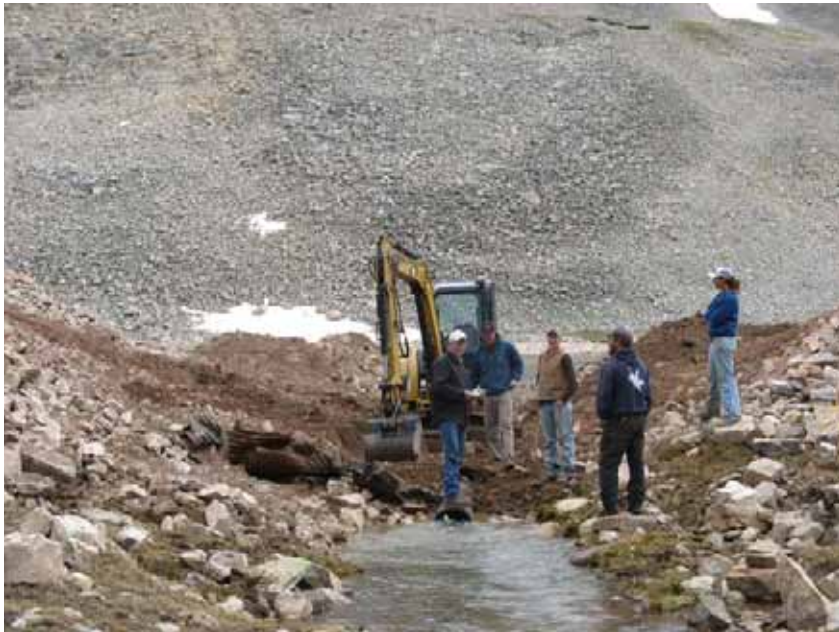
Figure 30: Crew cut through dam and removed the outlet pipe.

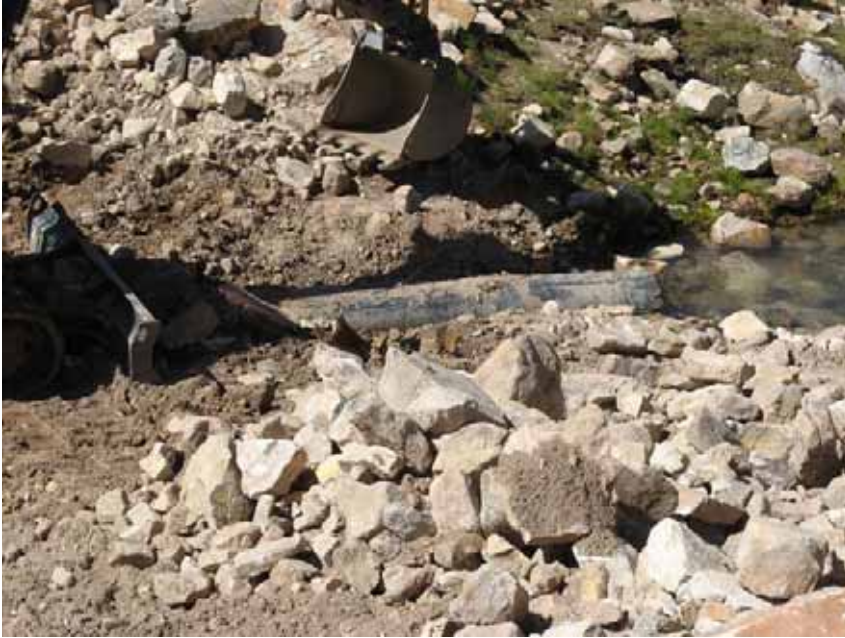
Figure 33: Crew used trackhoe to remove the outlet pipe.

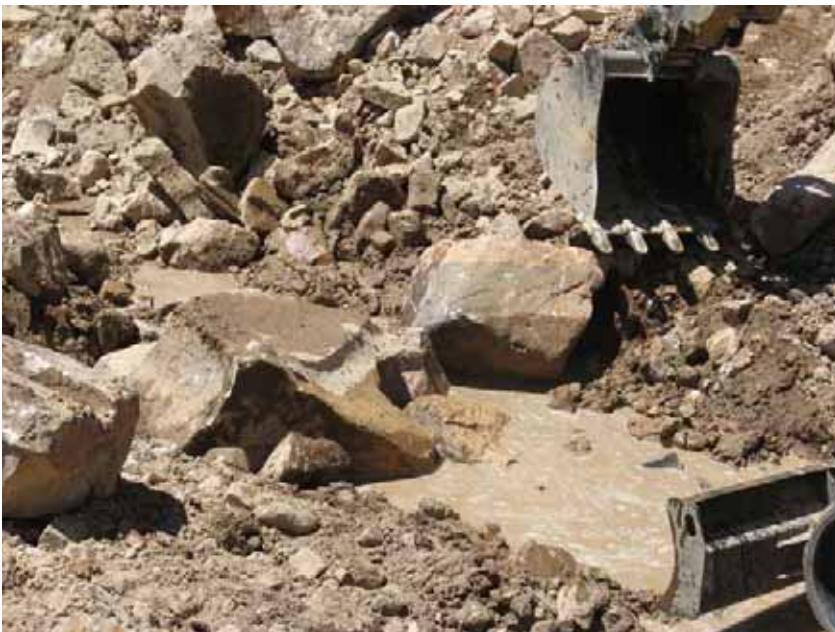
Figure 34: Rock sills placed in channel.

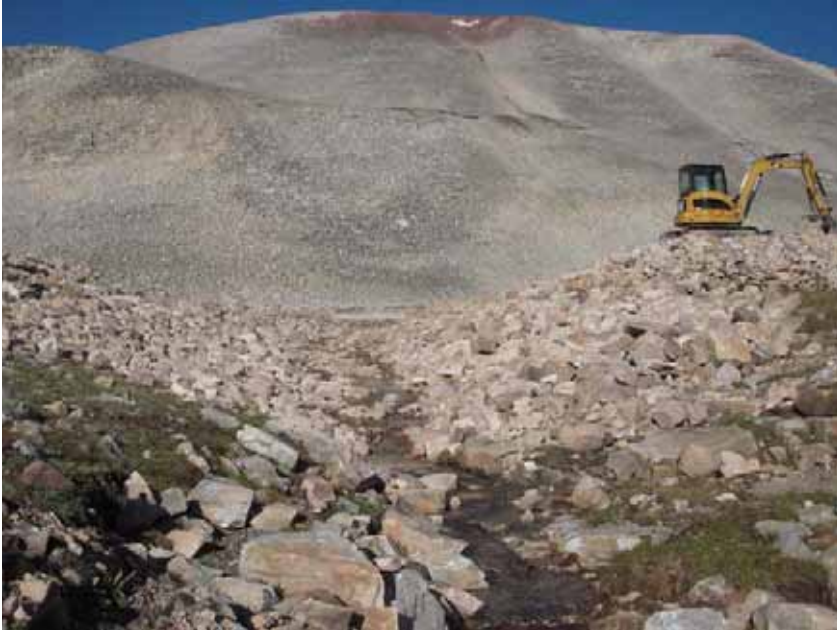
Figure 37: Looking upstream on the completed breach channel at Drift Lake.

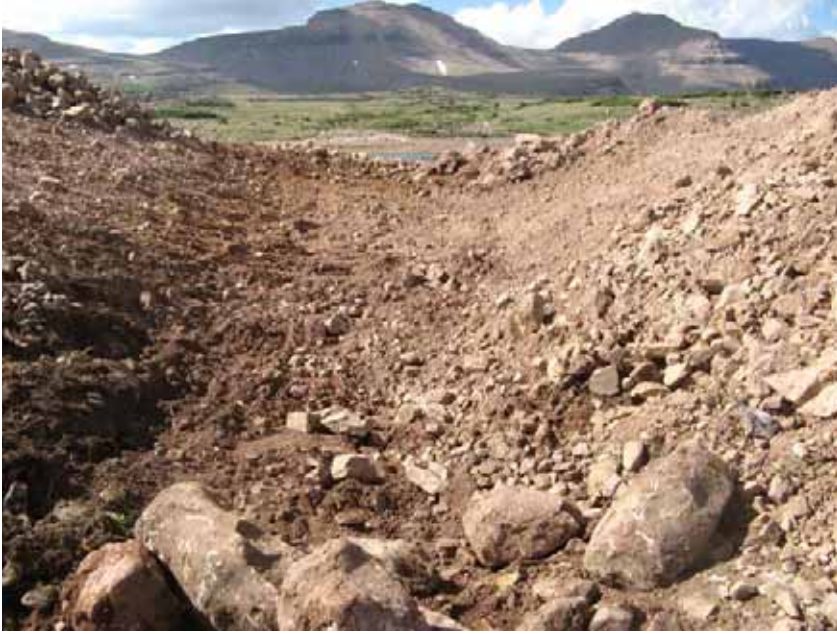
Figure 40: Completed breach prior to placing gabion cutoff walls and riprap.

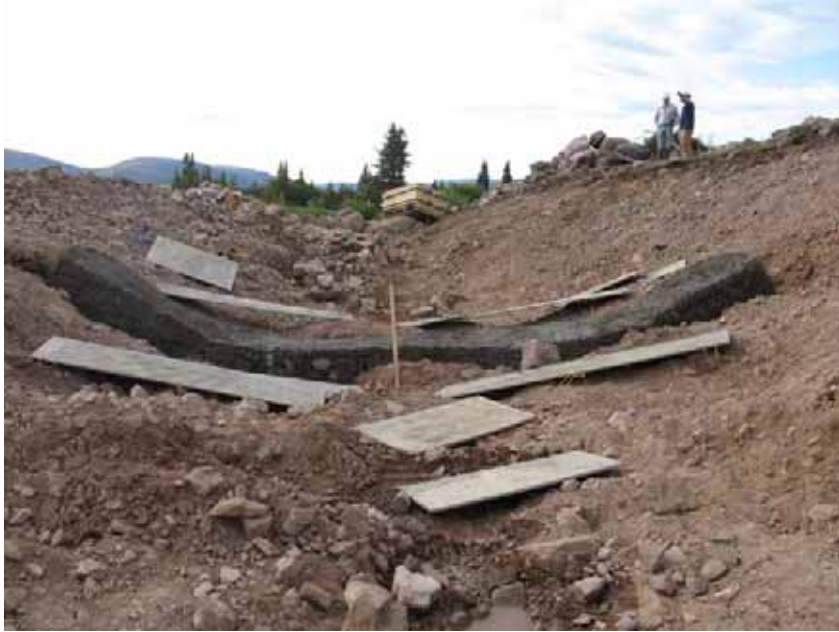
Figure 43: Grouted middle cutoff wall in place with forms removed.

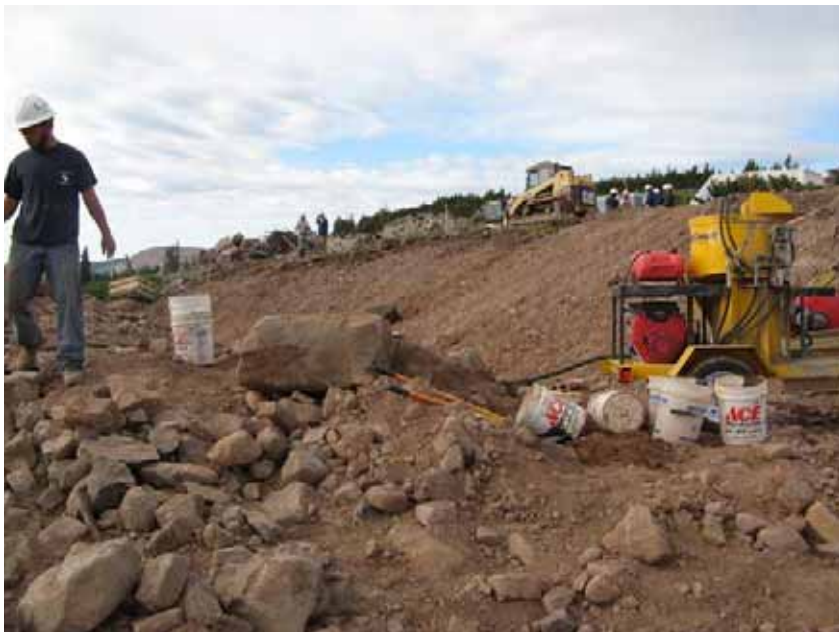
operation started on August 5th and the crew quickly learned that the outlet pipe had several holes in it which required extra cement bags to fill. Bob Leake and Brad Weber rode to Five Point to carry 40 leftover bags of cement back to Superior Lake using their pack horses, enabling the crew to fill the Superior outlet pipe. The calculated volume of cement needed to grout the outlet pipe was 140 bags, when all was completed the crew used 189 bags of cement (47 pounds each) to fully grout the outlet pipe. Filter sand and gravel was installed at the downstream side of the lower outlet gabion to bedrock.

Figure 50: Grouting operation underway for plugging the outlet pipe.

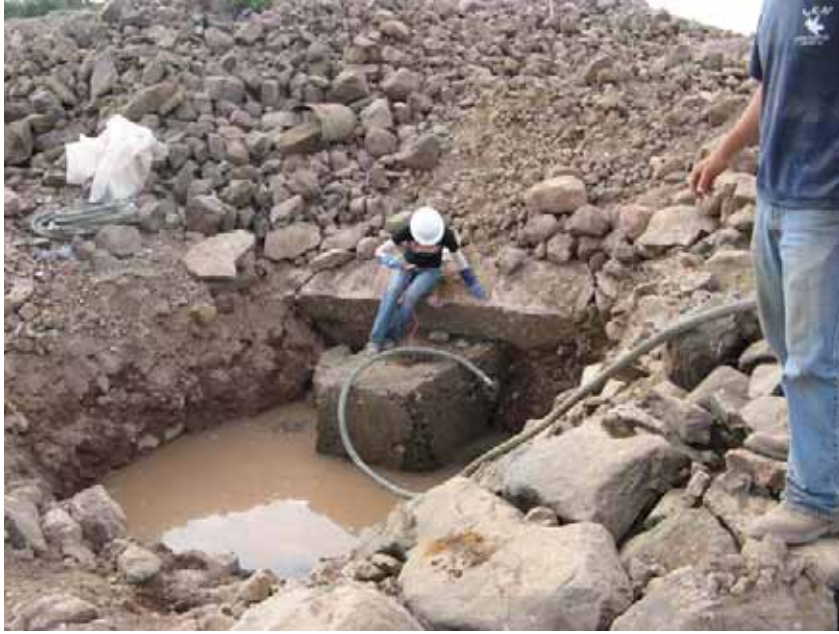
Figure 47: Crew sealed outlet pipe by placing 3'x3'x3' gabion basket filled with rock and grout on the upstream side of the outlet pipe.

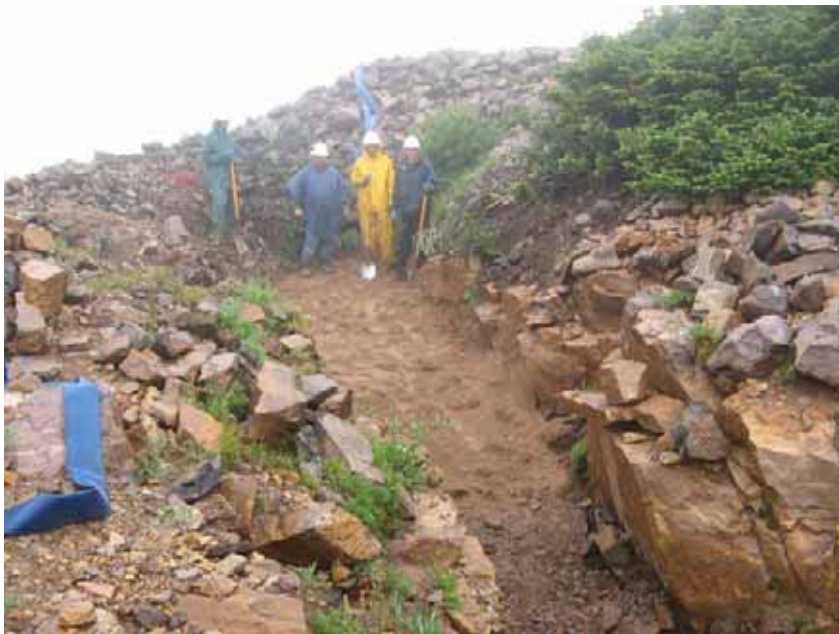
Figure 48: Sand filter in place at plugged outlet.

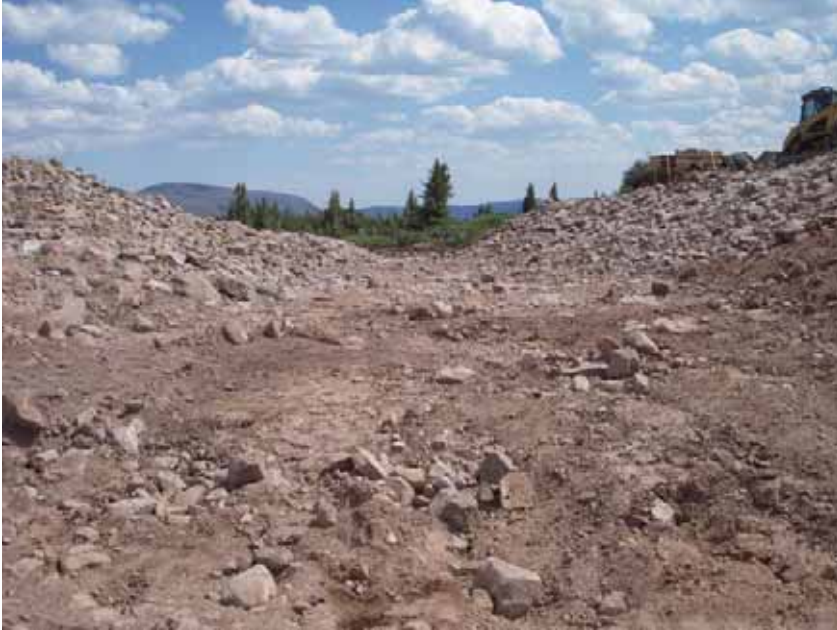
Figure 49: New breach at Superior Lake after work was completed.
