High Lakes Stabilization East Timothy Lake Construction Report

Uinta Basin Replacement Project

U.S. Department of the Interior
Bureau of Reclamation
Provo Area Office
Provo, Utah

November 2010

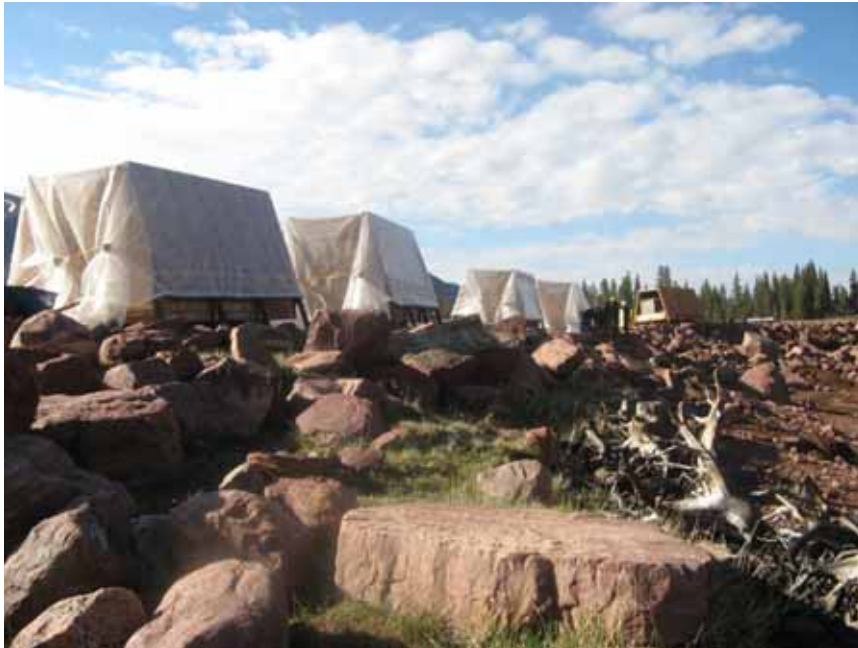
Figure 3: Fuel containment cover in place in preparation for blast.

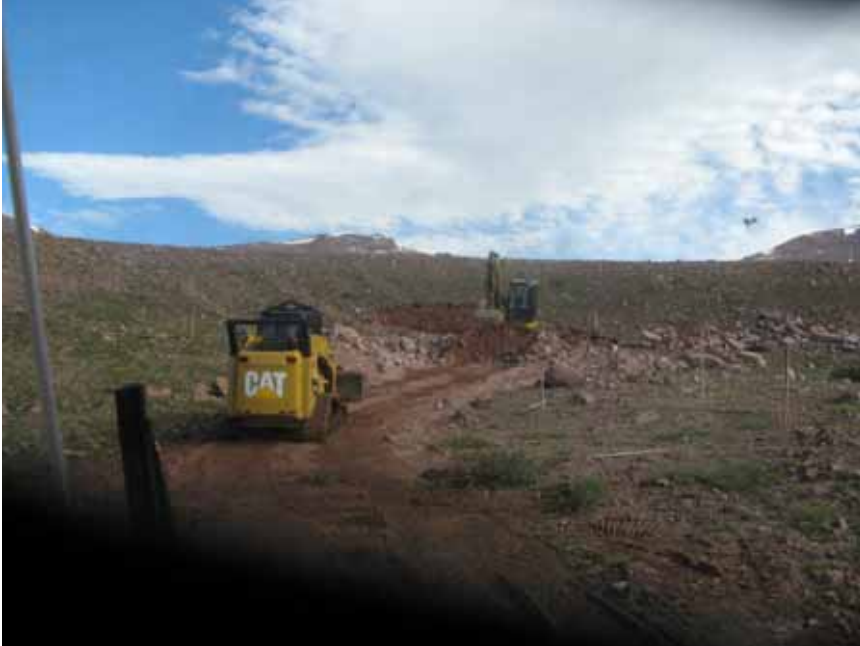
Figure 4: Crew using trackhoes and skidsteers to excavate breach.

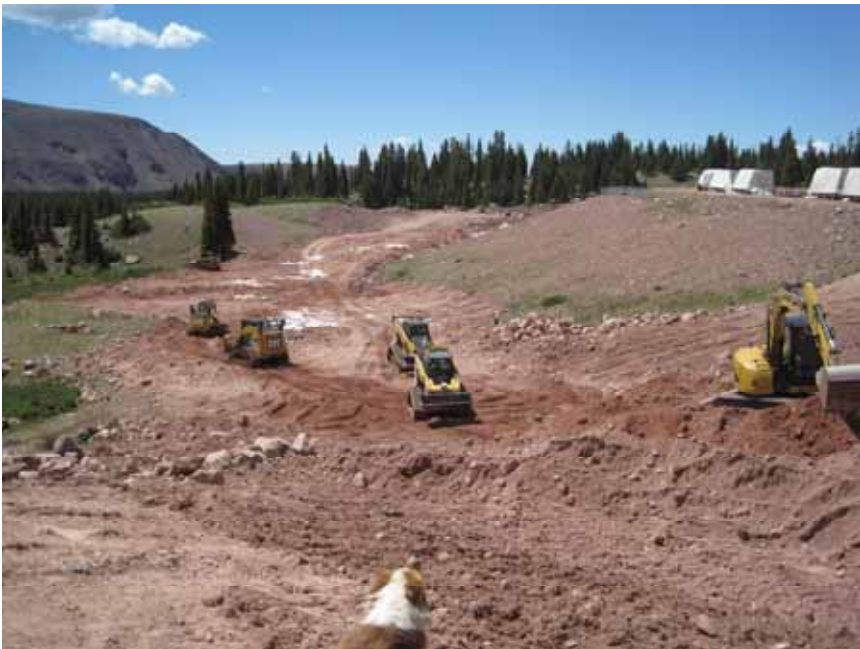
Figure 5: Material was removed from the dam and transported to spoil areas in an assembly line fashion.

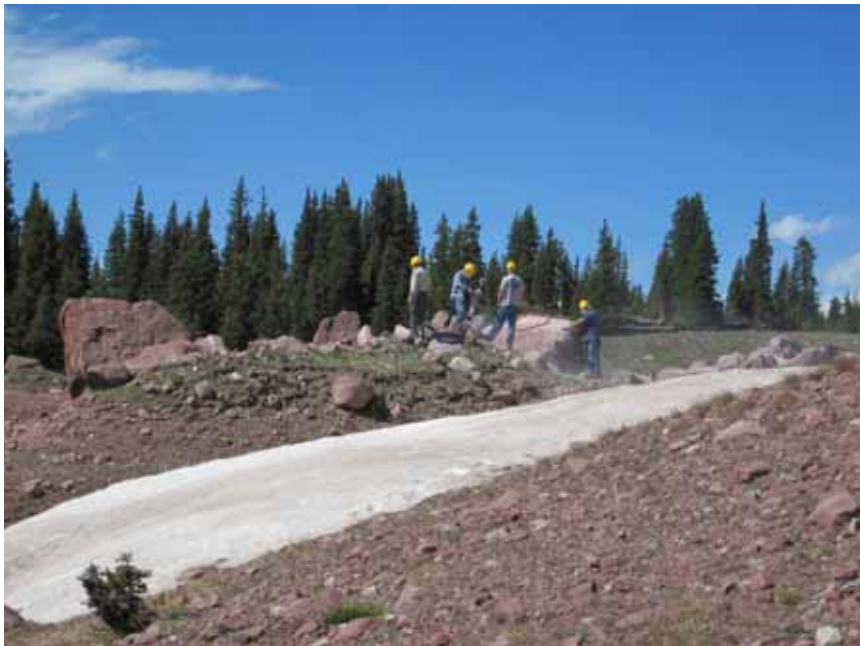
Figure 6: Forest Service blasters drilling and setting charge holes for blasting.

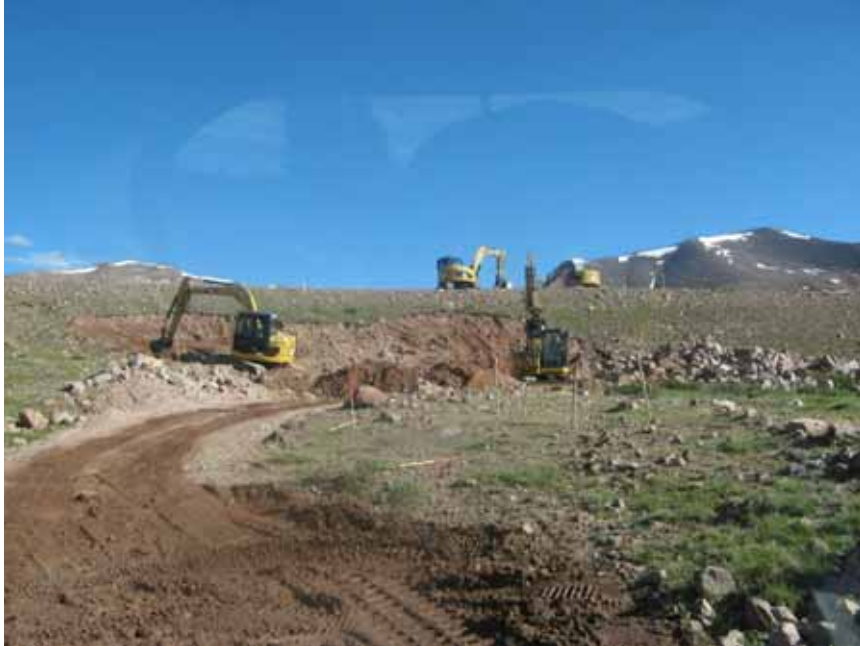
Figure 7: Four trackhoes were used to excavate the breach while six skidsteers hauled the material to the spoil pile.

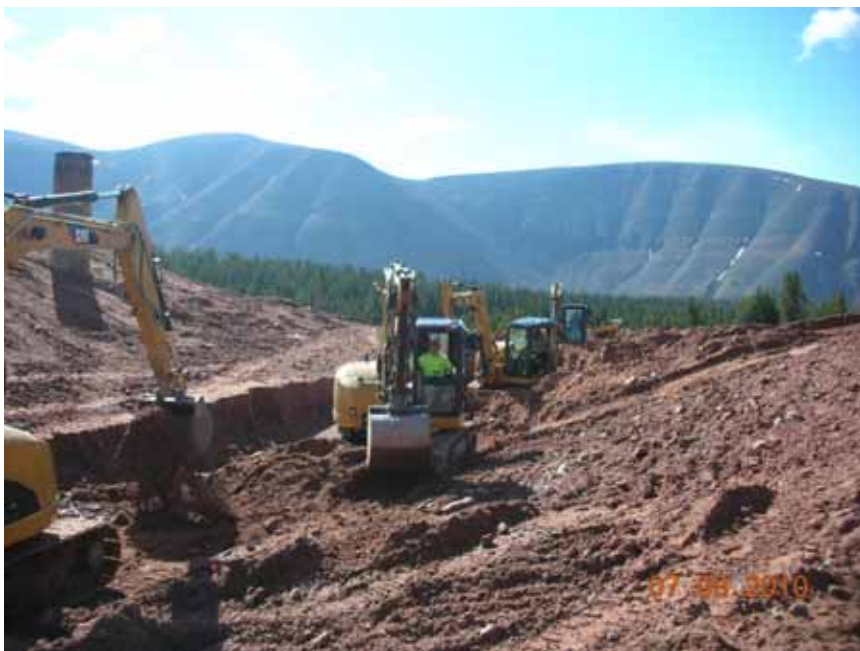
Figure 8: View of all four trackhoes working in breach before placing cut-off walls and riprap.

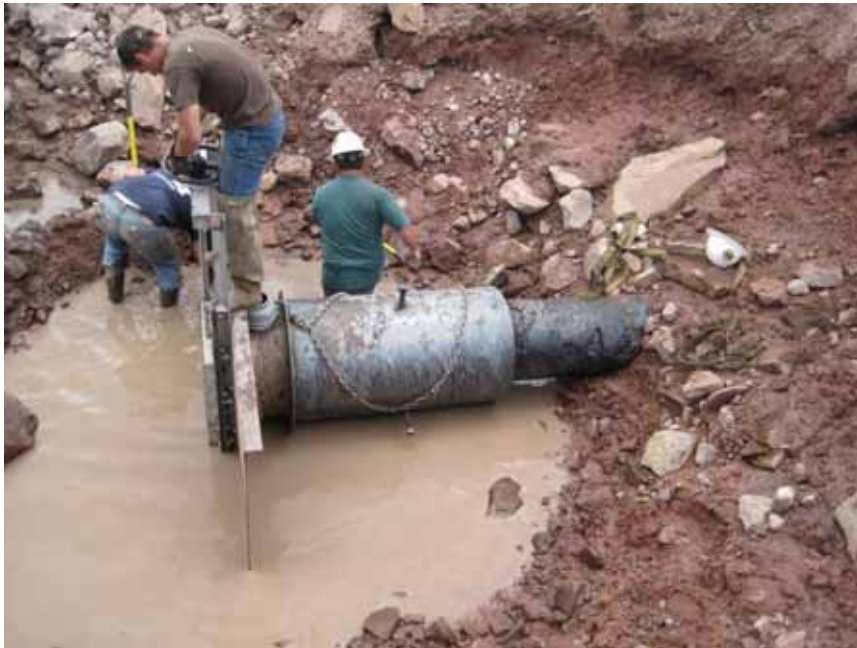
Figure 9: DCWCD and UCC crews installing head structure (designed for up to 30lb back pressure).

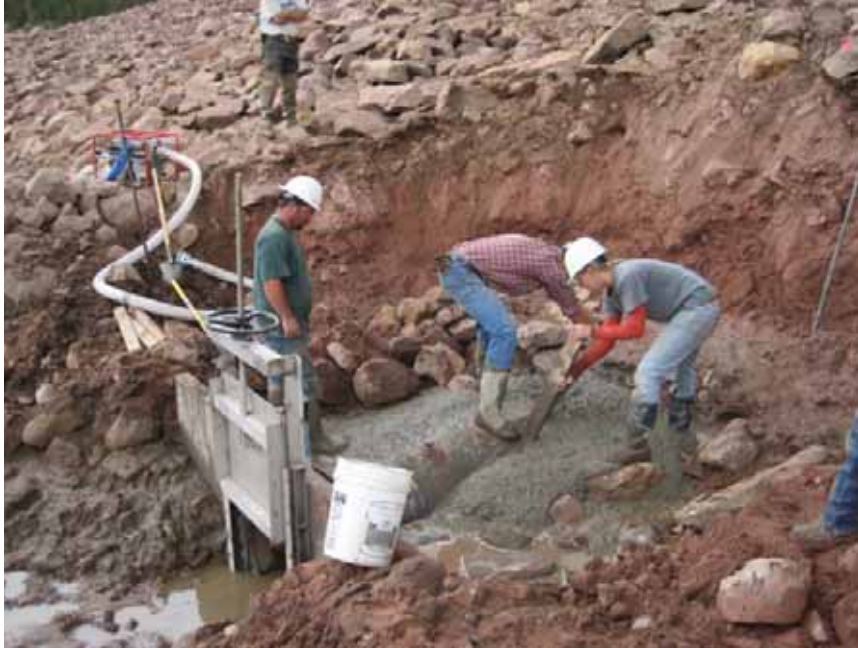
Figure 10: Crew batching and pouring cement on new head structure on existing outlet pipe.

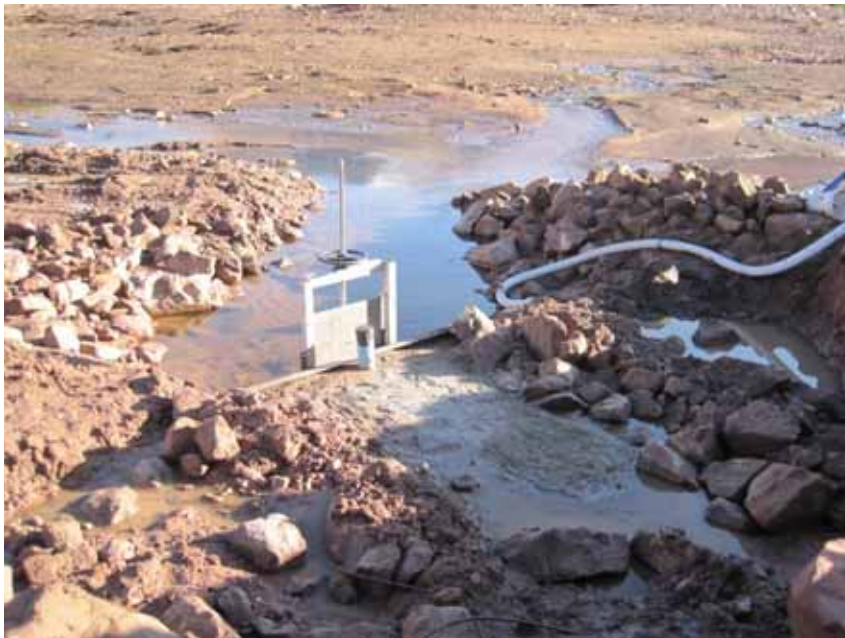
Figure 11: View of new head structure with concrete poured around existing outlet pipe.

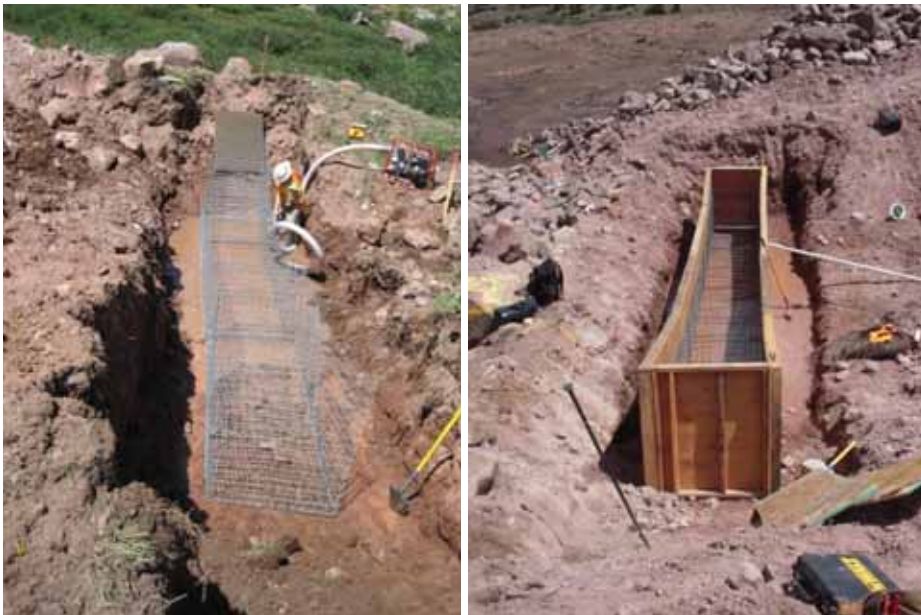
Figure 12: Gabion cutoff walls with forms and #9 wires ((3) 3'x4'x9').

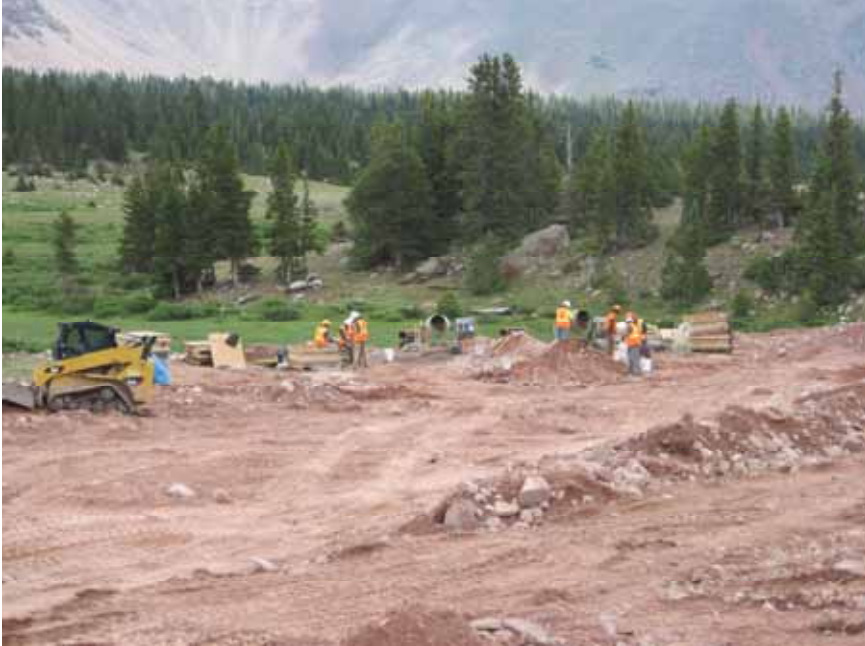
Figure 13: Crew mixing and delivering cement for gabion cutoff walls.

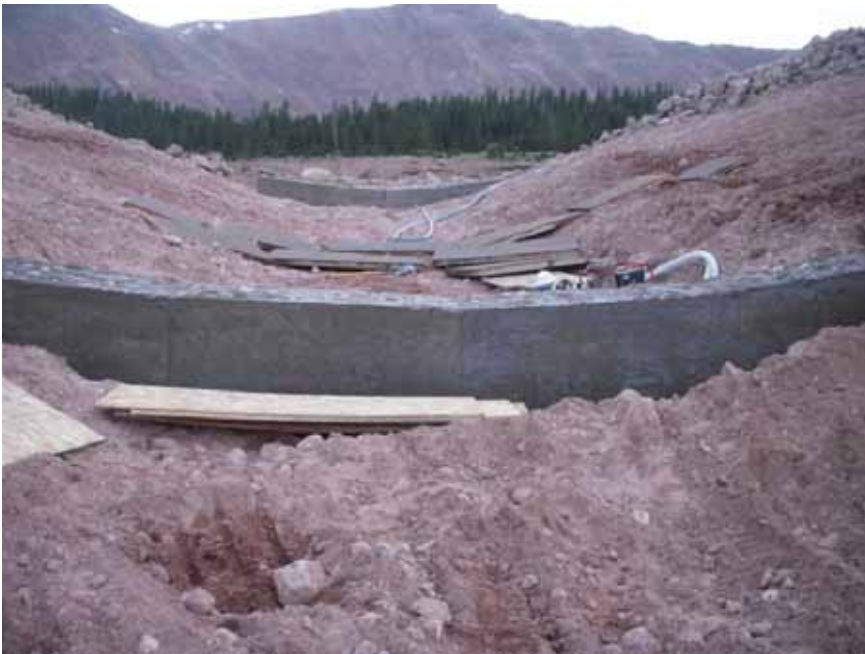
Figure 14: First and second gabion cutoff walls poured in place (looking upstream).

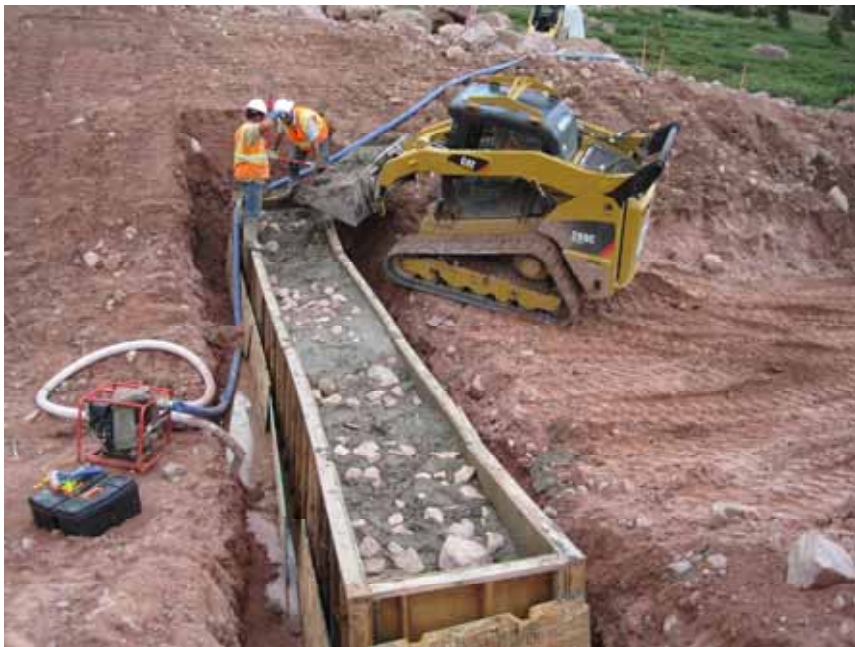
Figure 15: Crew pouring 3rd gabion basket using skidsteer for transporting cement.

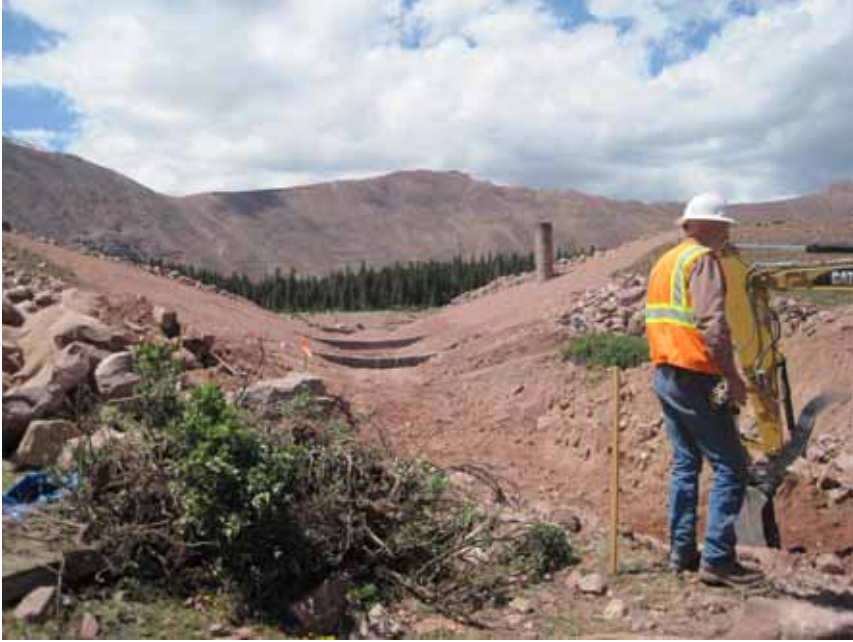
Figure 16: Looking upstream with three gabion walls in place.

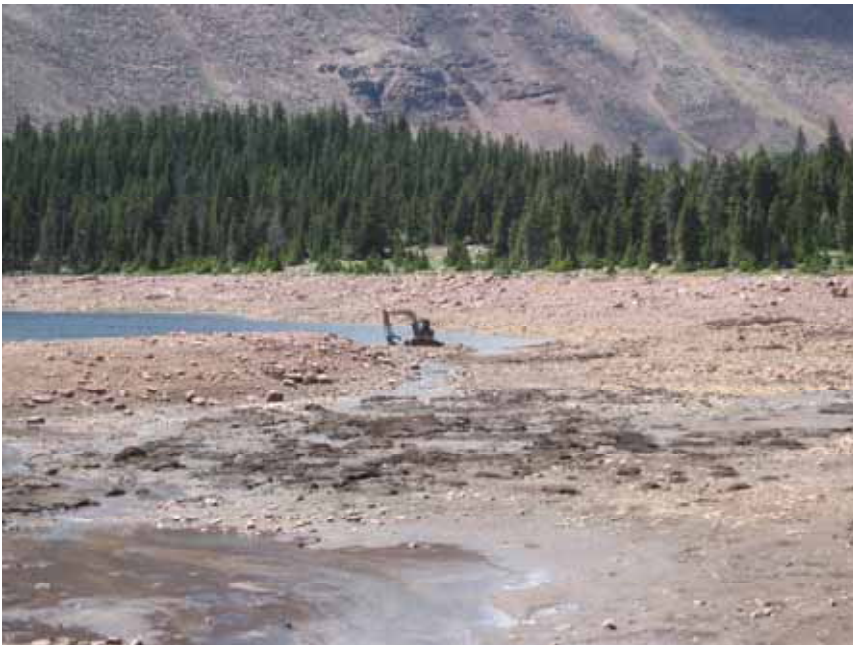
Figure 17: Trackhoe excavating the lake connection channel.

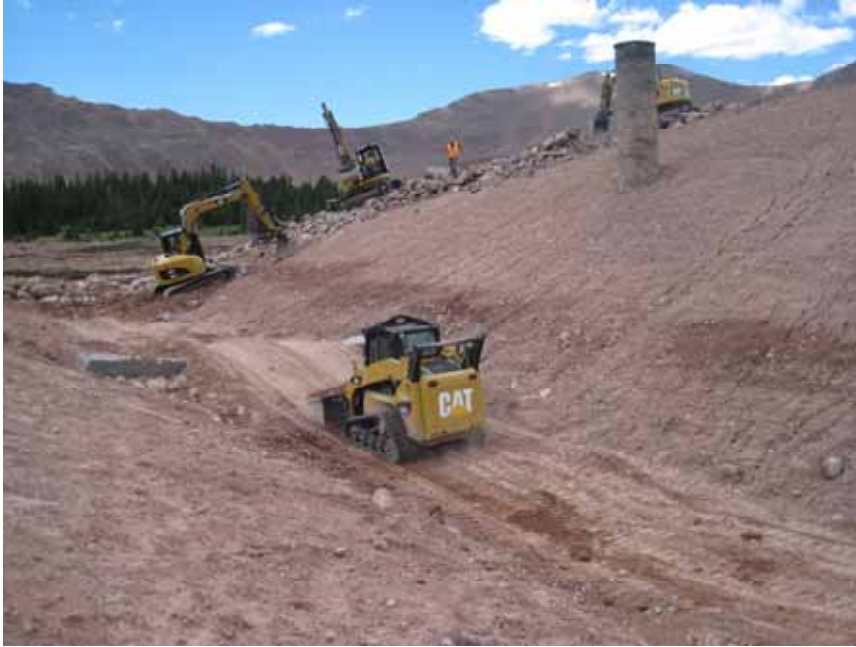
Figure 18: Skidsteer transporting rip-rap and fines while trackhoes place riprap on breach.

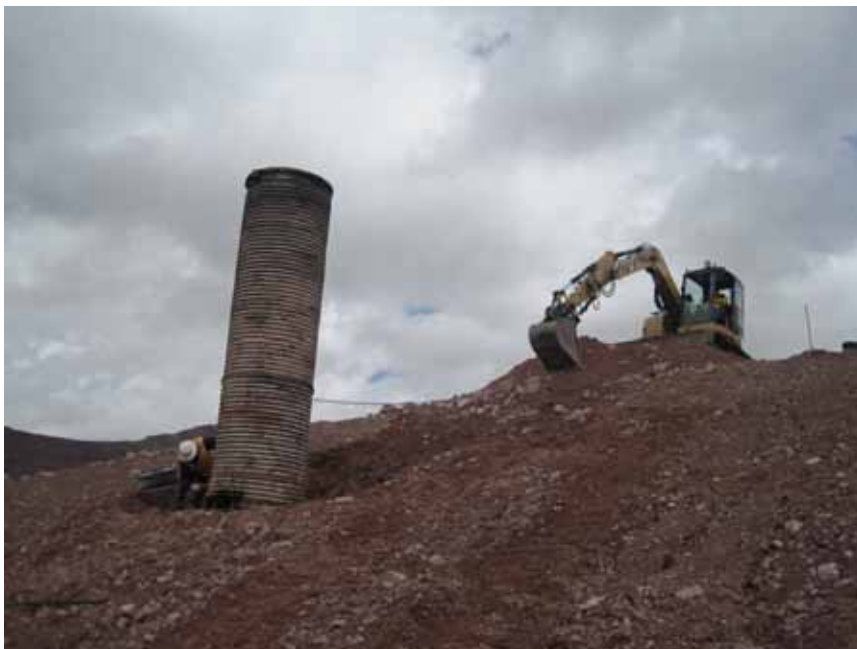
Figure 19: Randy Crozier cutting the 48 inch gate well tower with a torch.

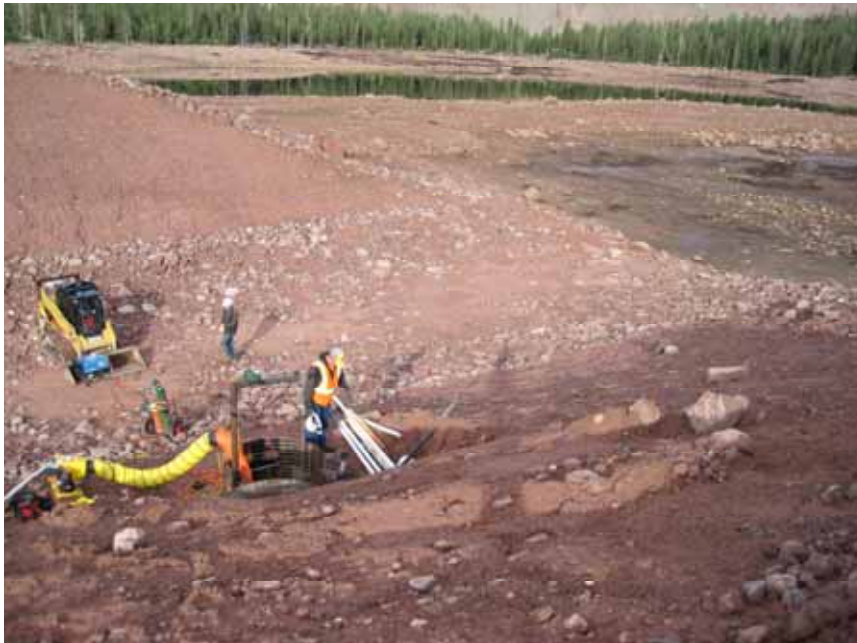
Figure 20: Crew preparing for confined space entrance into gate well.

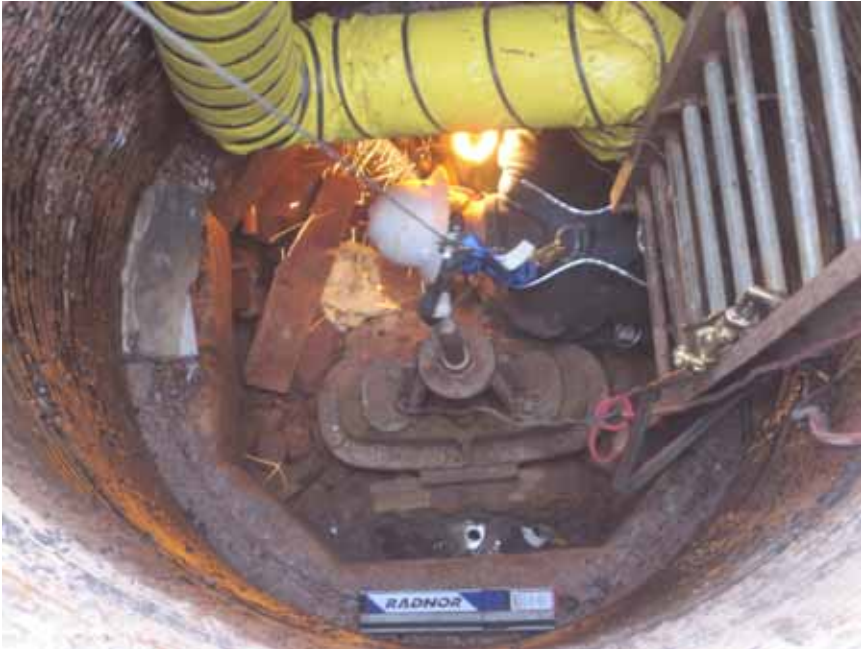
Figure 21: Randy Crozier in gate well welding in 1-1/4" nipples.

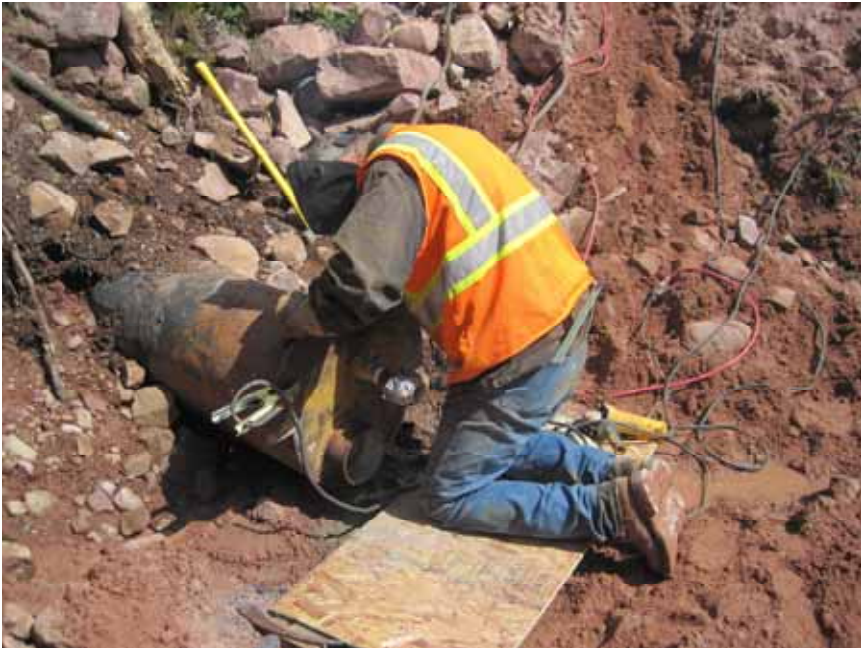
Figure 22: Randy Crozier welding steel plate on downstream end of pipe.

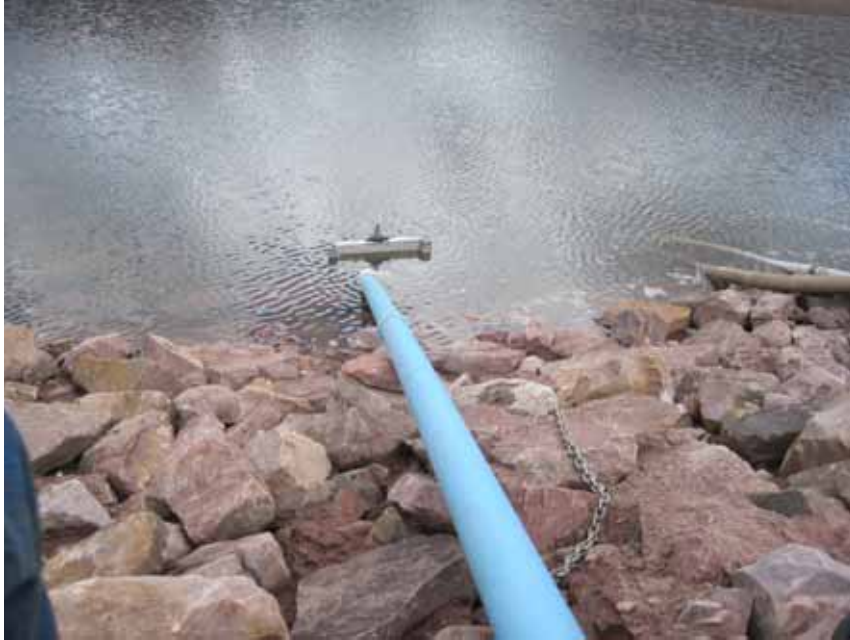
Figure 23: 4" vent pipe on upstream structure used for grouting; it was broken off when grouting operation was completed.

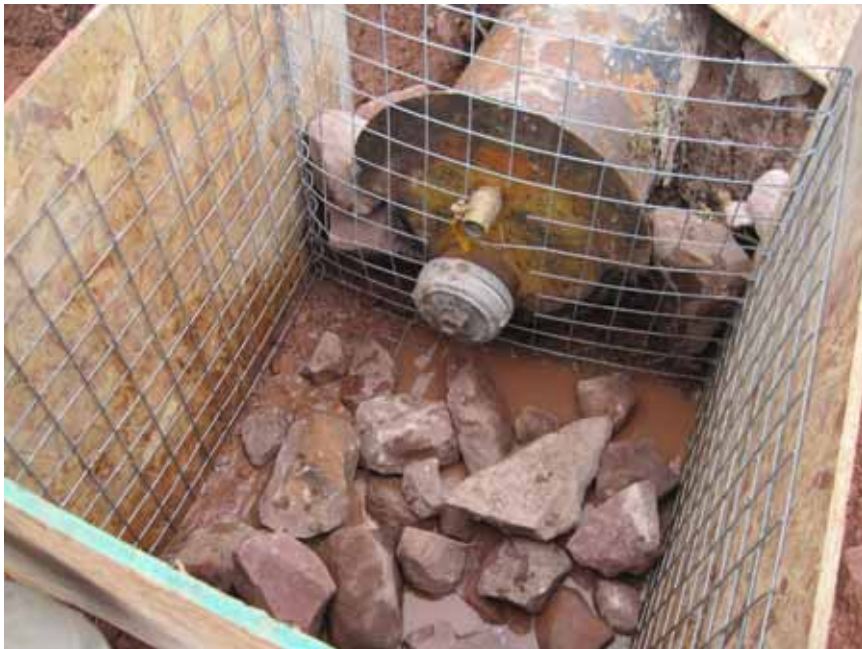
Figure 24: 3'x3'x3' gabion at downstream end of pipe.

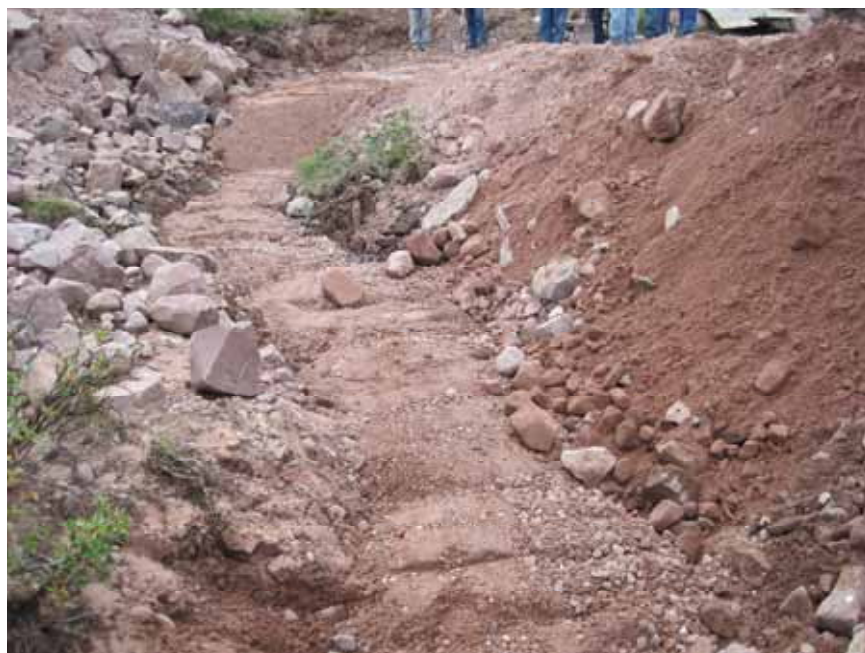
Figure 25: Looking upstream to sand filter and pea gravel drain in place on downstream side of outlet pipe.

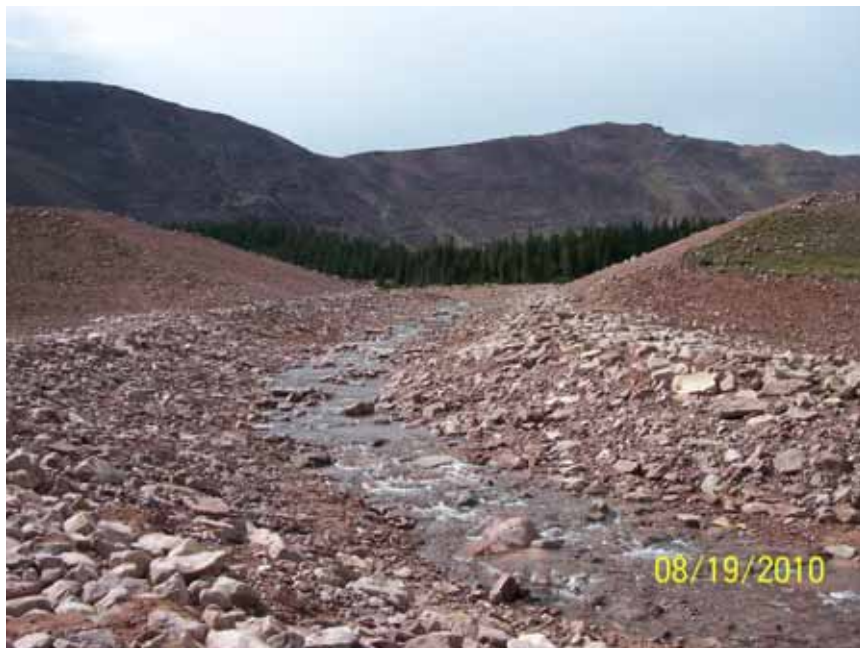
Figure 26: Looking upstream to the completed breach with water flowing through it.
