As-Built Report
Turnbow Diversion near Hanna, Utah

**Utah Reclamation Mitigation
and Conservation Commission**

Allred Restoration, Inc

August 2010

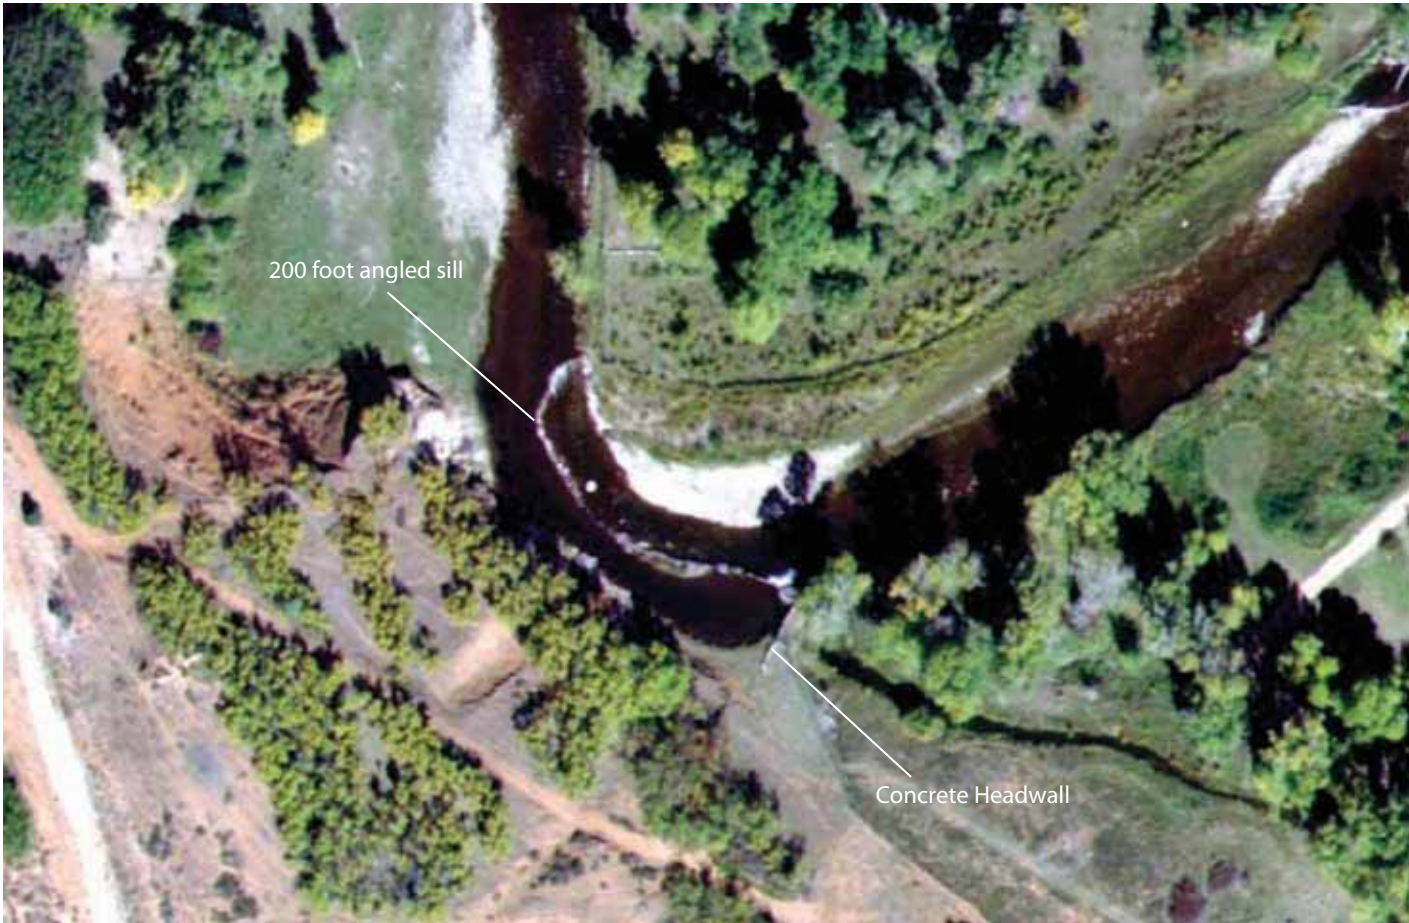
The Turnbow Diversion area is on river right, and is located roughly 1000 feet downstream of a county road bridge. The diversion previously consisted of a long angled sill and a concrete headwall (Figure 3). Although the width of the Duchesne River is only approximately 40 feet in this area, the sill length was almost 200 feet. The sill was composed of large rock, cobble, gabions, beams, plastic, chain link fencing, and other items (Figures 4, 5, and 6), and it required frequent maintenance because it was unstable

Figure 3. Aerial image of the pre-project condition of the Duchesne River at the Turnbow Diversion, showing the long angled sill and the location of the headwall.

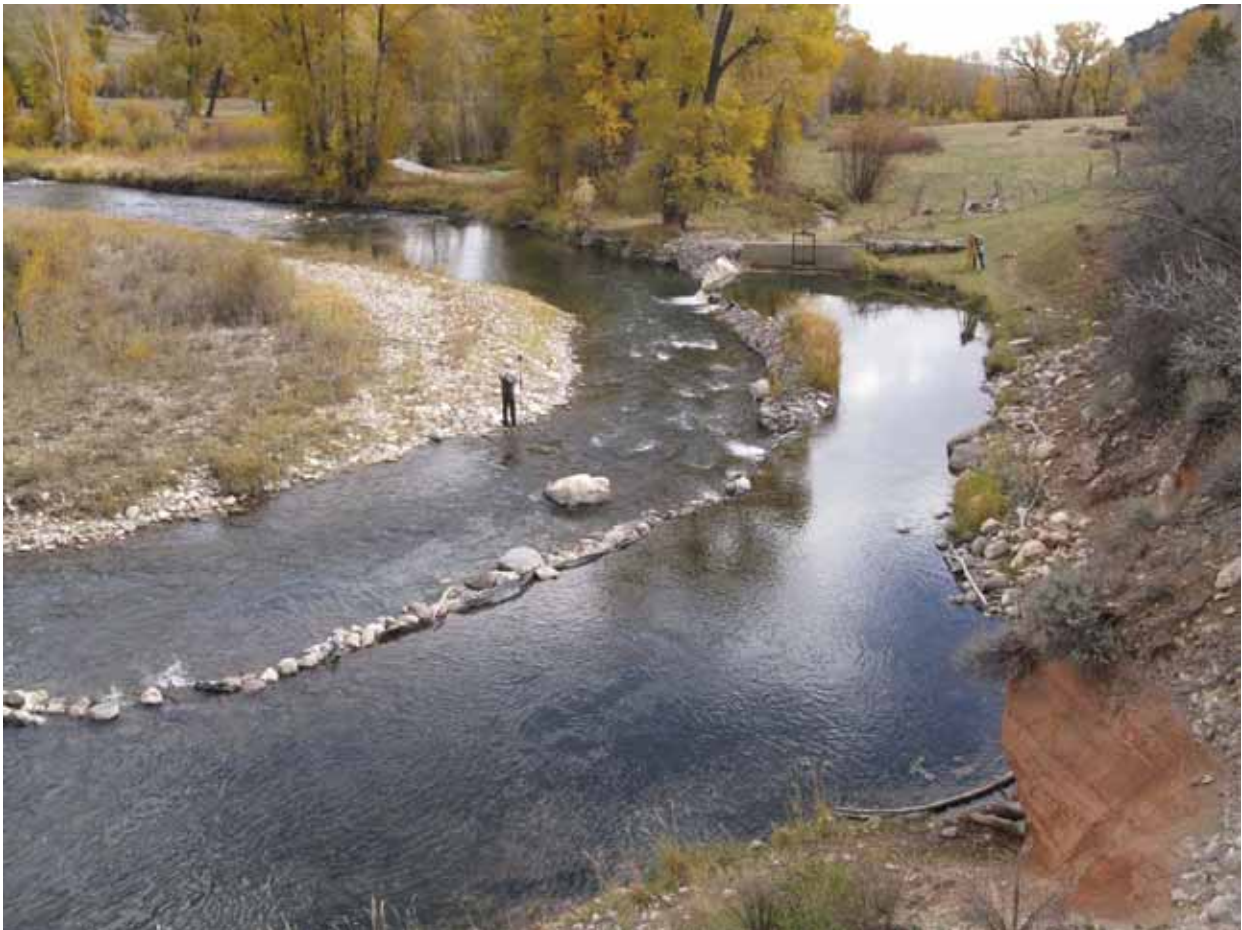
Figure 4. Photograph of the pre-project sill and headwall at the Turnbow Diversion, taken from cliffs on river right, looking downstream.

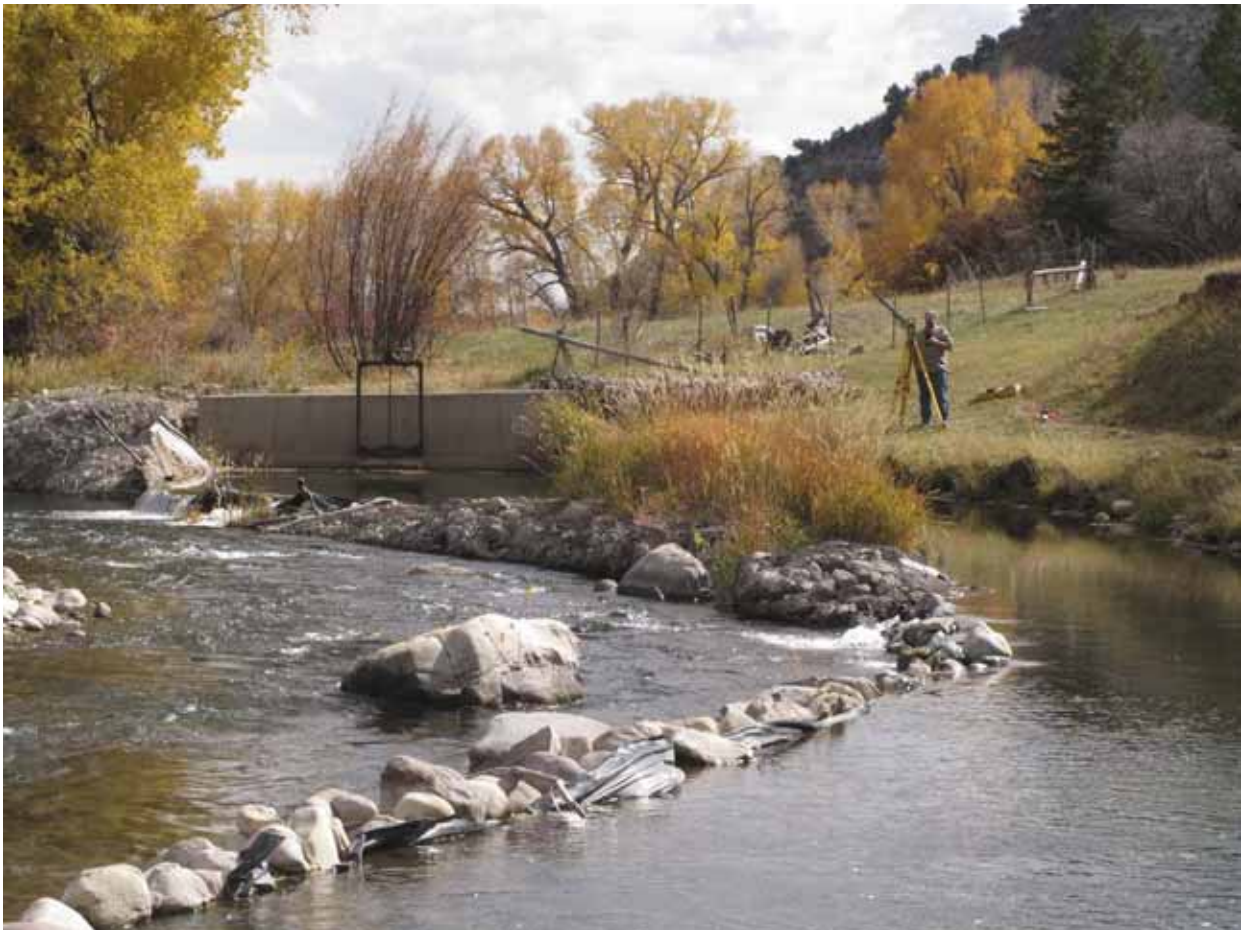
Figure 5. Photograph of the pre-project sill and headwall at the Turnbow Diversion, showing plastic and other debris in the sill.

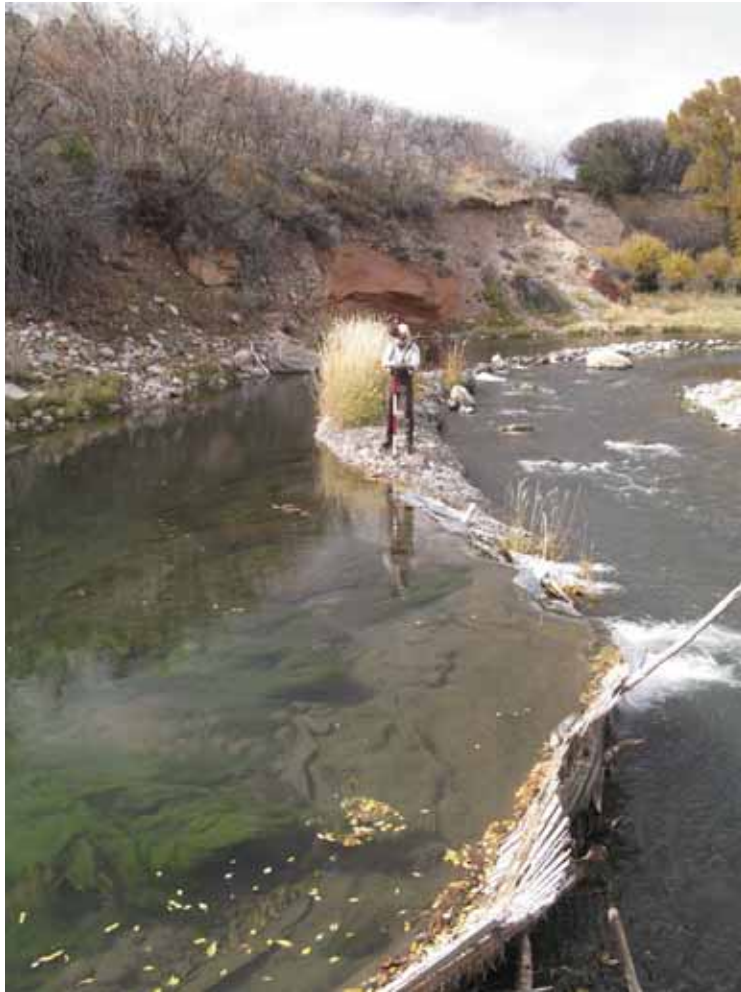
Figure 6. Photograph of the pre-project sill at the Turnbow Diversion, showing miscellaneous debris used in the sill.

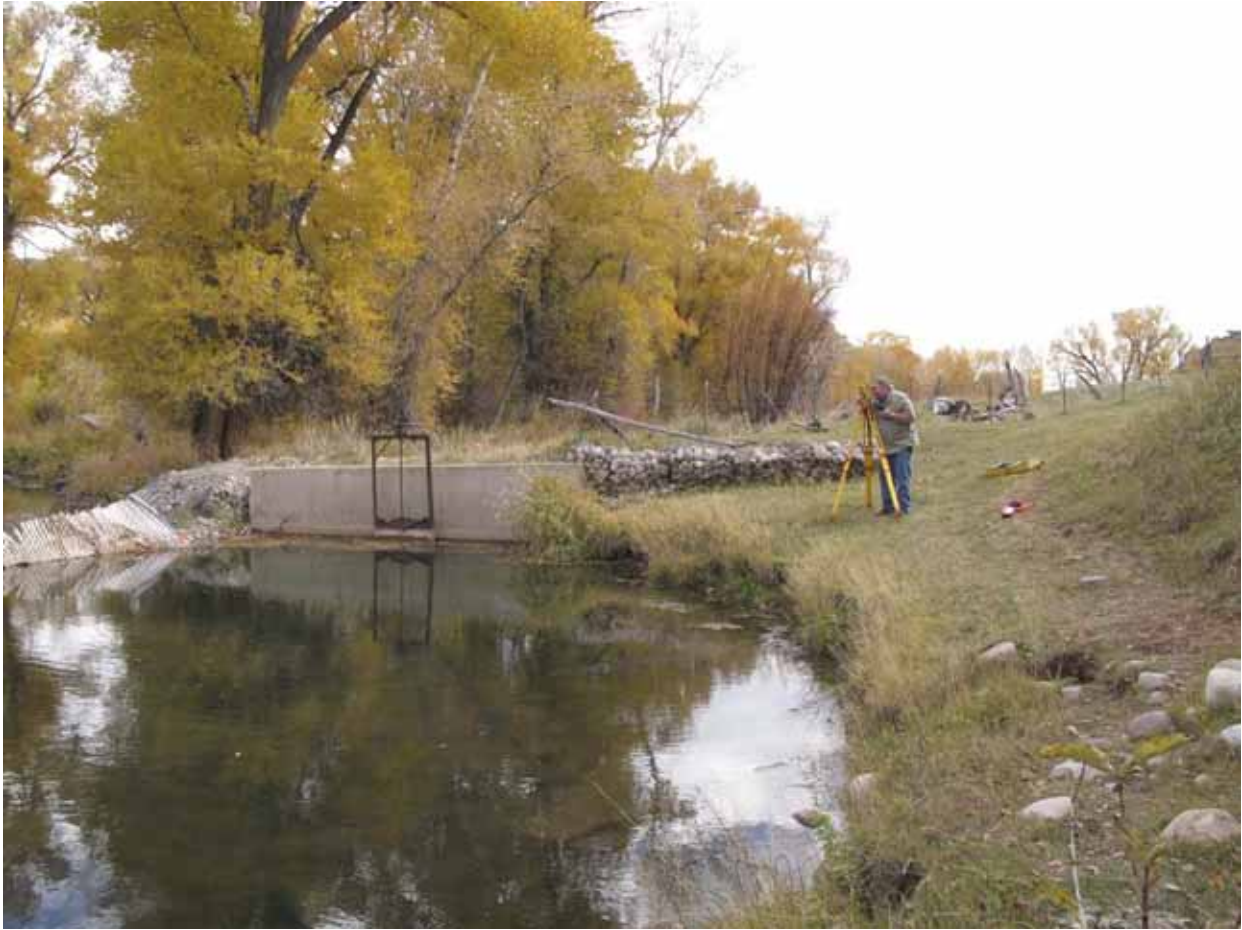
during periods of high streamflow. The headwall was protected by gabions (Figure 7) and was fairly new and in relatively good condition, however, its location and configuration, with respect to the channel, promoted sediment deposition in the entry and did not provide adequate flow to the ditch system (Figure 8), which has a very low gradient.

Figure 7. Photograph of the pre-project headwall and gabions at the Turnbow Diversion.

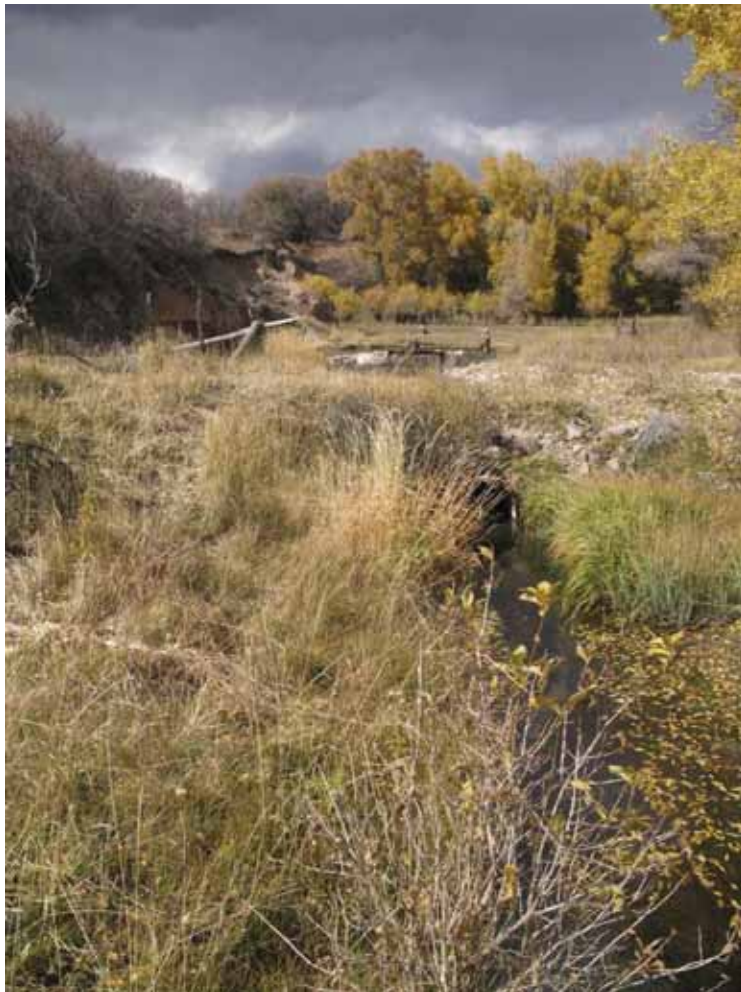
Figure 8. Photograph of the pre-project exit culvert and ditch at the Turnbow Diversion, looking upstream.

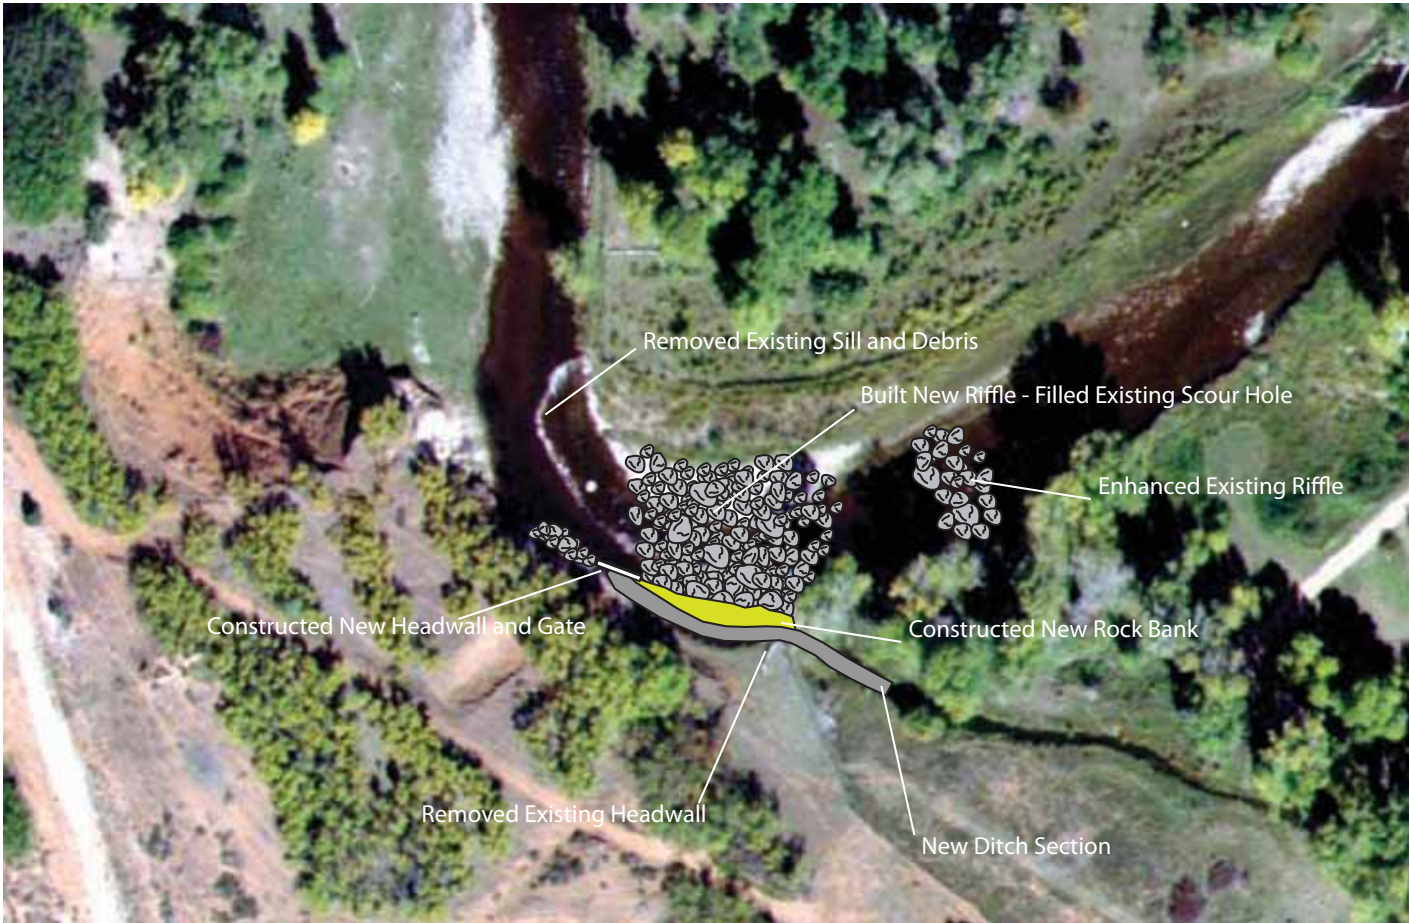
Figure 9. Completed action elements to rebuild the Turnbow Diversion.

The major elements of the diversion project are shown in Figure 9. The old sill was replaced with a new rock riffle at the location shown. The riffle was constructed to mimic a “natural” form (Figure 10), which allows fish passage while providing upstream water surface elevations that allow sufficient water to be diverted into the ditch. Instead of an abrupt drop, the new riffle loses elevation over a much longer distance. The gradual elevation loss required more rock to construct, but has the advantage of being very stable over time because it eliminates undercutting that is common at more abrupt sills. The scour hole below the old sill was filled with a matrix of large rock: voids were filled with river cobble during riffle construction. A smaller riffle located immediately downstream was enhanced and stabilized somewhat to create a small pool below the main riffle.

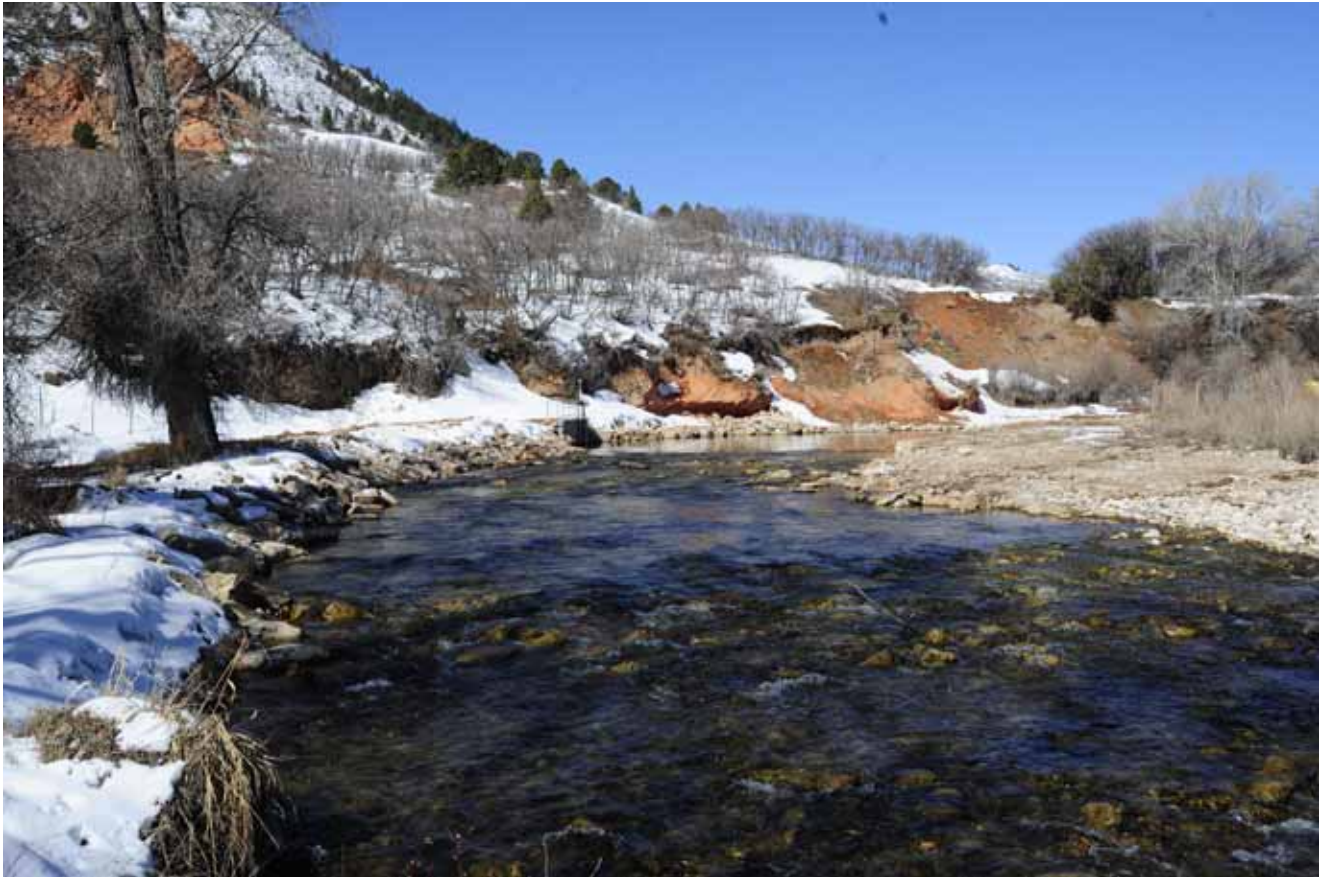
Figure 10. Photograph of newly-constructed riffle below the Turnbow Diversion. The riffle was constructed to have a natural form that does not promote erosion near the structure, and allows fish movement. This image was taken looking upstream. The new structure is visible near the center of the photo.

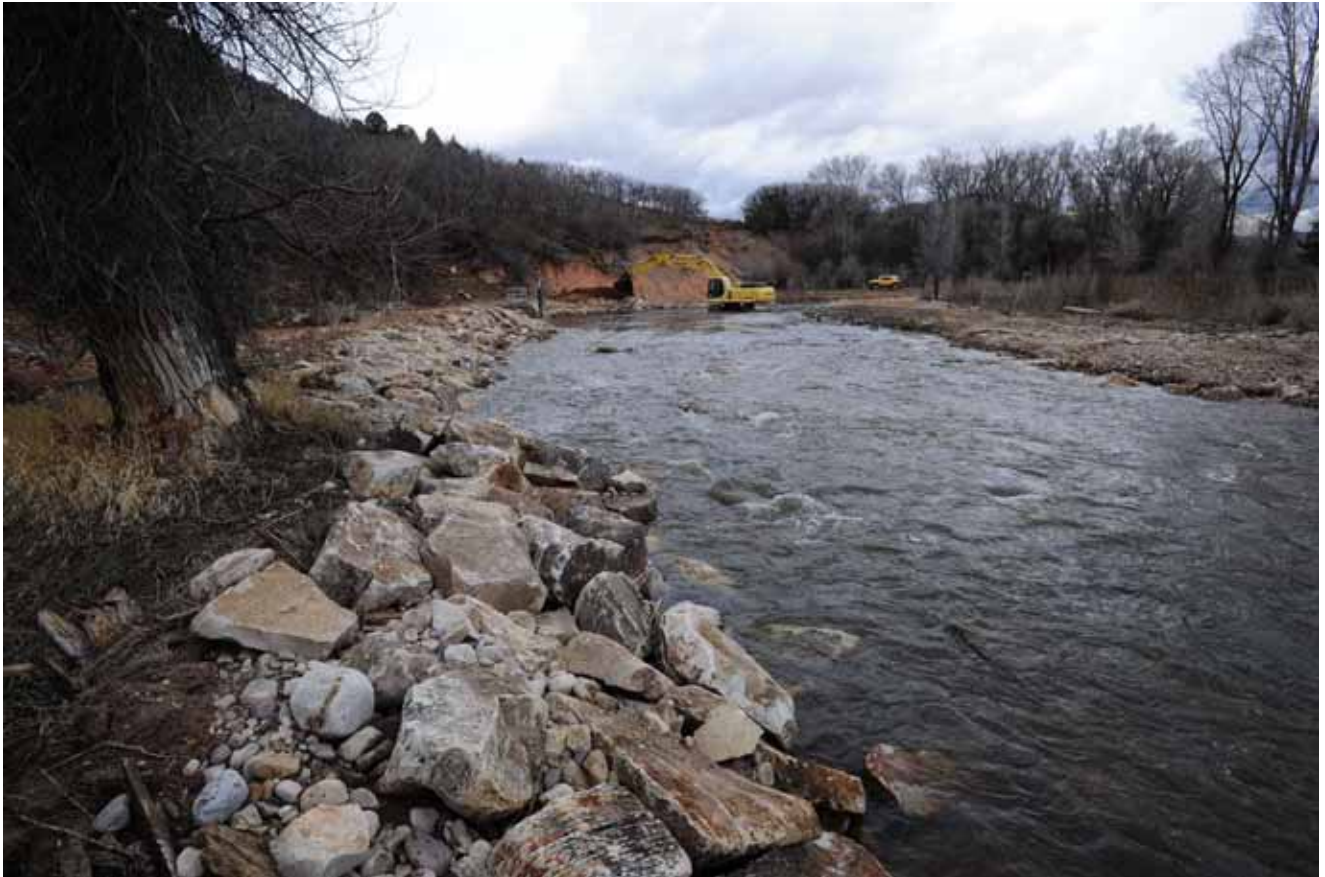
Figure 11. Photograph of the newly-constructed bank and rock protection downstream of the new structure. This photo also shows the constructed riffle at a somewhat higher discharge than is shown in Figure 10.

A new bank (Figure 11) was constructed using large rock with a minimum 1.5 foot median diameter, at the location shown in Figure 9. The bank was built with a riprap layer that is a minimum of 3 feet thick, with a side slope of 2 to 1. The rock layer in the new bank ties in directly to the large rock filling the scour hole to deter any future erosion or channel incision at the site. The new rock bank was positioned to allow room for a short ditch section to be constructed behind it (Figure 12). This new ditch section required some excavation of the finer-grained slope material, which was compacted and used to maintain separation between the river channel and the ditch, and to control leakage. The ditch did not require a fabric liner because leakage did not appear to be a problem. The new ditch joins the existing ditch system at grade.

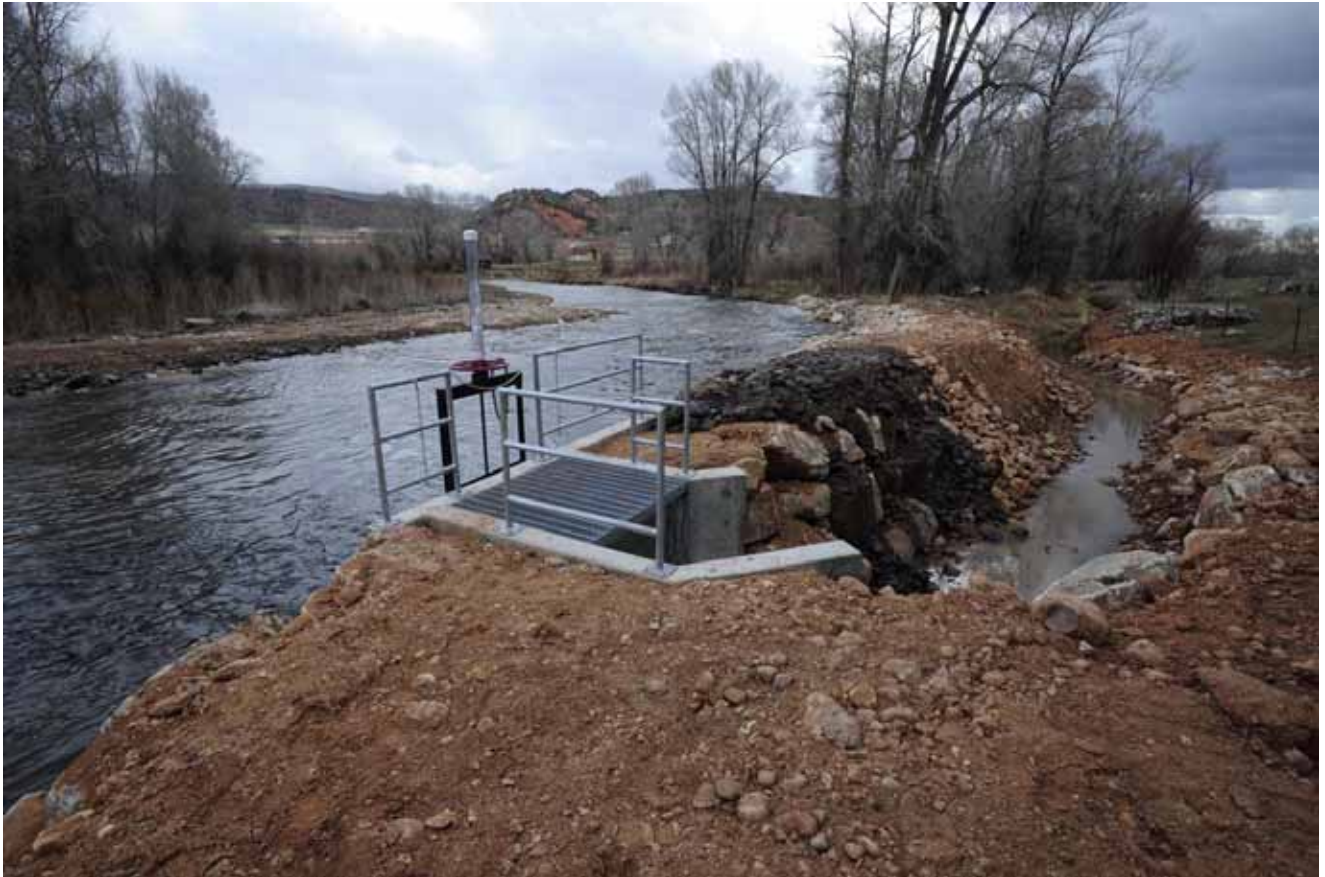
Figure 12. Photograph of the diversion area following construction: showing the concrete structure, the bank that divides the river channel from the new section of ditch, and the new riffle.

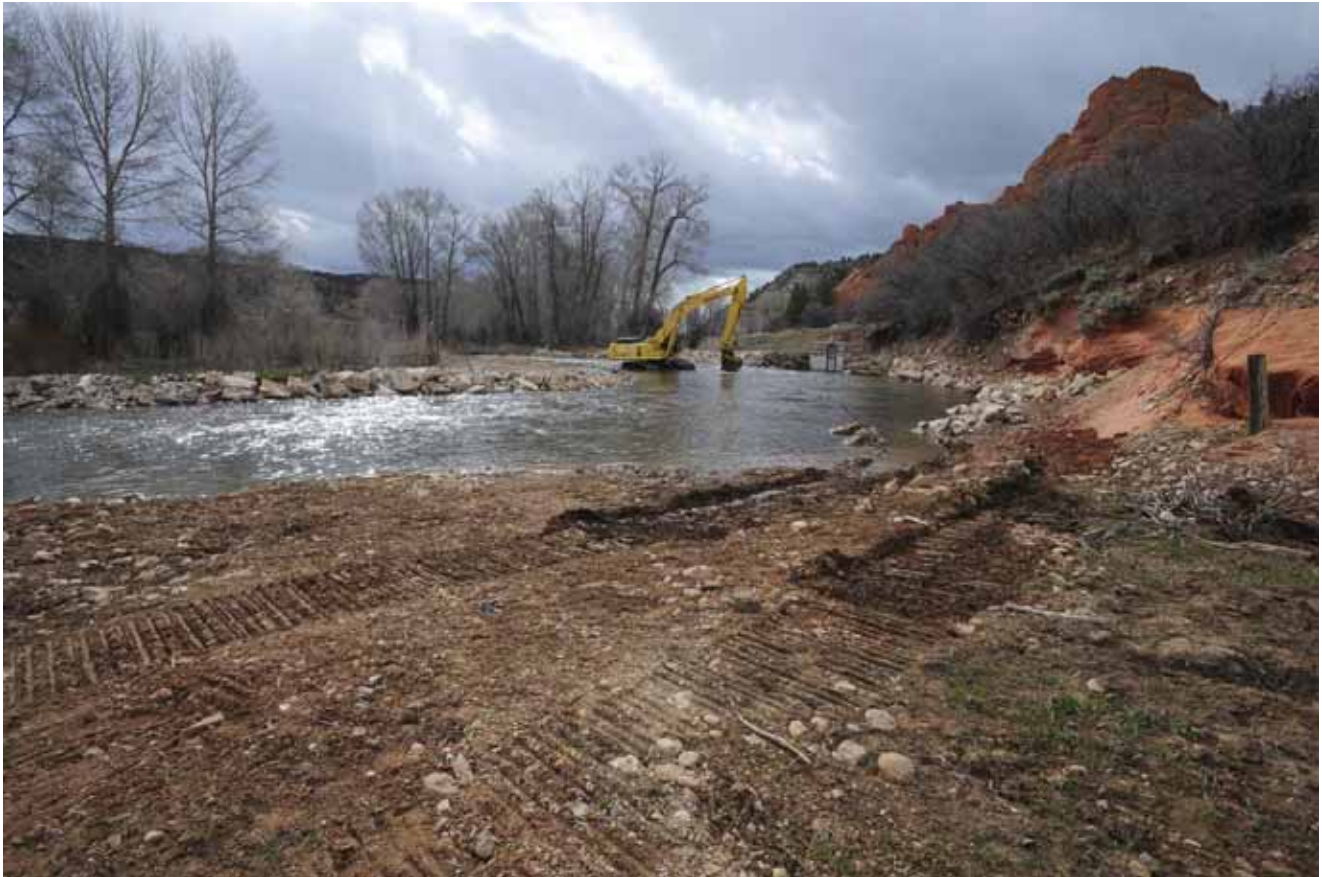
Figure 13. Photograph of the area immediately upstream of the new diversion. The new channel blends smoothly into the existing channel. Track marks from equipment were subsequently removed and the area was scarified and reseeded. The image was taken from river right, looking downstream.

The channel area located immediately upstream of the diversion was recontoured and shaped to provide a smooth bed transition into the reconstructed area (Figure 13). Some additional rock was placed along the river left bank, upstream of the structure to limit future stream movement at the site.

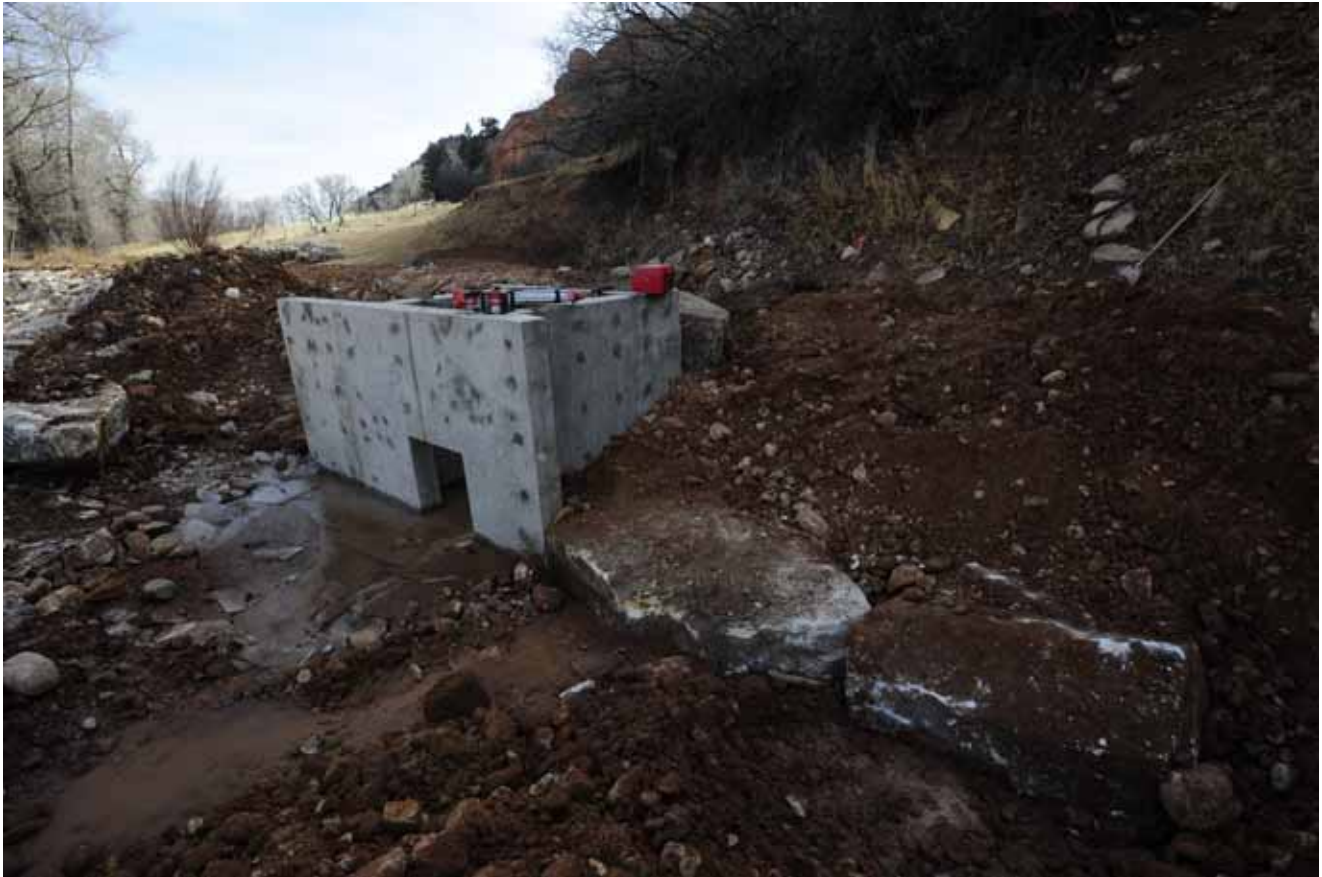
Figure 14. Photograph of the new diversion, during bank construction, showing large rocks that were placed to transition between the structure and new banks. The soil behind the large rock was compacted to limit seepage, using a trackhoe and a rolling compactor.

A new headwall and gate system was constructed by Extreme Excavating of Park City, Utah, via a contract with the Duchesne County Water Conservancy District (Figures 14 and 15). It was positioned at the location and orientation shown in Figure 9. The invert of the gate opening of the new headwall structure was located slightly above the new bed of the stream to avoid excessive sediment deposition in the new structure and ditch. Flow

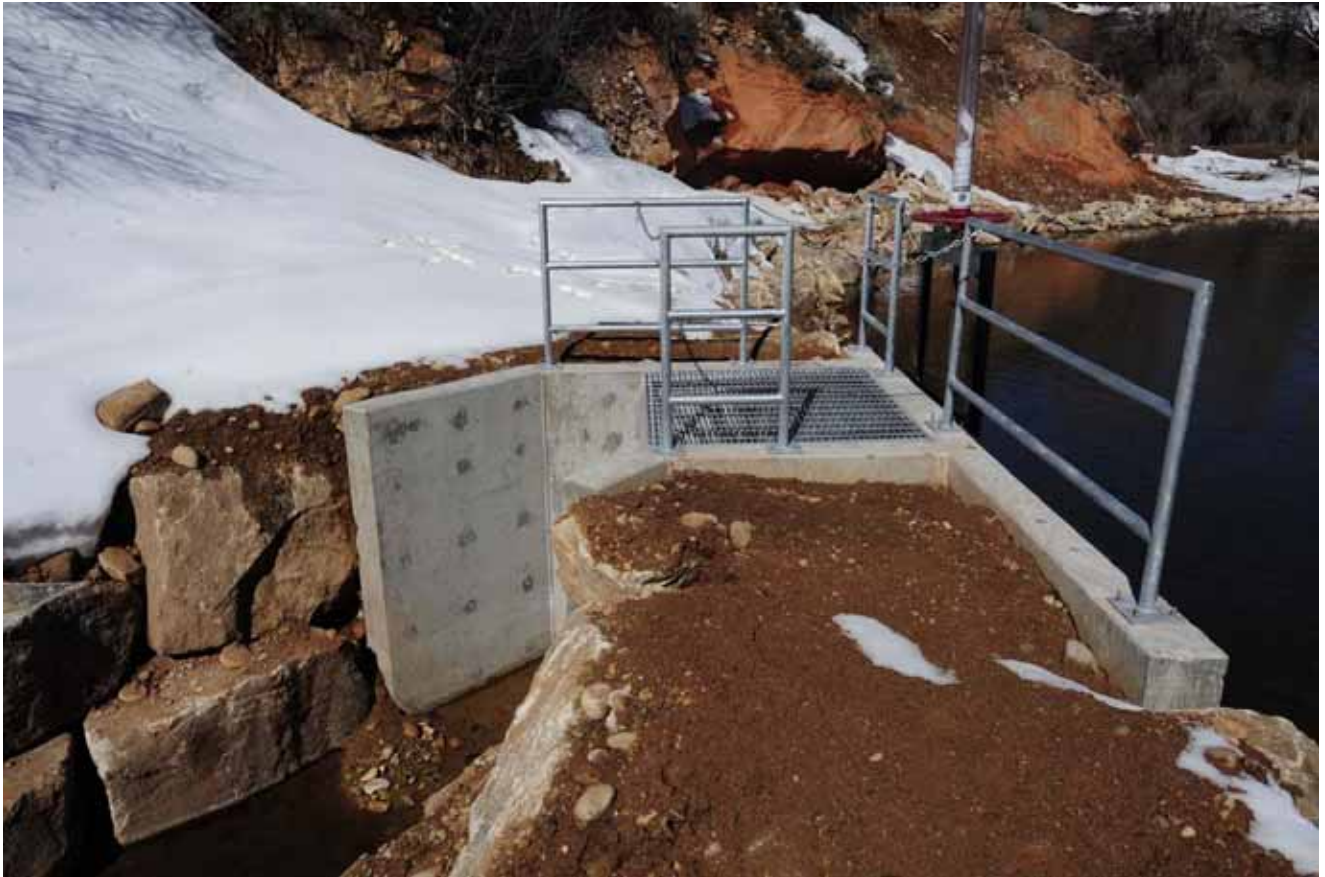
Figure 15. Photograph of the completed concrete diversion; with railings, gate, and grating installed.
