Dollar Ridge Fire Watershed Restoration Plan

Prepared by:
Eco Logical Research, Inc.
JW Associates
Martin & Nicholson
Environmental Consultants, LLC
for
The Utah Division of Wildlife
Resources

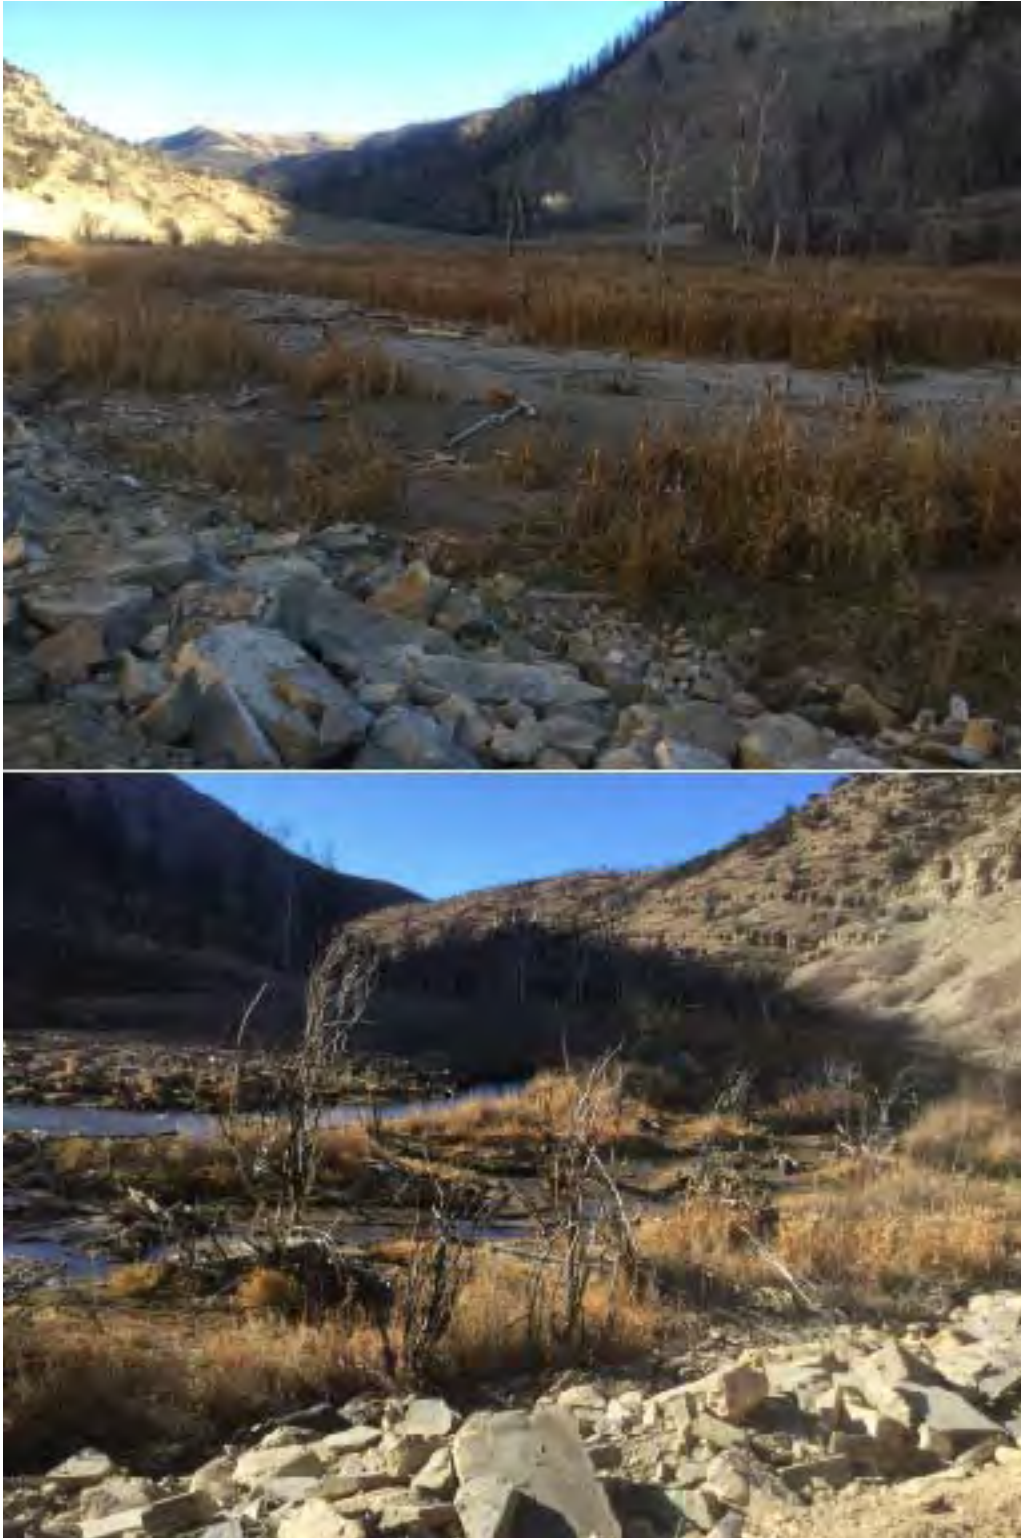
Figure 3.15. Upstream (top) and downstream (bottom) views near Timber Draw. This backwater was drained after July 2021. Prior to draining, this area supported extensive riparian vegetation, including cattails.

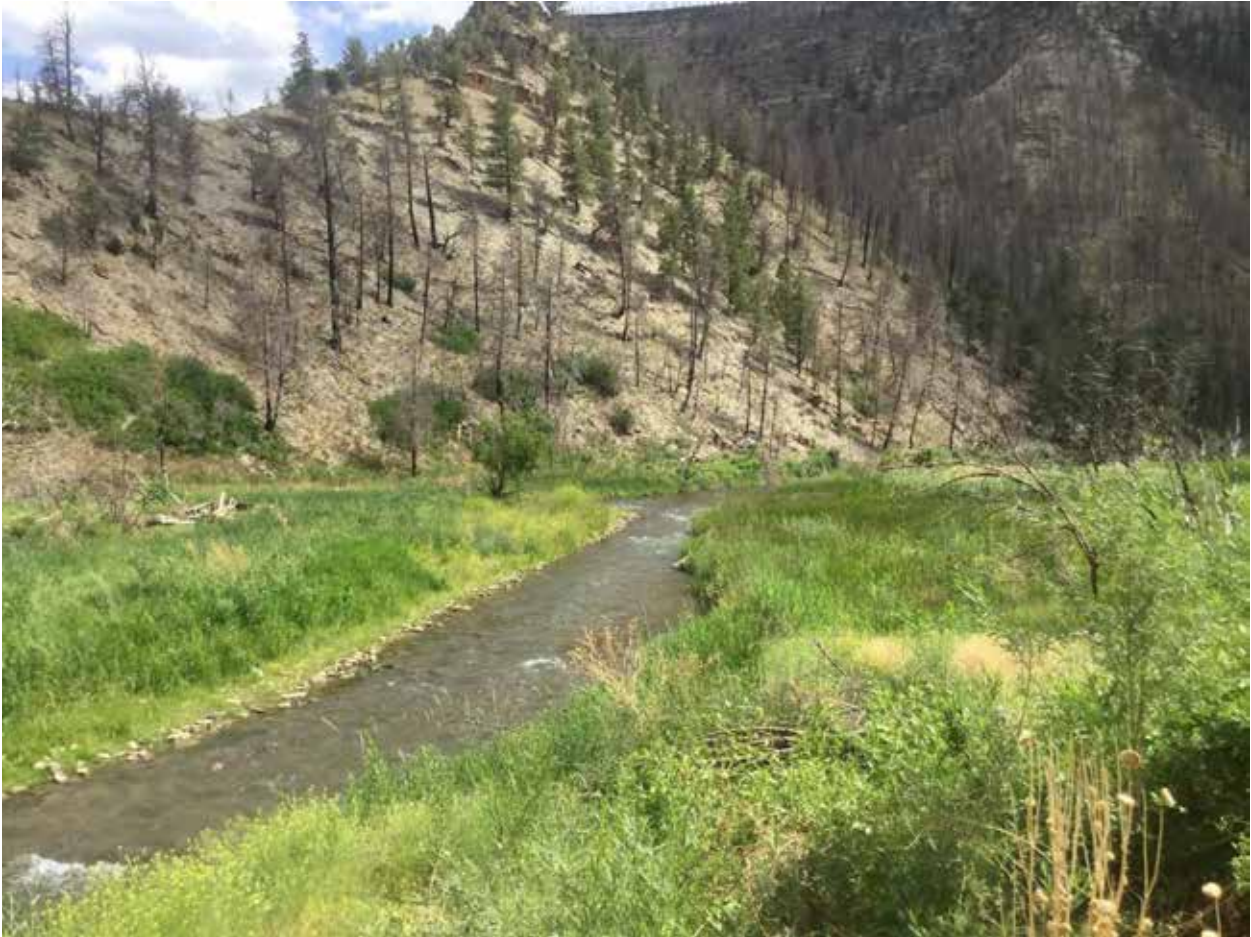
Figure 3.16. Single-thread conditions along the Strawberry River. Along this reach, there is low relief from the channel-bed to floodplain, and it could be connected with high flow releases and/or the addition of low-tech instream structures. The channel itself is planar with low bank, substrate, or hydraulic complexity and no current wood jams or available sources of wood.

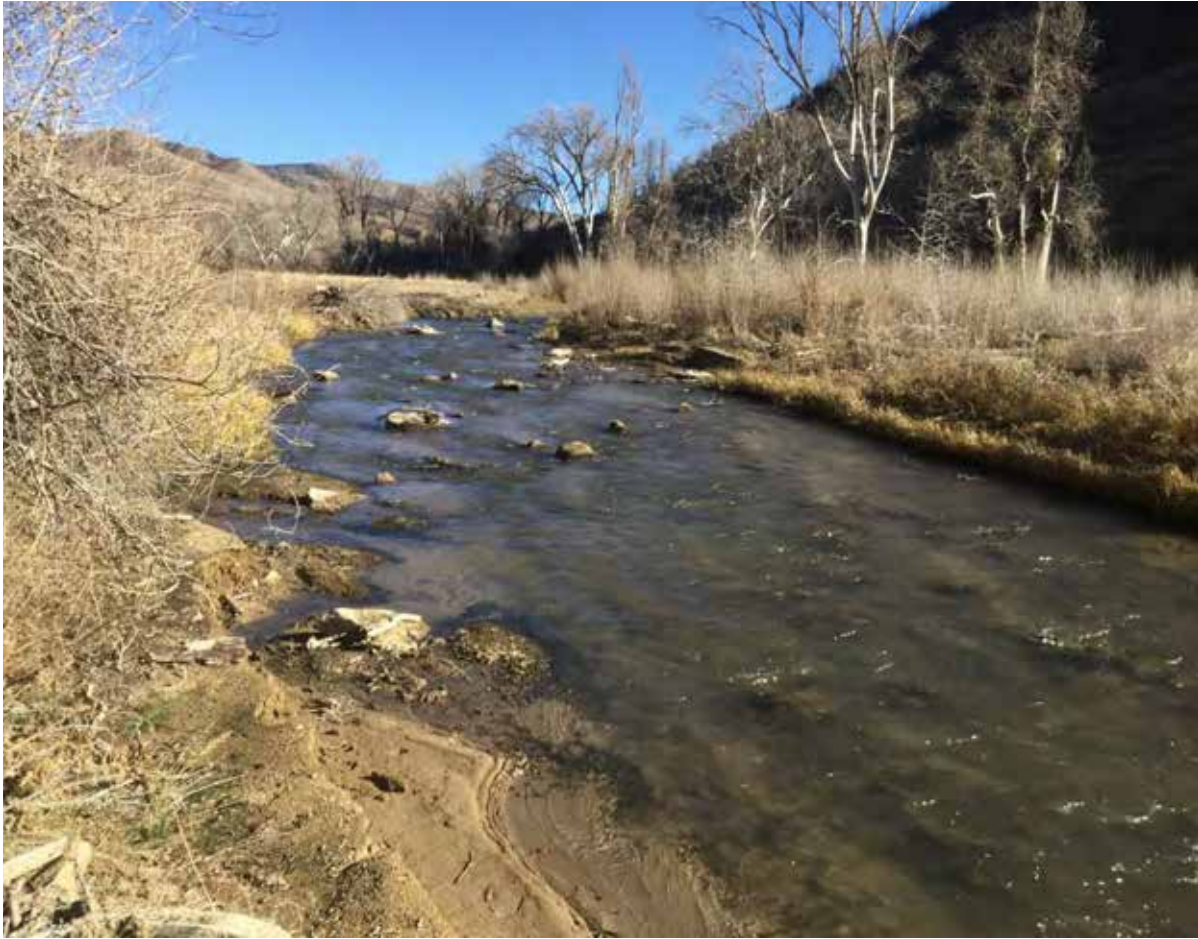
Figure 3.17. Single thread channel dominated by planar features and limited complexity on the Strawberry River at river km 13.5-14. Channel bed-floodplain relief is moderate.

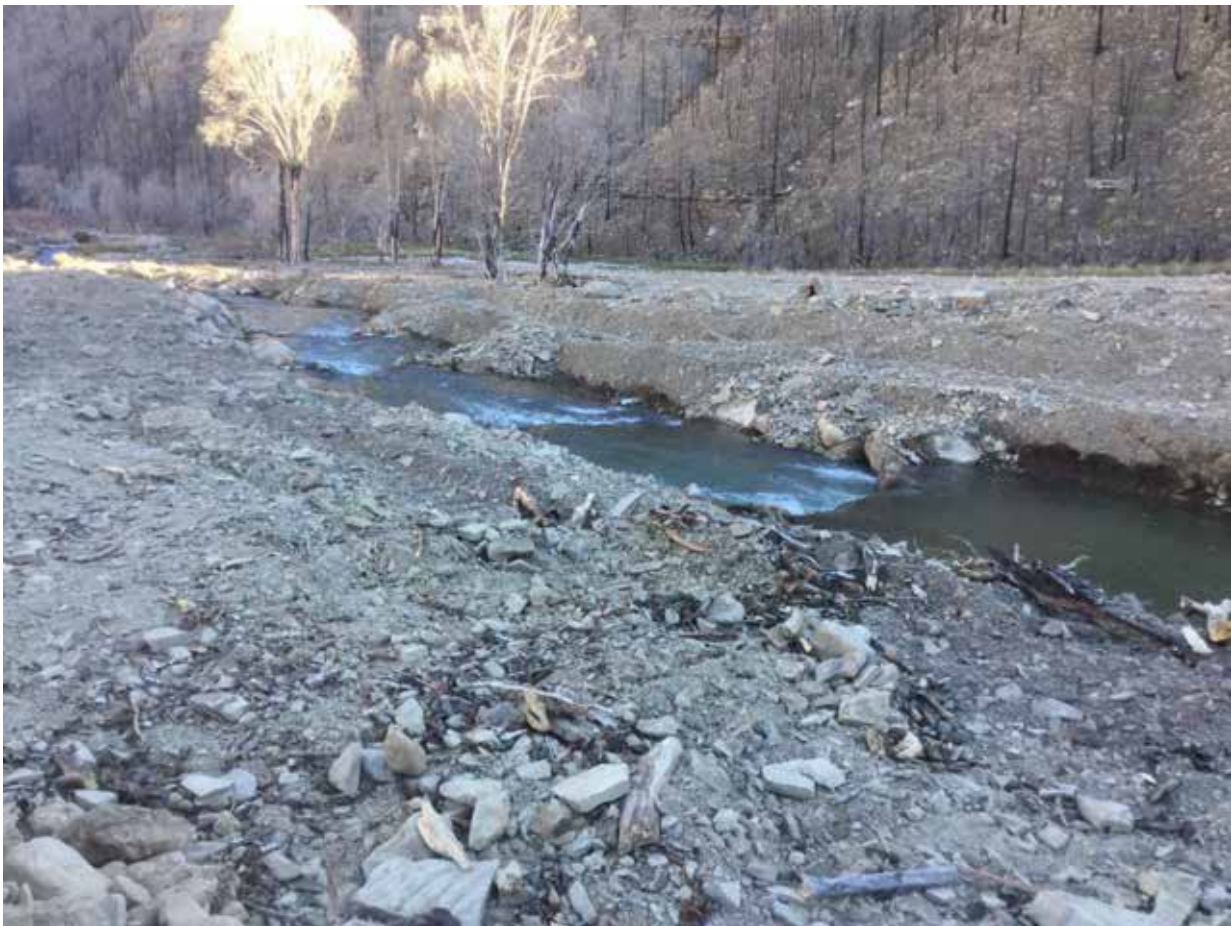
Figure 3.18. Recently constructed single-thread high-entrenchment (due to material deposited on the bank during channel straightening) channel with instream structures.

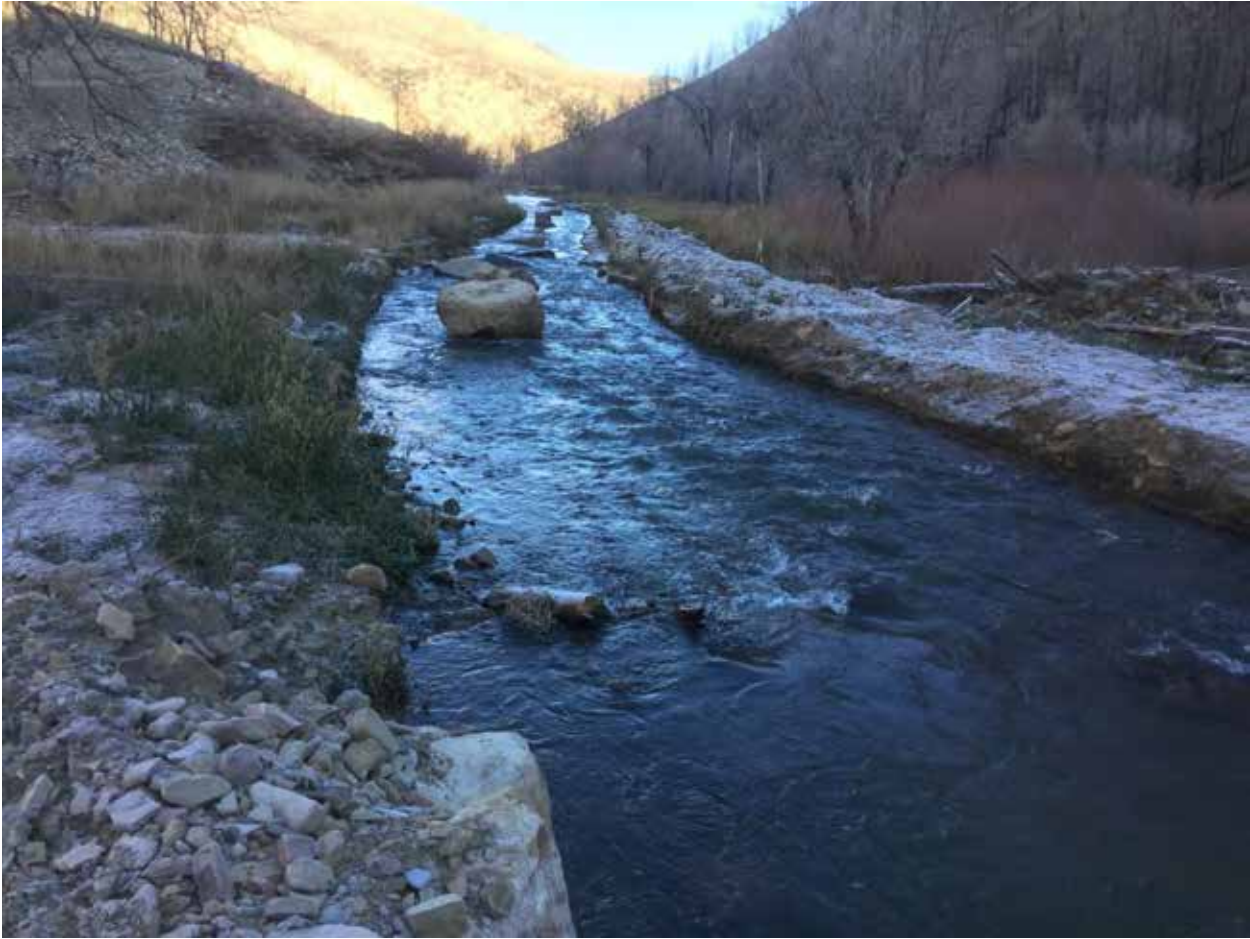
Figure 3.19. Single thread channel with recently placed large boulders. These boulders are unlikely to be moved by the Strawberry River. Also note the levee on the right bank. We recommend removing levees in areas where there is no infrastructure to allow high flows to access the floodplain, thereby decreasing flood risk downstream.

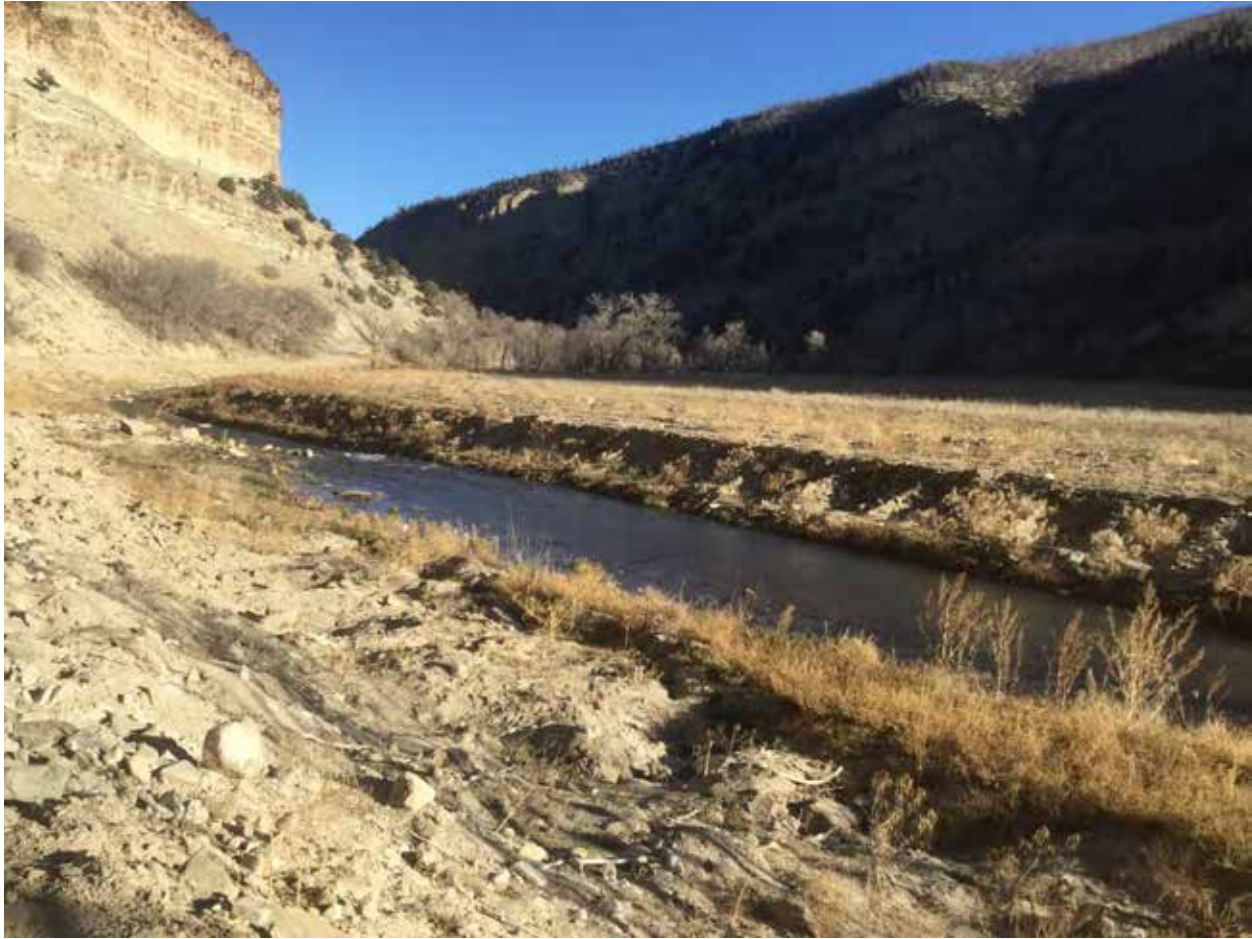
Figure 3.20. Single thread channel with high channel-floodplain relief and a large valley bottom and no riparian vegetation. Areas like this could use a combination of heavy equipment and instream and floodplain wood to increase the width of the active channel, support the reestablishment of woody riparian vegetation, both naturally and with planting and buffer the delivery of wood and sediment to downstream reaches. The road, which has already been protected by extensive rip rap would also be more protected by a wide active channel that disperses stream power over a wider area.

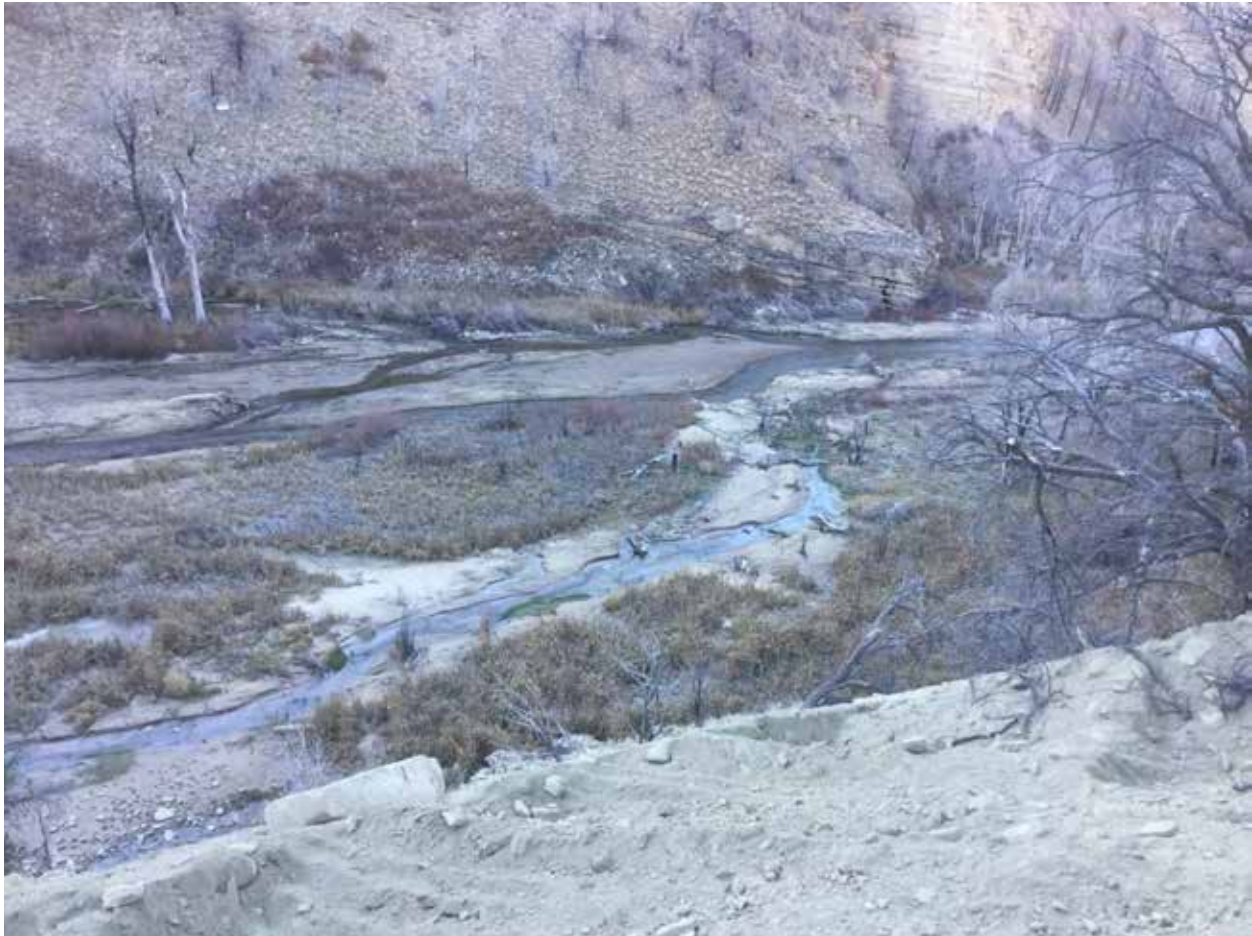
Figure 3.21. Multi-threaded area with wide active channel. We recommend LTPBR structures in these areas to maintain the wide active channel, and multiple channels.

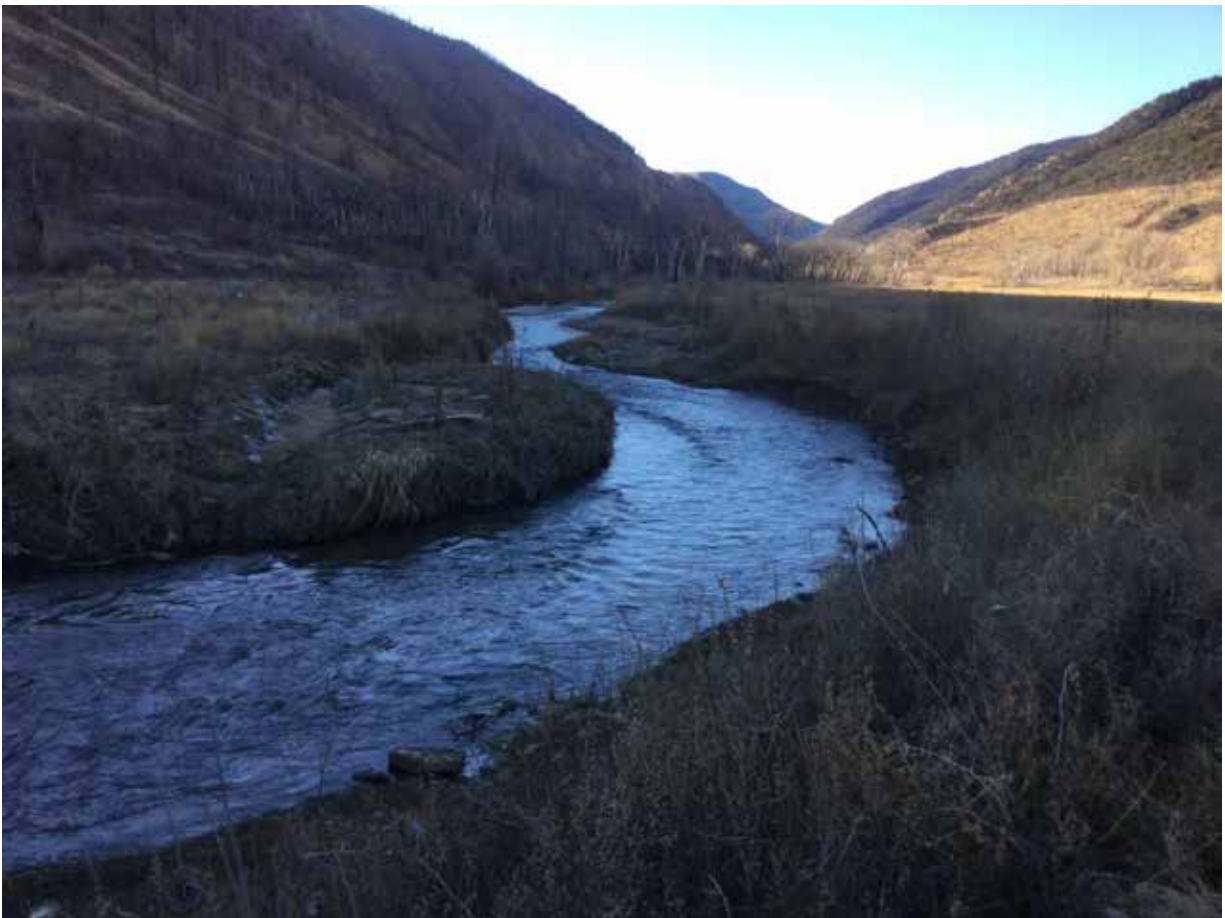
Figure 3.30. River Km 14-14.75. The large floodplain in the previous picture is in the right-hand portion of this picture. In this reach, several areas are incised. Heavy machinery and structures can be used to increase floodplain connection.

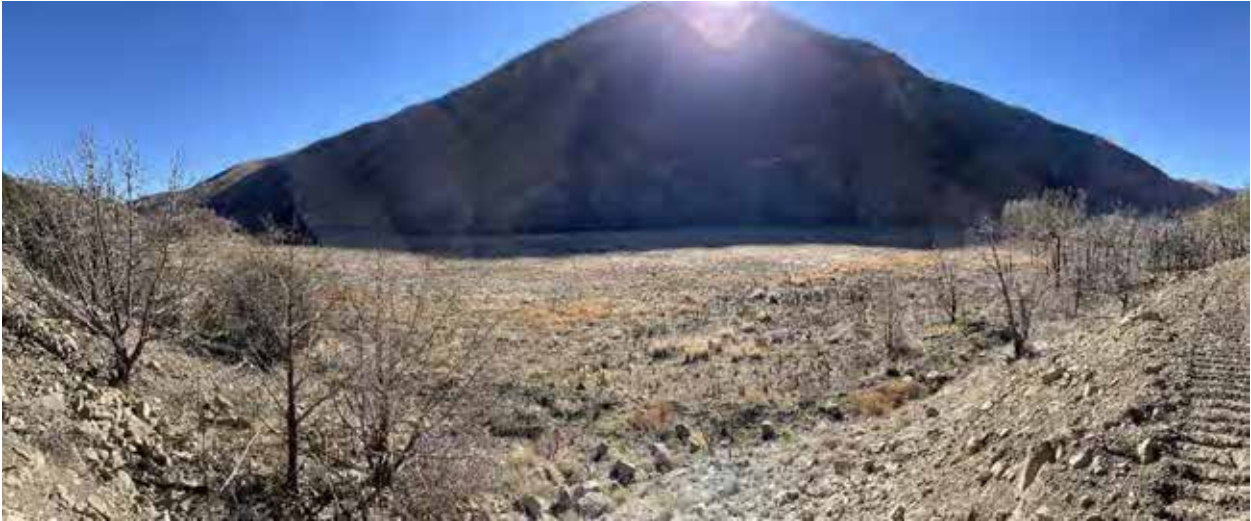
Figure 3.31. River Km 14-14.75. Large floodplain with irrigation infrastructure present (irrigation ditch is in foreground). Riparian plantings, channel modification, structure addition and irrigation could potentially greatly increase riparian vegetation.

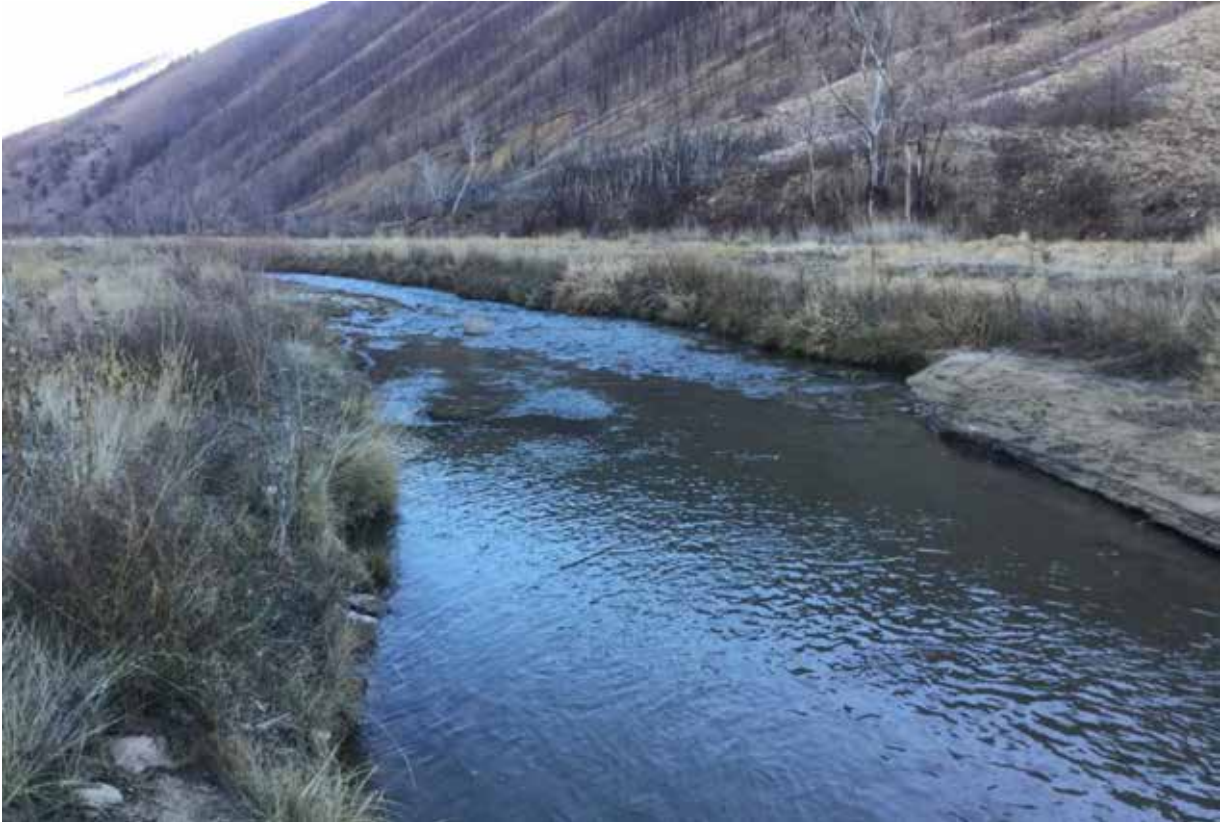
Figure 3.32. River Km 14.75-15.5. Slab Lake is just downstream and may back water into this reach if the alluvial fan that dammed the river increases in size. However, structure can be added here to increase complexity and potentially force water onto the floodplain.

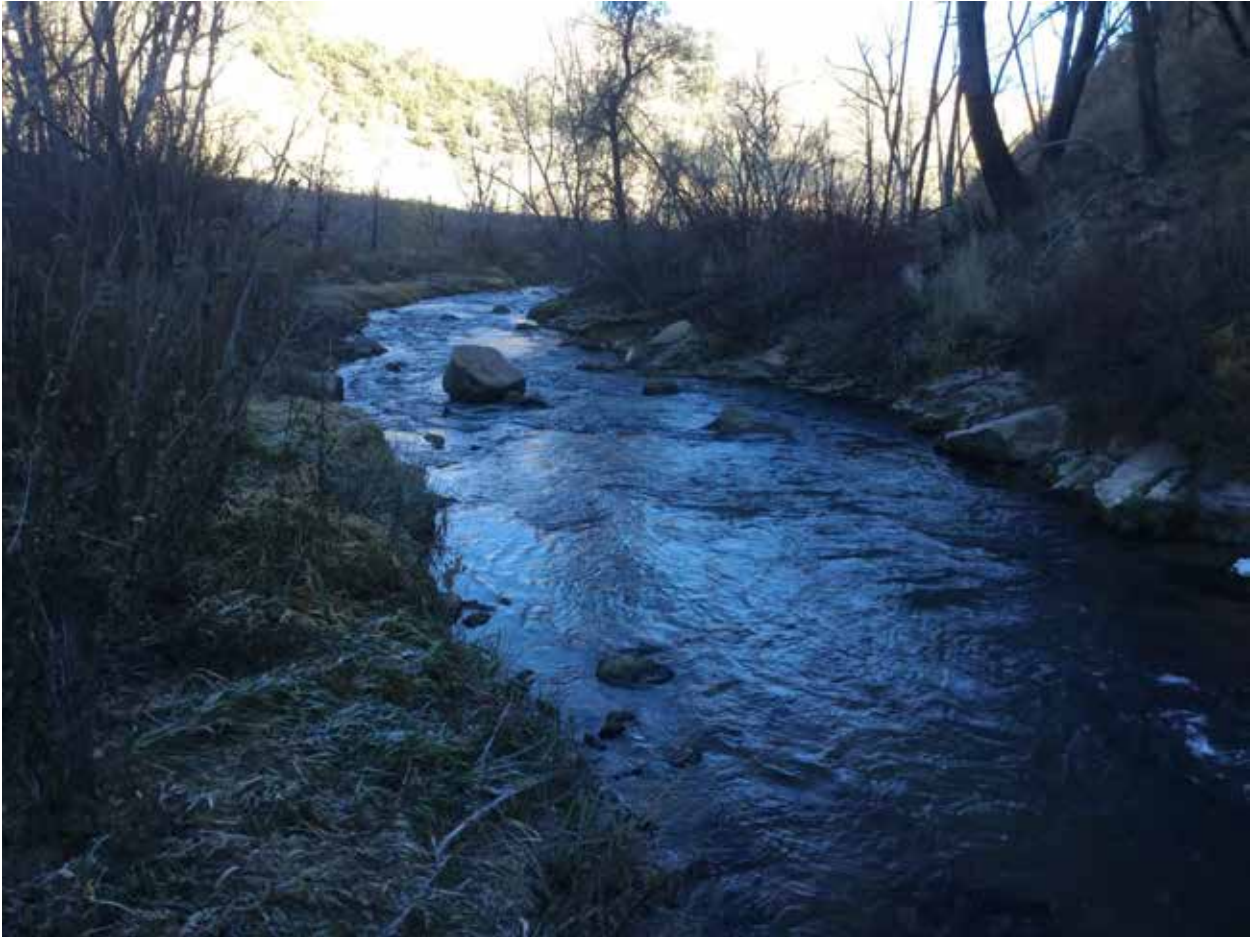
Figure 3.36. River Km 17-17.5. Structure additions can increase habitat complexity in this reach.

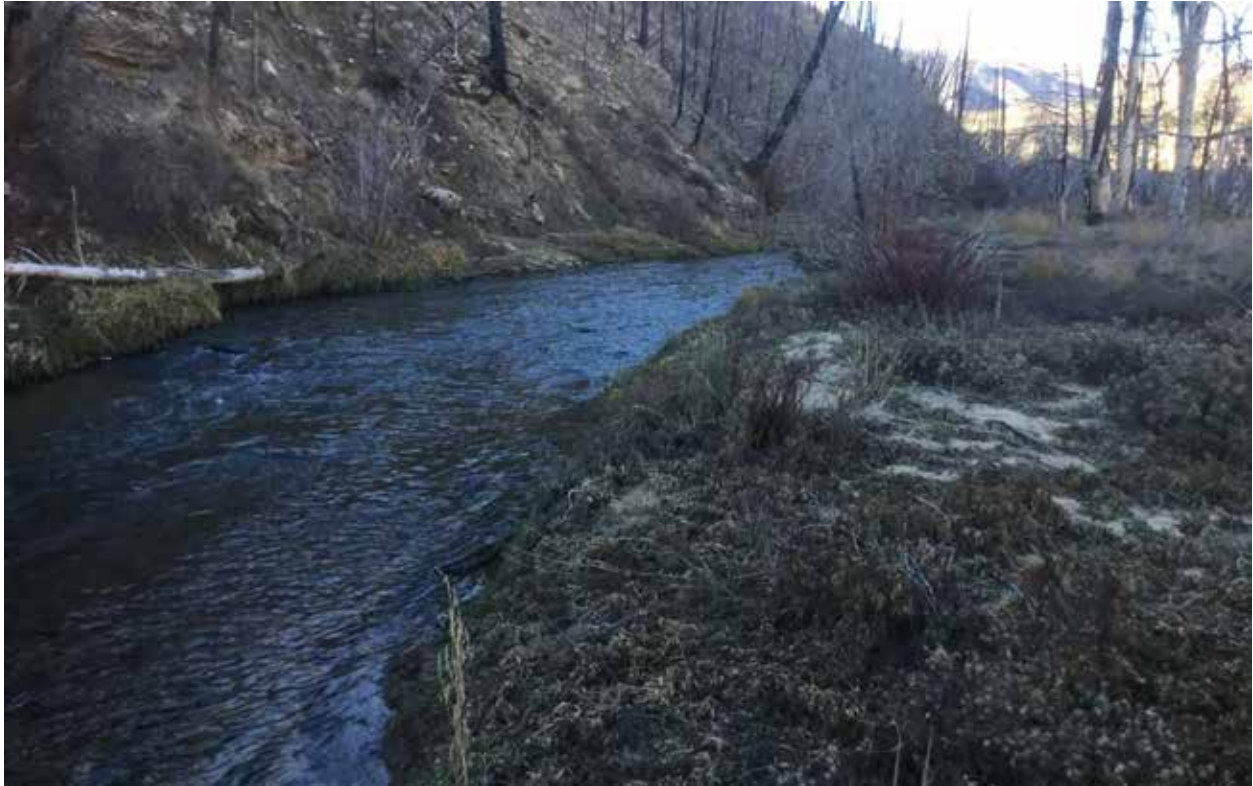
Figure 3.37. River Km 17.5-18. The upper section of this reach has banks about 1 m high, requiring heavy machinery to create channels within the floodplain along with structure additions to increase floodplain connectivity.

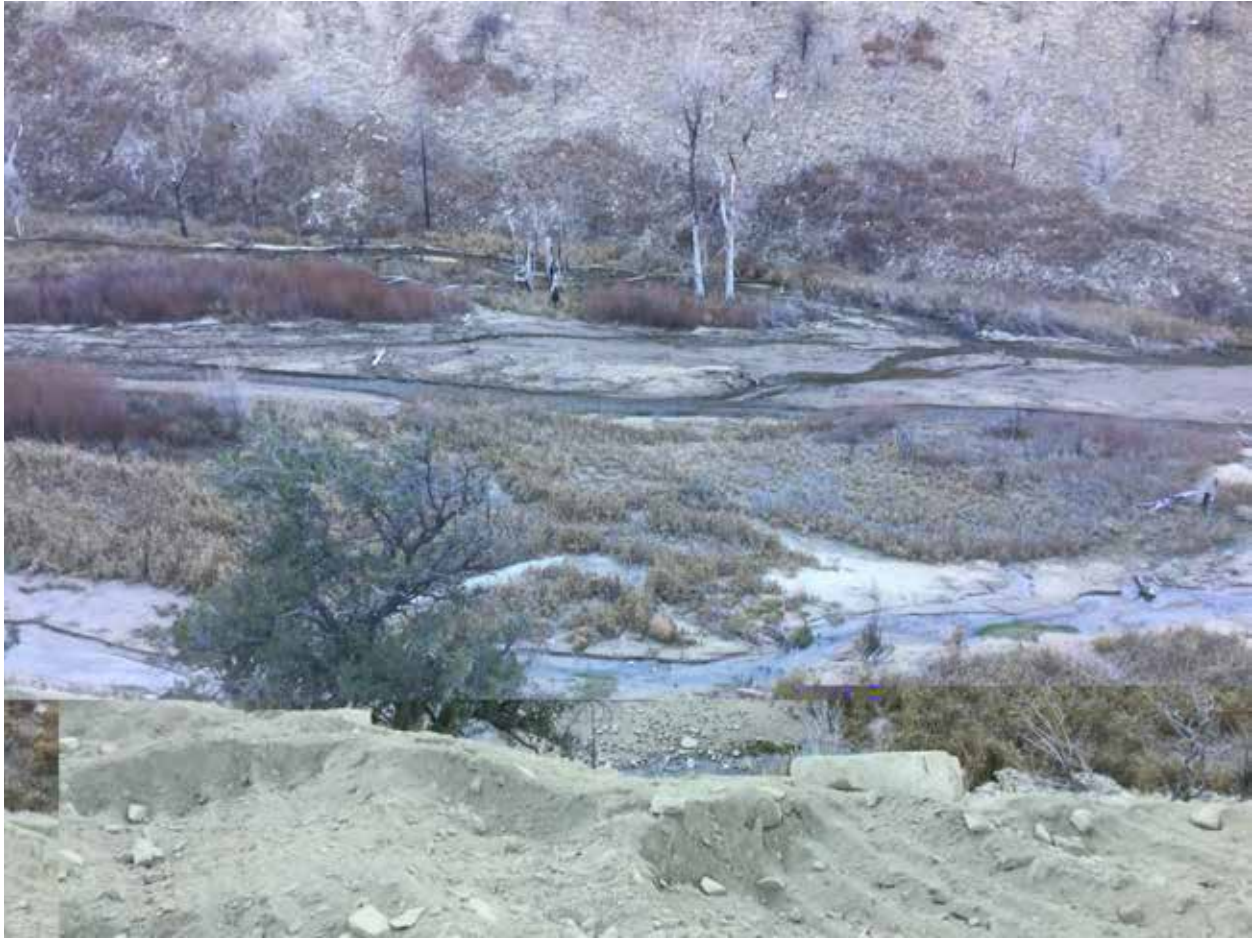
Figure 3.40. River Km 18-18.5. This multi-threaded system is likely a reference condition of mainstem Strawberry River. The newly deposited alluvium and well-connected floodplain should allow for highly productive riparian plantings.

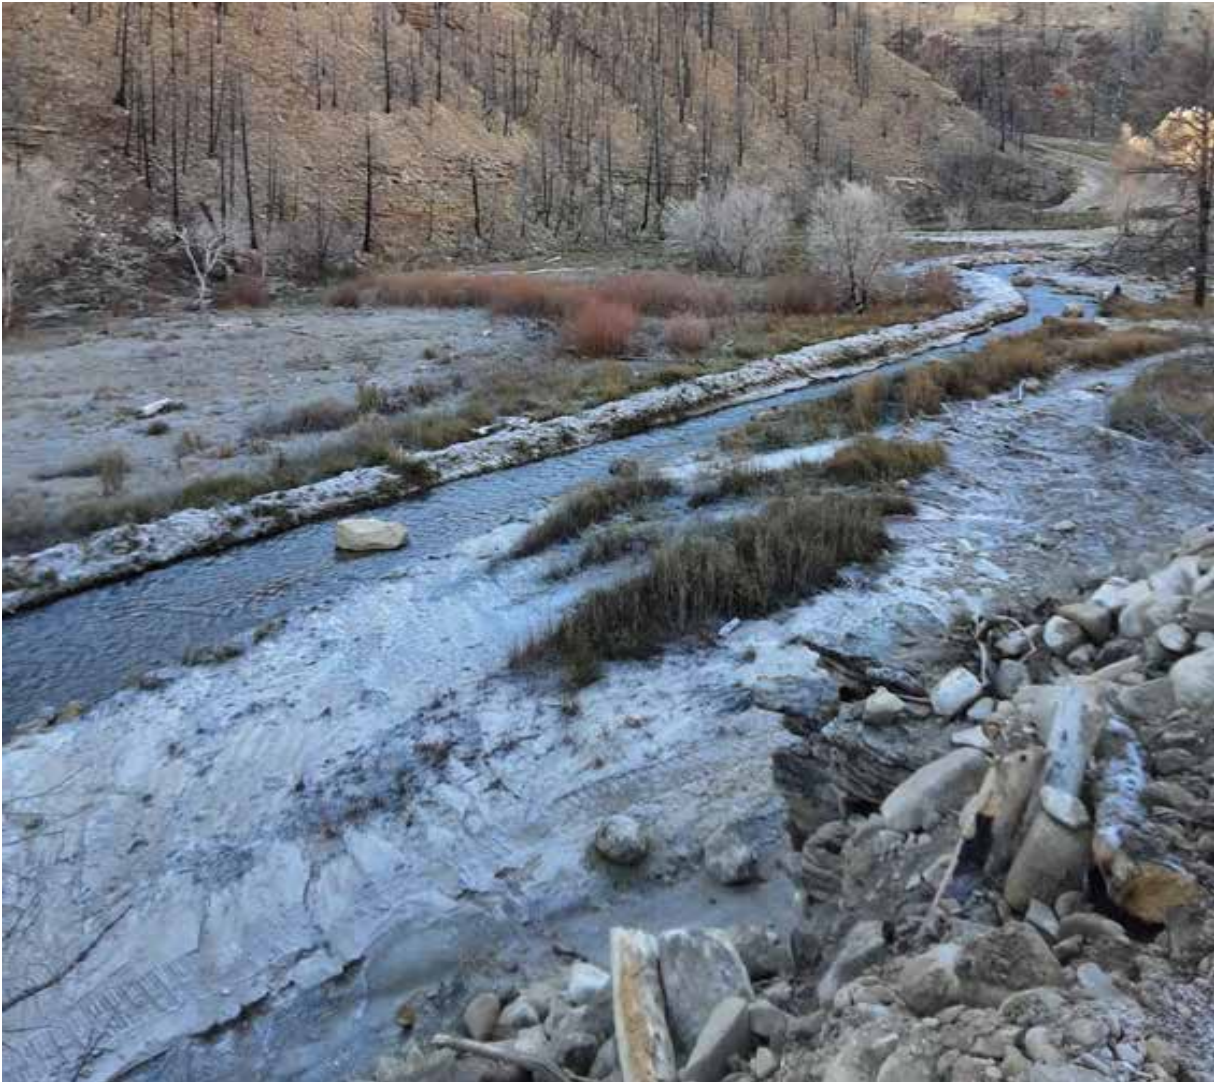
Figure 3.41. River Km 18.5-18.75. EWP modified narrow straighten channel below Sulphur Draw. Note levee on the river right side of the channel (water right to left). Levee removal, new channels in the floodplain, and structures will allow frequent inundation of the floodplain that will support riparian plantings.

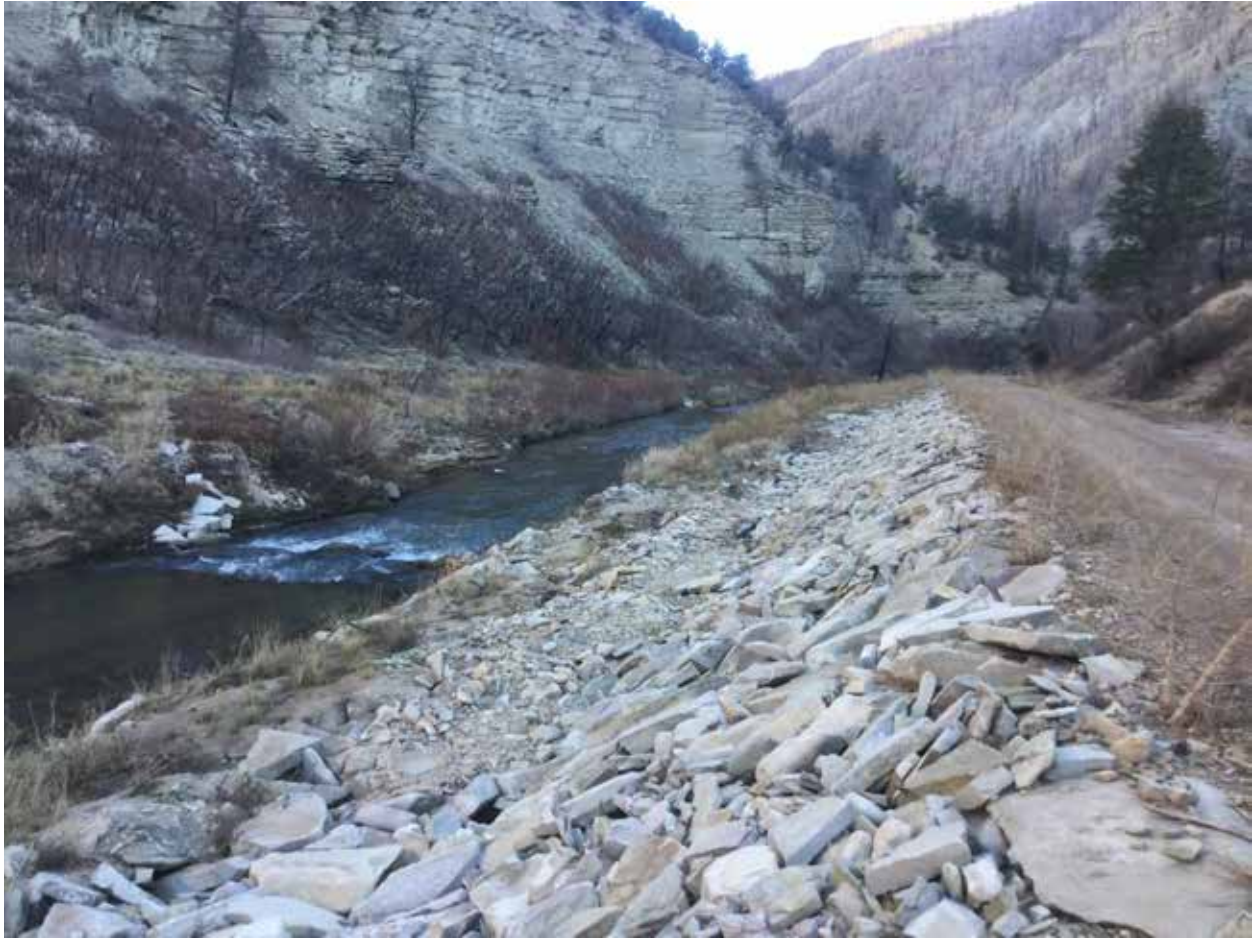
Figure 3.48. River Km 22.25-23.5. The channel is confined by the road and valley margin with rip-rap in several locations. Because geomorphic changes are limited here, only structure additions are recommended to increase habitat complexity.

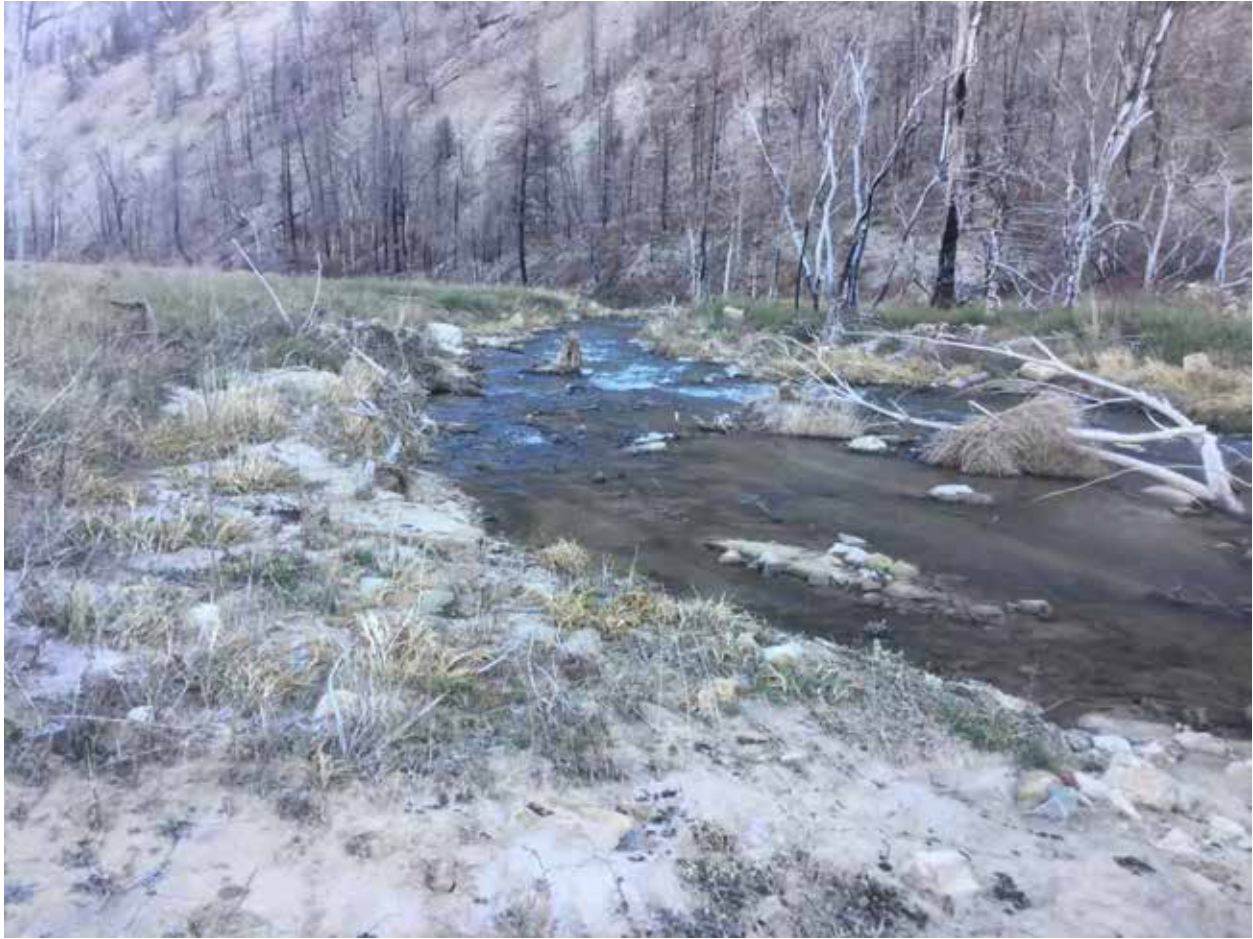
Figure 3.49. River Km 23.5-24.25. This reach is a simple entrenched, planar, single-threaded channel. Structure and channel modification with heavy machinery can be used to increase complexity and floodplain reconnection.

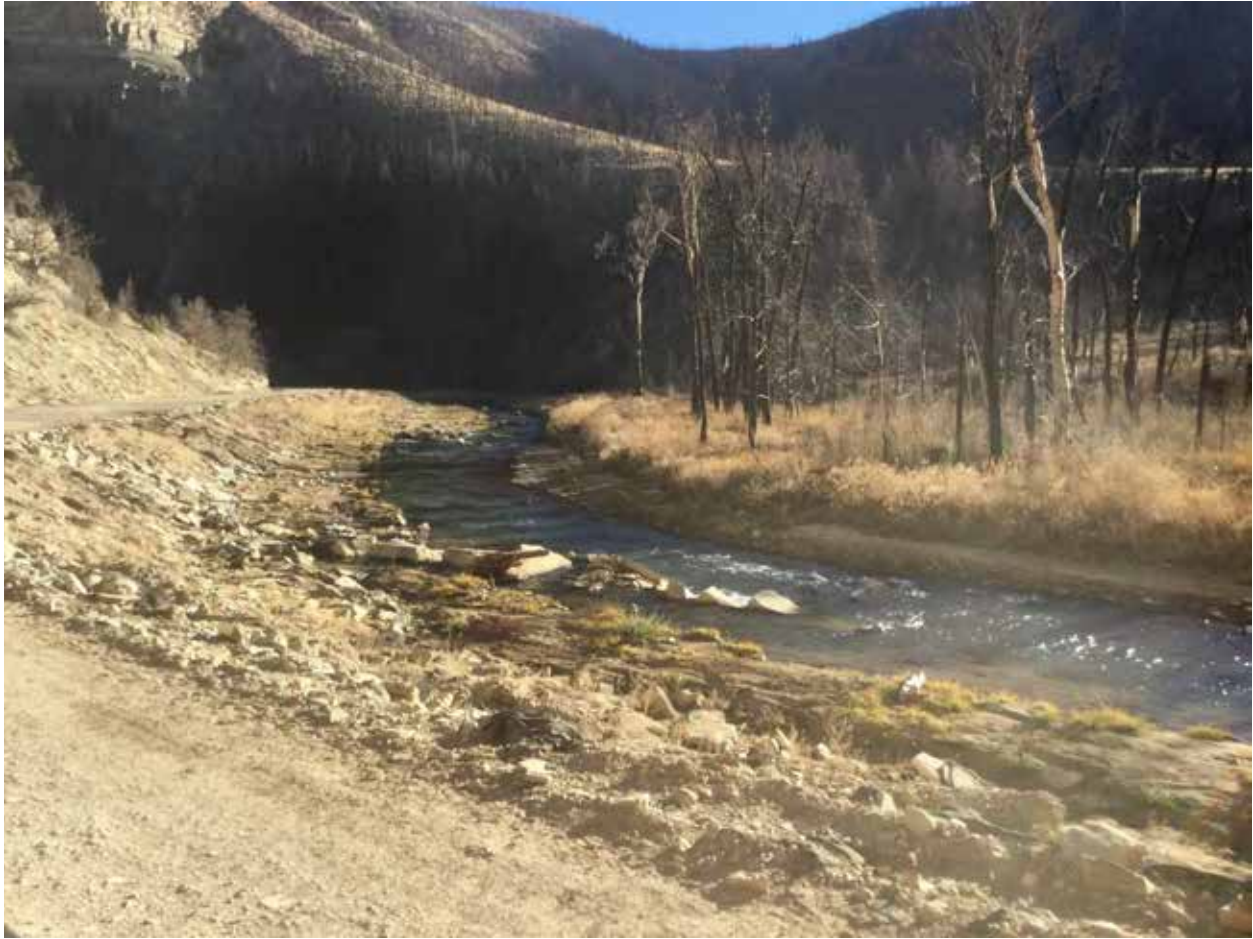
Figure 3.52. River Km 25.5-27.25. This reach is a moderately entrenched, planar, single-threaded channel with a narrow valley bottom. Structures can be used to increase complexity and floodplain reconnection with low risk to the road.

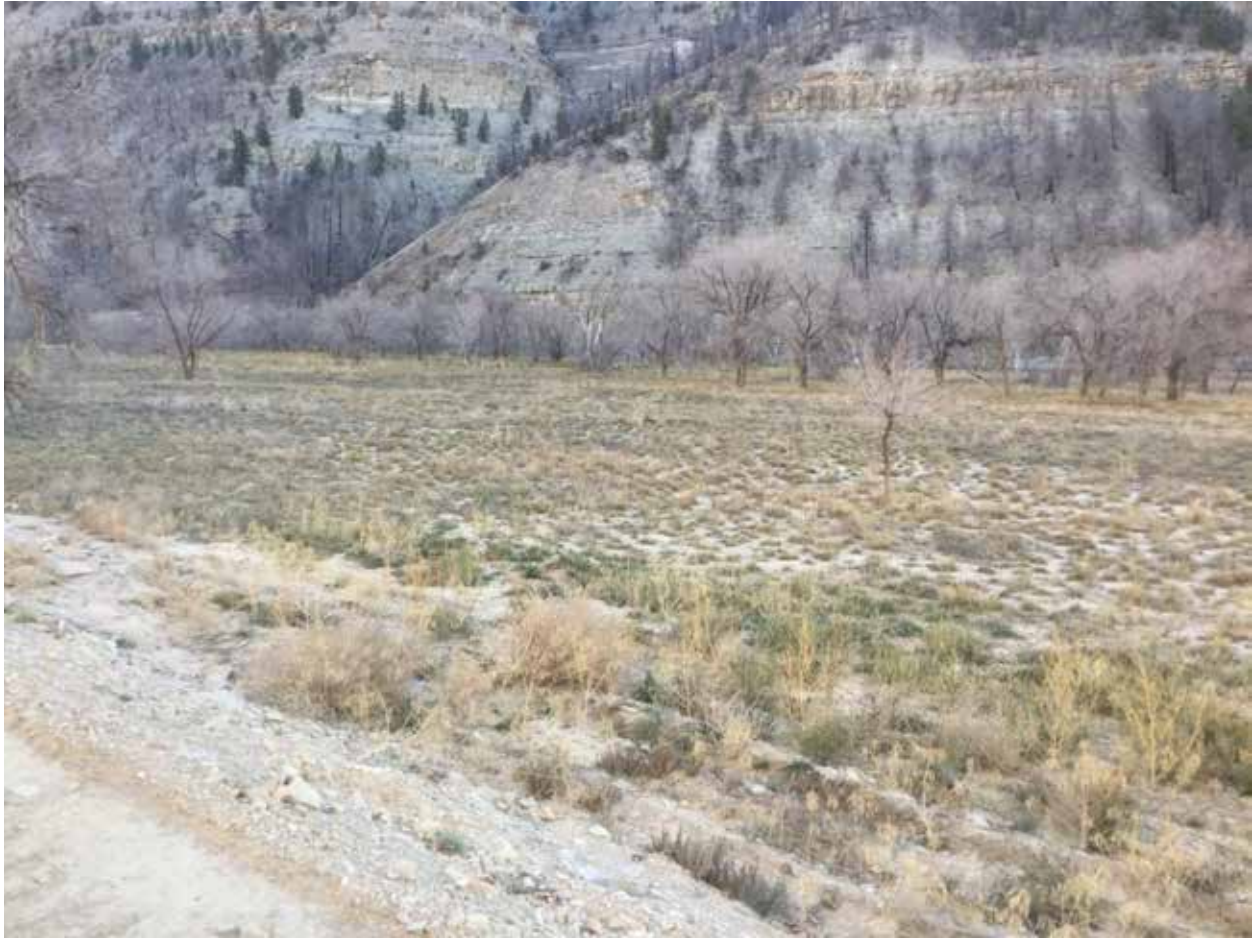
Figure 3.55. The channel is against the valley margin in the right of the photo. A large floodplain could be used as a buffer for high flows and material if multiple channels were created.

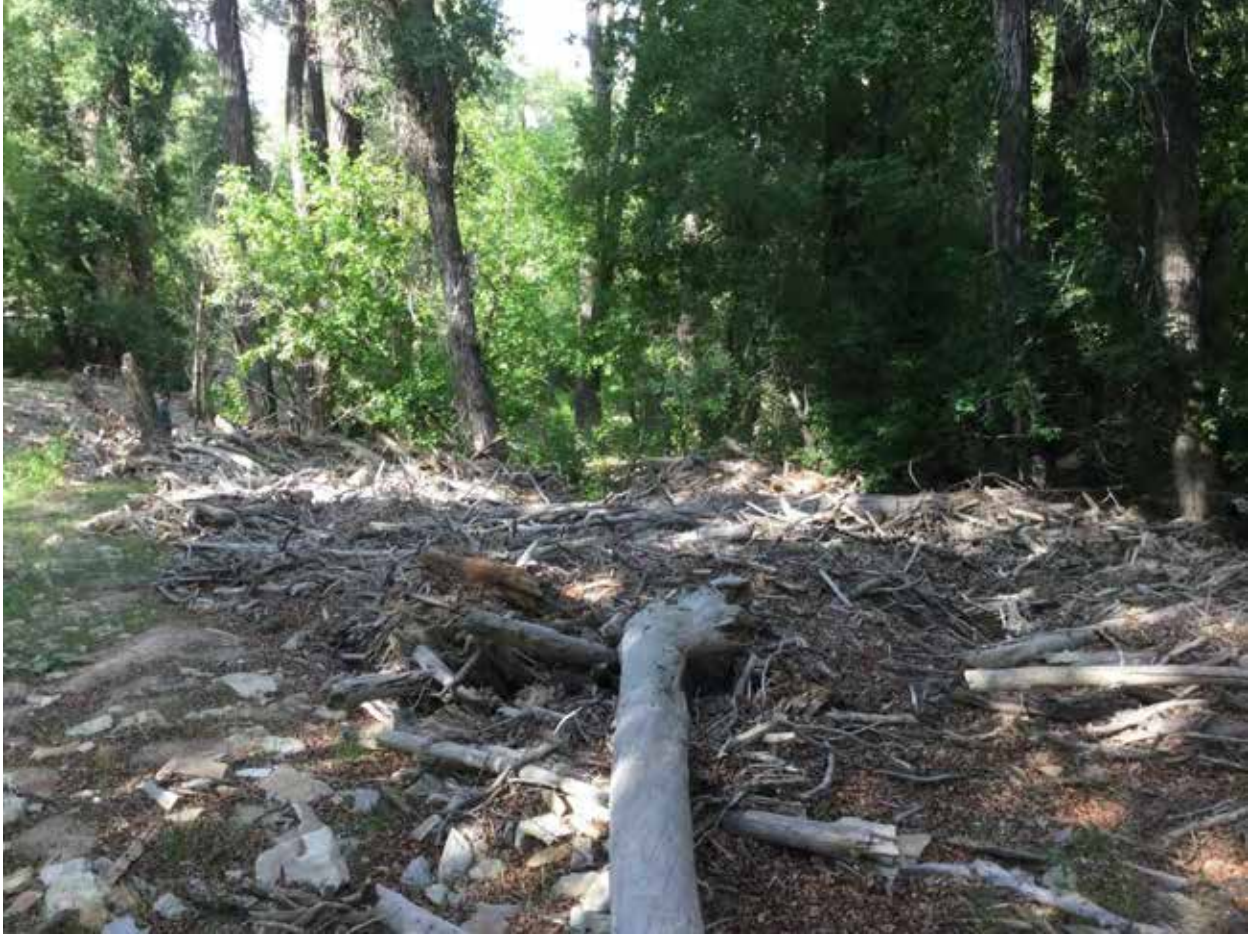
Figure 3.9. Debris jam on Timber Creek. July 2021
