Dollar Ridge Fire Watershed Restoration Plan

Prepared by:
Eco Logical Research, Inc.
JW Associates
Martin & Nicholson
Environmental Consultants, LLC
for
The Utah Division of Wildlife
Resources

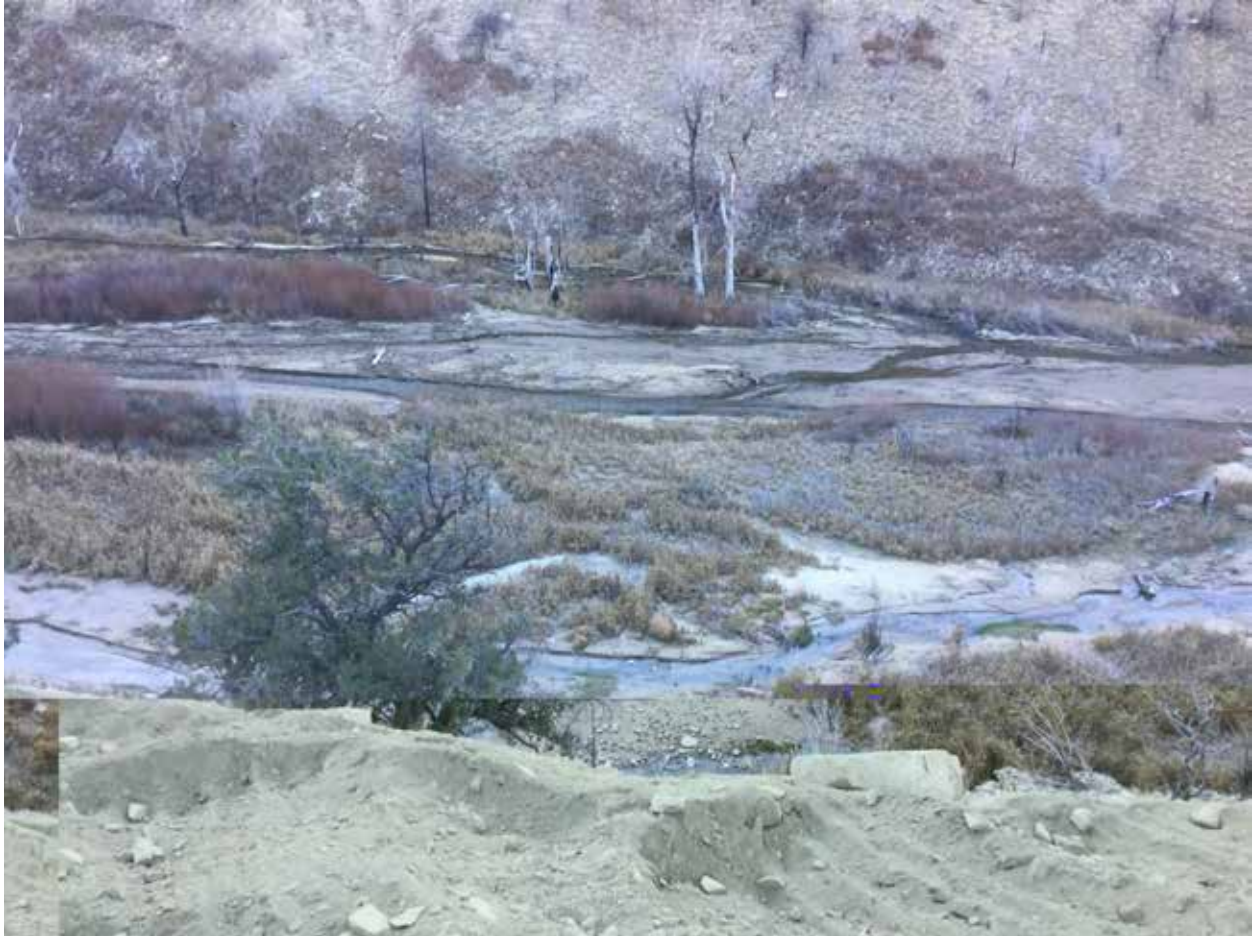
Figure 5.7. Field photo of region show in Figure 5.6. There are multiple channels, and a diverse arrangement of both bare and vegetated surfaces that would be highly connected during high flow events. This reach is likely to promote sediment deposition, attenuate high flows and store wood delivered from upstream reaches. Photo: 12/02/2021. Flow: 28 cfs at USGS 09285900 near Pinnacles.
