Document Review Report

Jordan River, Between 90th South and 78th South
Section 206 Restoration
Review of Planning Documents

West Jordan, Utah Section 206 Aquatic Ecosystem Restoration
Draft Detailed Project Report and Environmental Assessment
US Army Corps of Engineers Sacramento District
November 2003

Allred Restoration Inc.
Tremonton, Utah

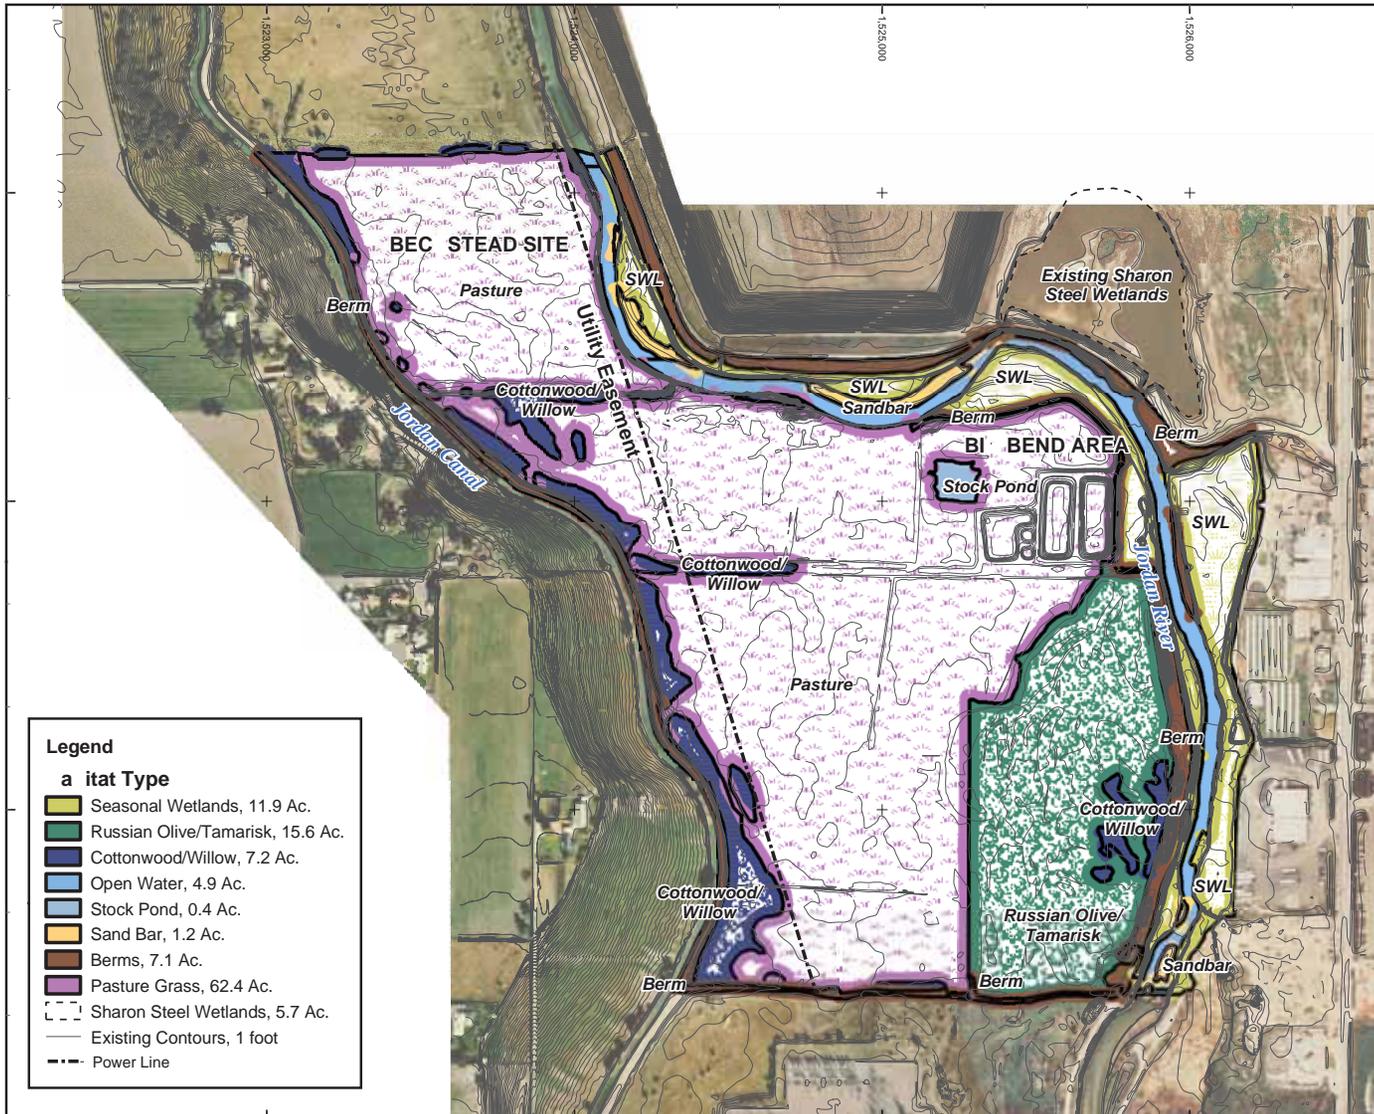
Plate 3

**Alternative 1
Existing Habitats**

- Seasonal Wetlands, 11.9 Ac.
- Russian Olive/Tamarisk, 15.6 Ac.
- Cottonwood/Willow, 7.2 Ac.
- Open Water, 4.9 Ac.
- Stock Pond, 0.4 Ac.
- Sand Bar, 1.2 Ac.
- Berms, 7.1 Ac.
- Pasture Grass, 62.4 Ac.
- Sharon Steel Wetlands, 5.7 Ac.
- Existing Contours, 1 foot
- Power Line

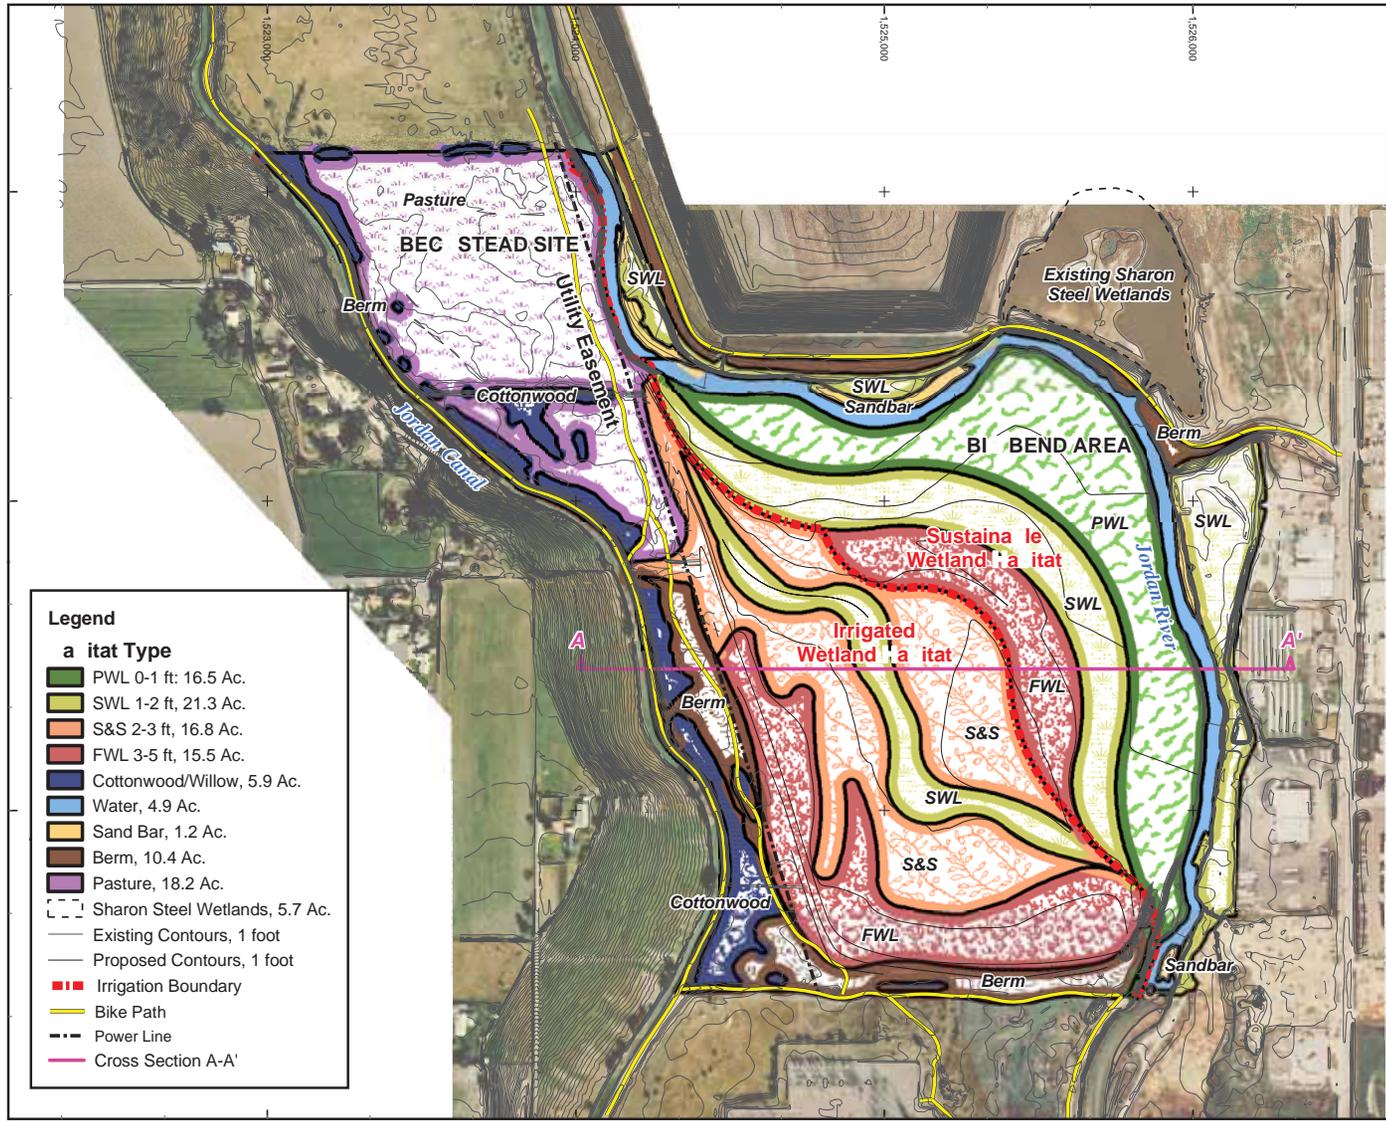
**Plate 4
Alternative 2
Benched Restoration
Without Off channel Wetlands**

PWL 0-1 ft: 16.5 Ac.
	SWL 1-2 ft, 21.3 Ac.
	S&S 2-3 ft, 16.8 Ac.
	FWL 3-5 ft, 15.5 Ac.
	Cottonwood/Willow, 5.9 Ac.
	Water, 4.9 Ac.
	Sand Bar, 1.2 Ac.
	Berm, 10.4 Ac.
	Pasture, 18.2 Ac.
	Sharon Steel Wetlands, 5.7 Ac.
	Existing Contours, 1 foot
	Proposed Contours, 1 foot
	Irrigation Boundary
	Bike Path
	Power Line
	Cross Section A-A'

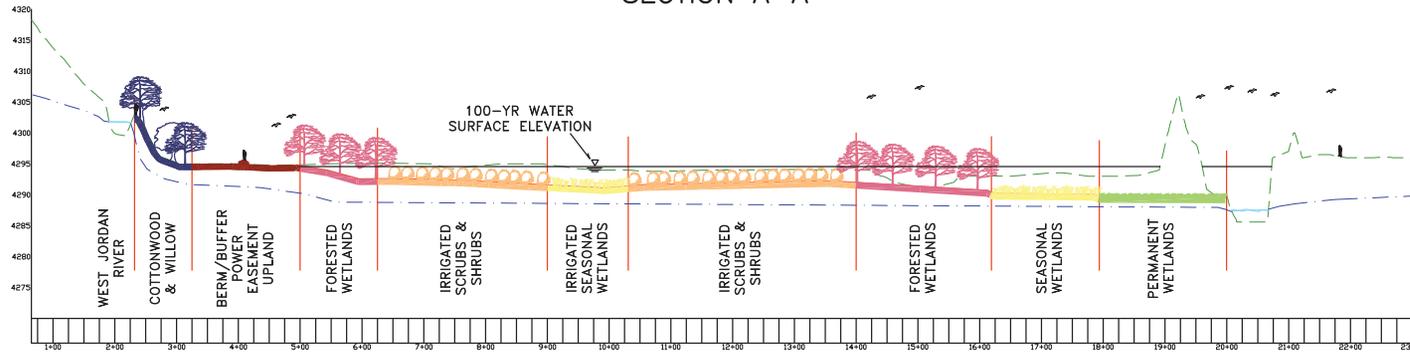
BENCHED RESTORATION
SECTION A-A'

- EXISTING GROUND SURFACE
- PROPOSED GROUND SURFACE
- ANTICIPATED WATER TABLE
- ▲ 100-YEAR WATER SURFACE ELEVATION

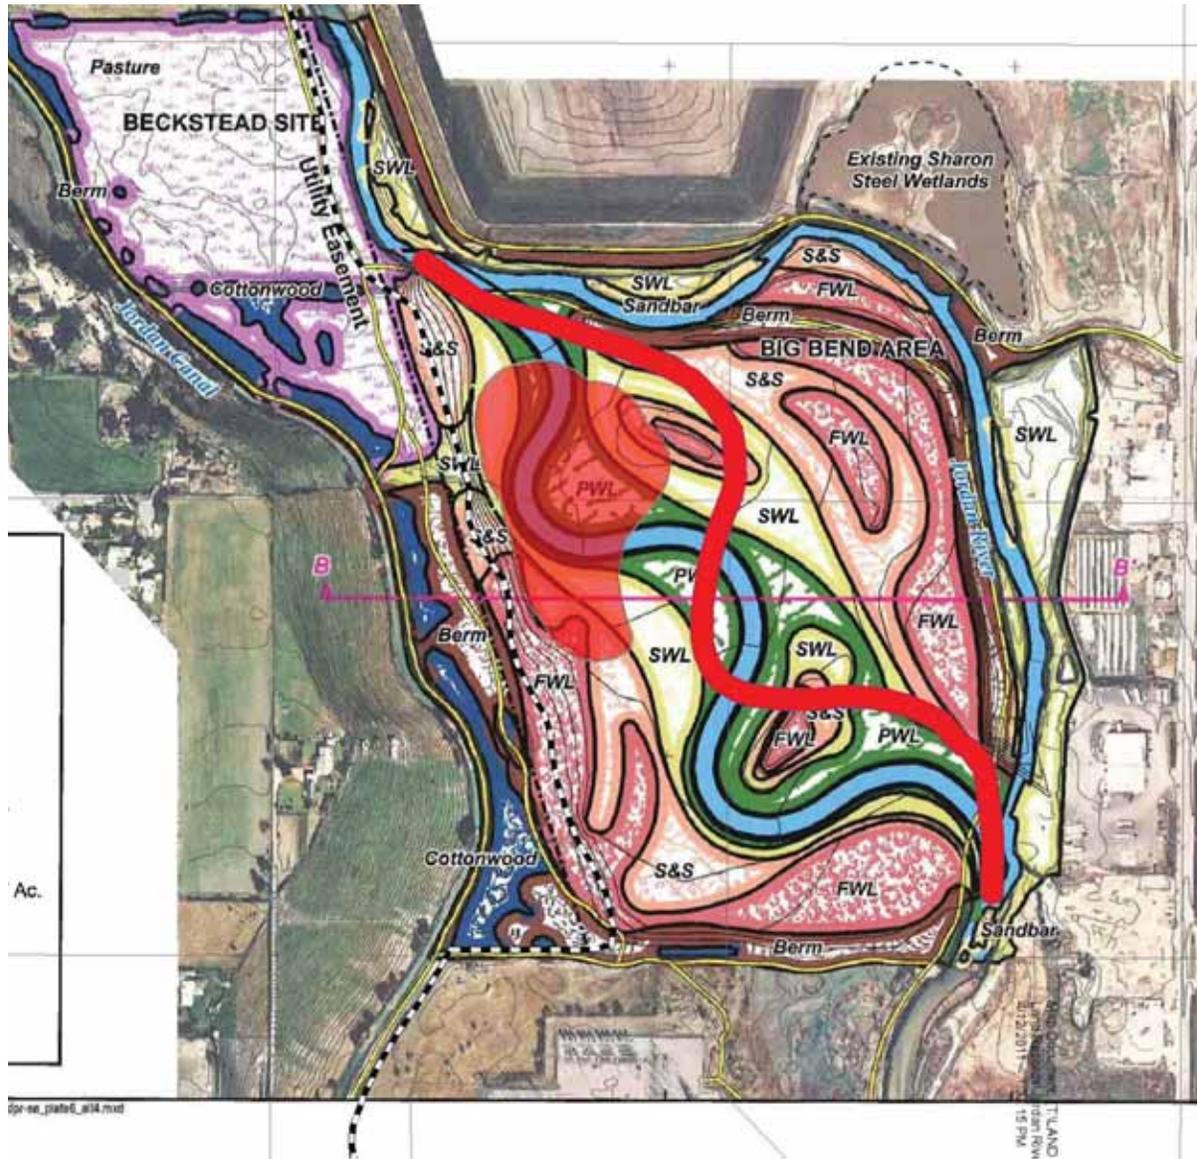
Figure 1. Conceptual drawing of one possible fishing pond design.

To further complicate the Alternatives Assessment, the city of West Jordan is now considering the addition of a large urban fishing pond within the project boundaries. Figure 1 shows a concept drawing of one possible pond location. Although early in the design phase, the City has suggested that they wish to include the pond within the project boundaries. If this pond is included in plans for the property, Alternatives 2 and 4 are no longer viable as proposed: leaving only the "No Action" alternative from the 2003 DDPR. Addition of the pond basically invalidates the alternatives assessment portion of the DDPR and essentially begins the entire process anew. These changes in land availability and project goals present the most pressing problem identified in the review process.

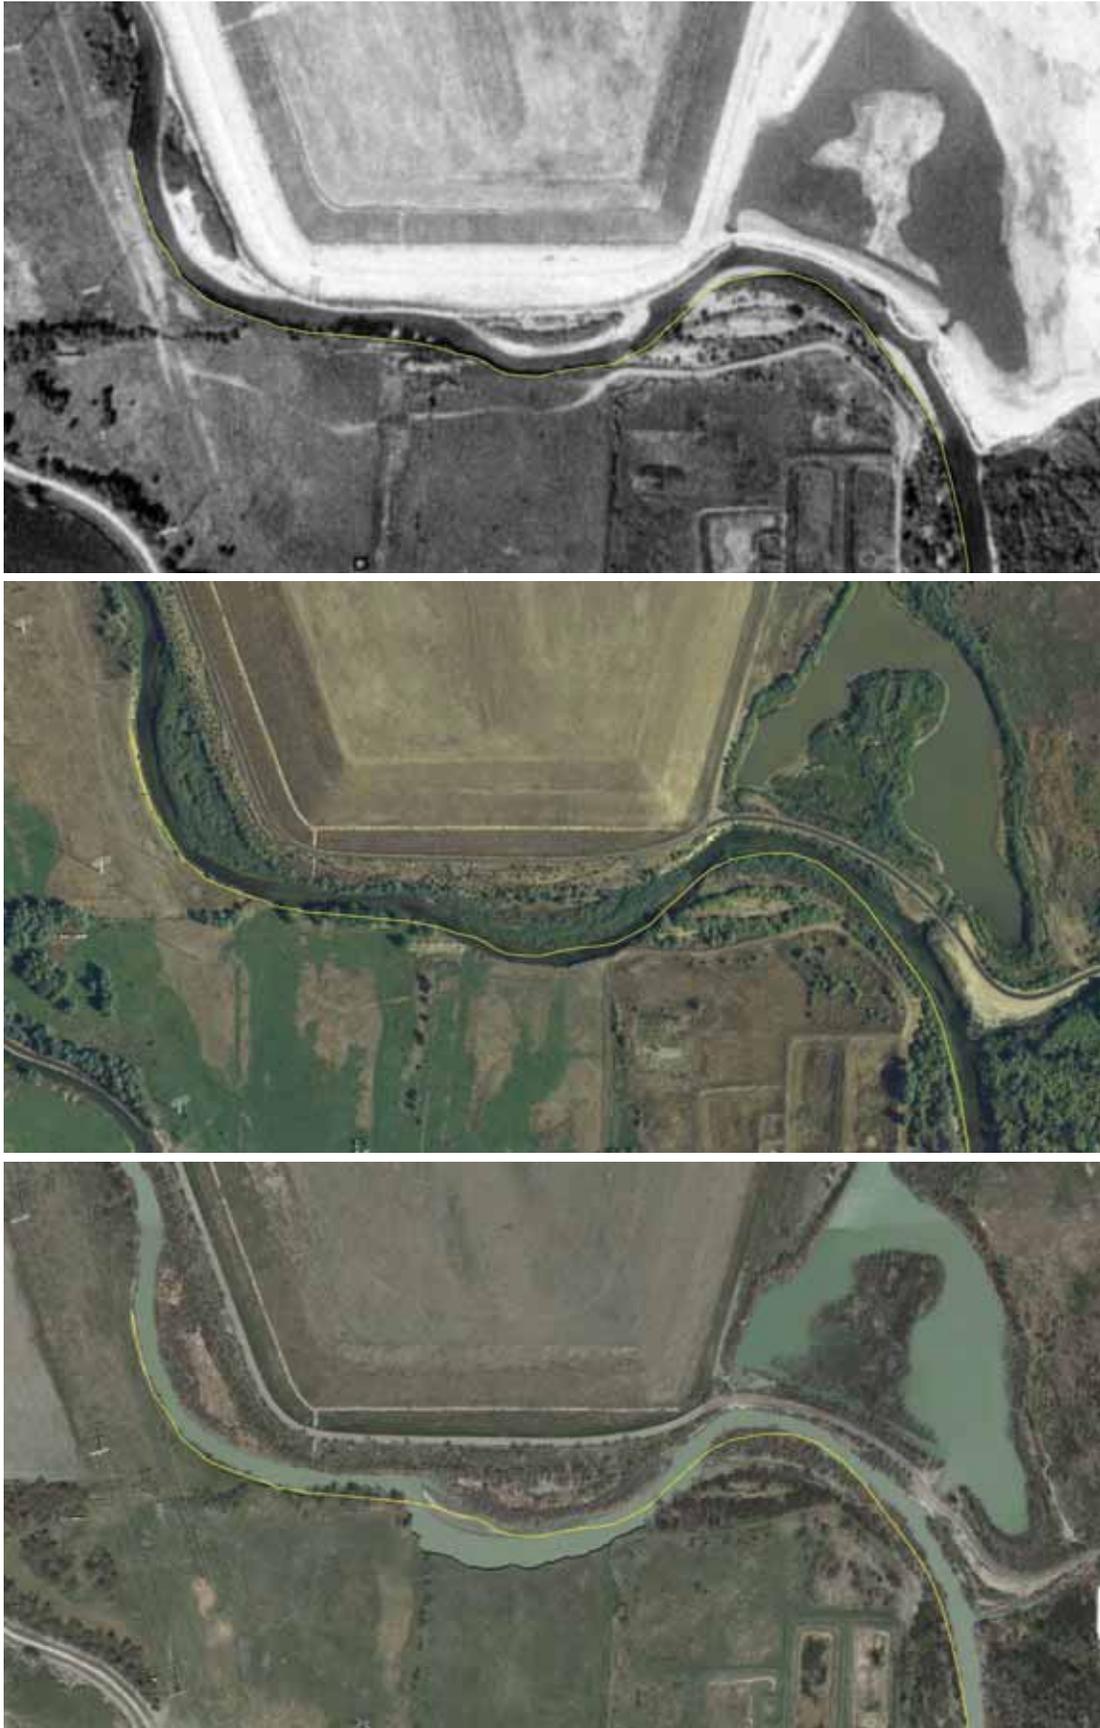
Figure 2. Channel erosion in the Big Bend area, south of the Sharon Steel cleanup site. The top image shows the channel as pictured in the 1990's Ortho Maps, including a trace of the southern edge of the active channel (yellow line). The middle and bottom images show the same area in 2003 and 2012, respectively. Note the bank erosion and channel widening that has occurred, mostly after the 2003 DDPR was completed.

Since completion of their assessment, considerable bank erosion and channel widening has occurred in portions of the Big Bend area. Figure 2 shows a section of the Jordan River within the project area, located just south of the Sharon Steel Tailings Cap, in which there has been substantial erosion, deposition, and channel widening. Nearly all of the erosion has occurred since completion of the 2000 Technical Memo. Further analyses demonstrated that the majority of the erosion occurred between 2009 and 2012 (Figure 3), probably driven primarily by the sustained high flows of 2011, which started in February and continued throughout the year, due to high snowpack and high water levels in Utah Lake. Streamflow in the Jordan River remained at levels that are geomorphically effective for nearly a full year, and large scale erosion occurred in areas that had been stable during the DDPR planning period.

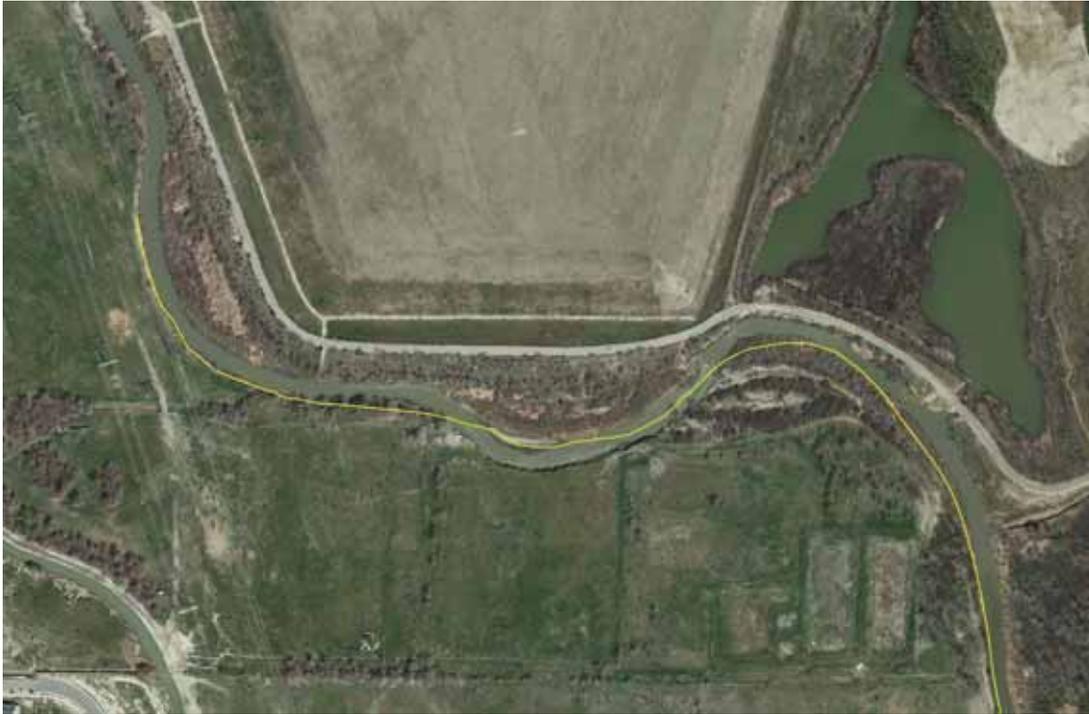
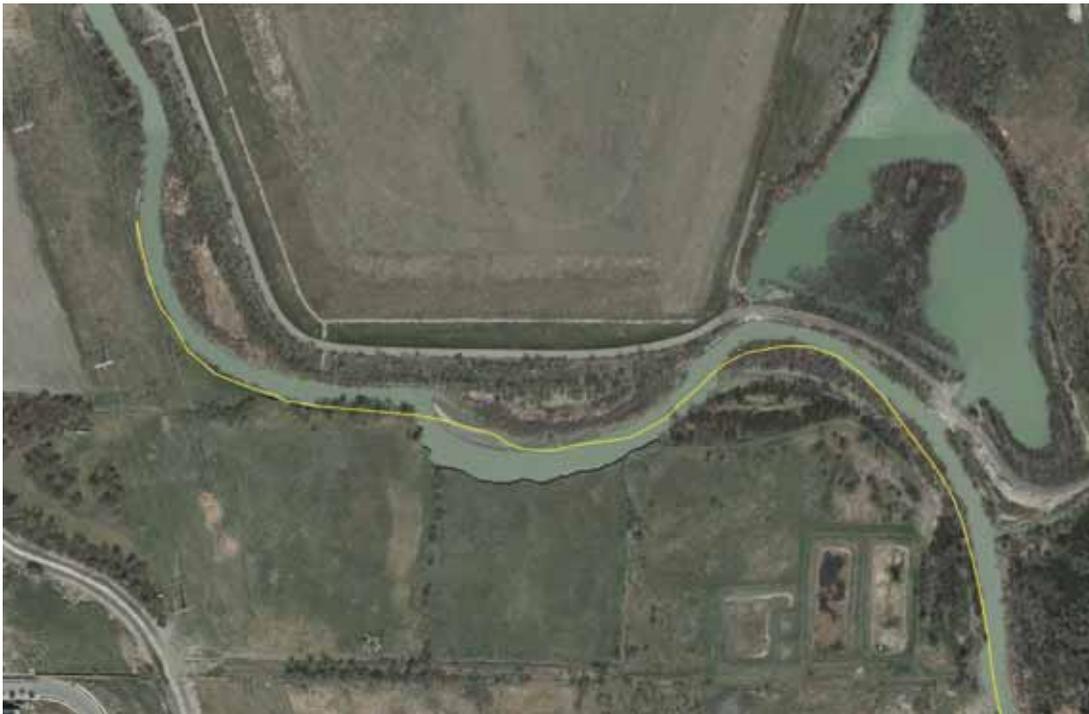
Figure 3. Aerial imagery from 2009 (top) and 2012 (bottom) showing the erosion that occurred during the sustained high flows of 2011.

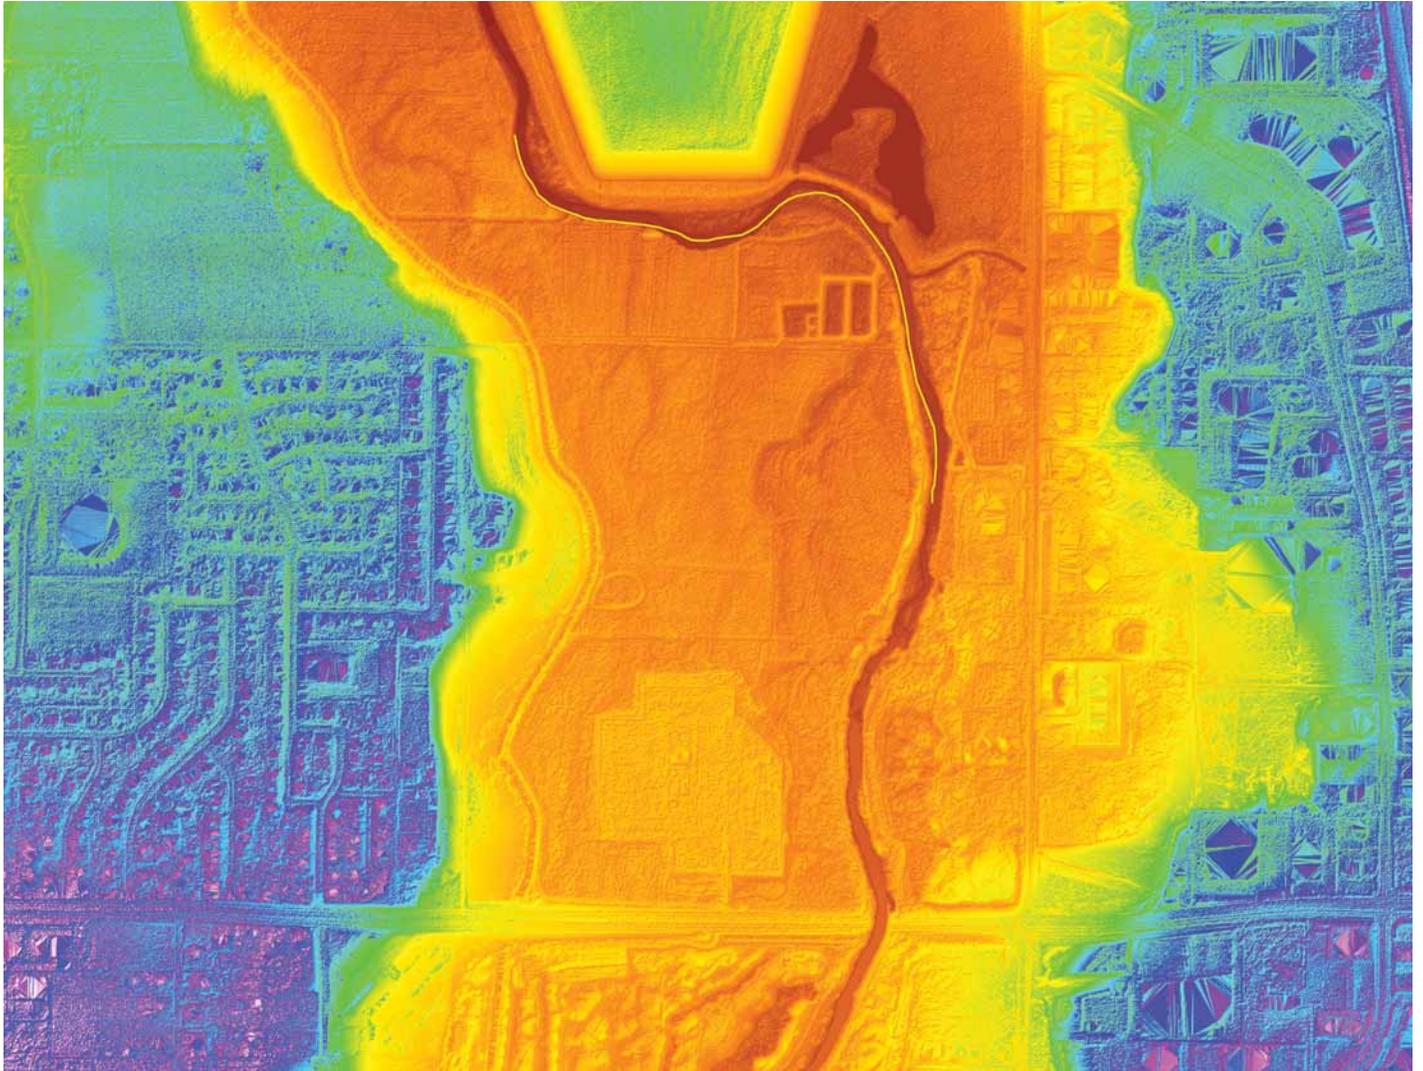
Figure 4. LIDAR data for the project area.

The Technical Memo and DDPR used topography based on ground surveys and aerial photogrammetry. These were the best data sources available at that time. More recently, LIDAR data have become available for the project site. These LIDAR data provide a high level of accuracy and resolution for design work and alternatives assessment. The LIDAR data are shown in Figure 4.

The vertical datum used for the LIDAR data is the North American Vertical Datum of 1988 (NAVD88). This datum is different than that used for the work in the Technical Memo and the DDPR, which was apparently based on the National Geodetic Vertical Datum of 1929 (NGVD29), although the datum is not referenced in the document. NAVD88 differs from NGVD29 by roughly 3 feet in the project area. When the DDPR data are adjusted by 3 feet, the elevations align reasonably well. It is important to note that the differences between these two datums vary from location to location, so a 3-foot adjustment is only useful for a rough estimate in the project area. Care should be taken to ensure that current planning efforts based on the LIDAR data account for these differences.

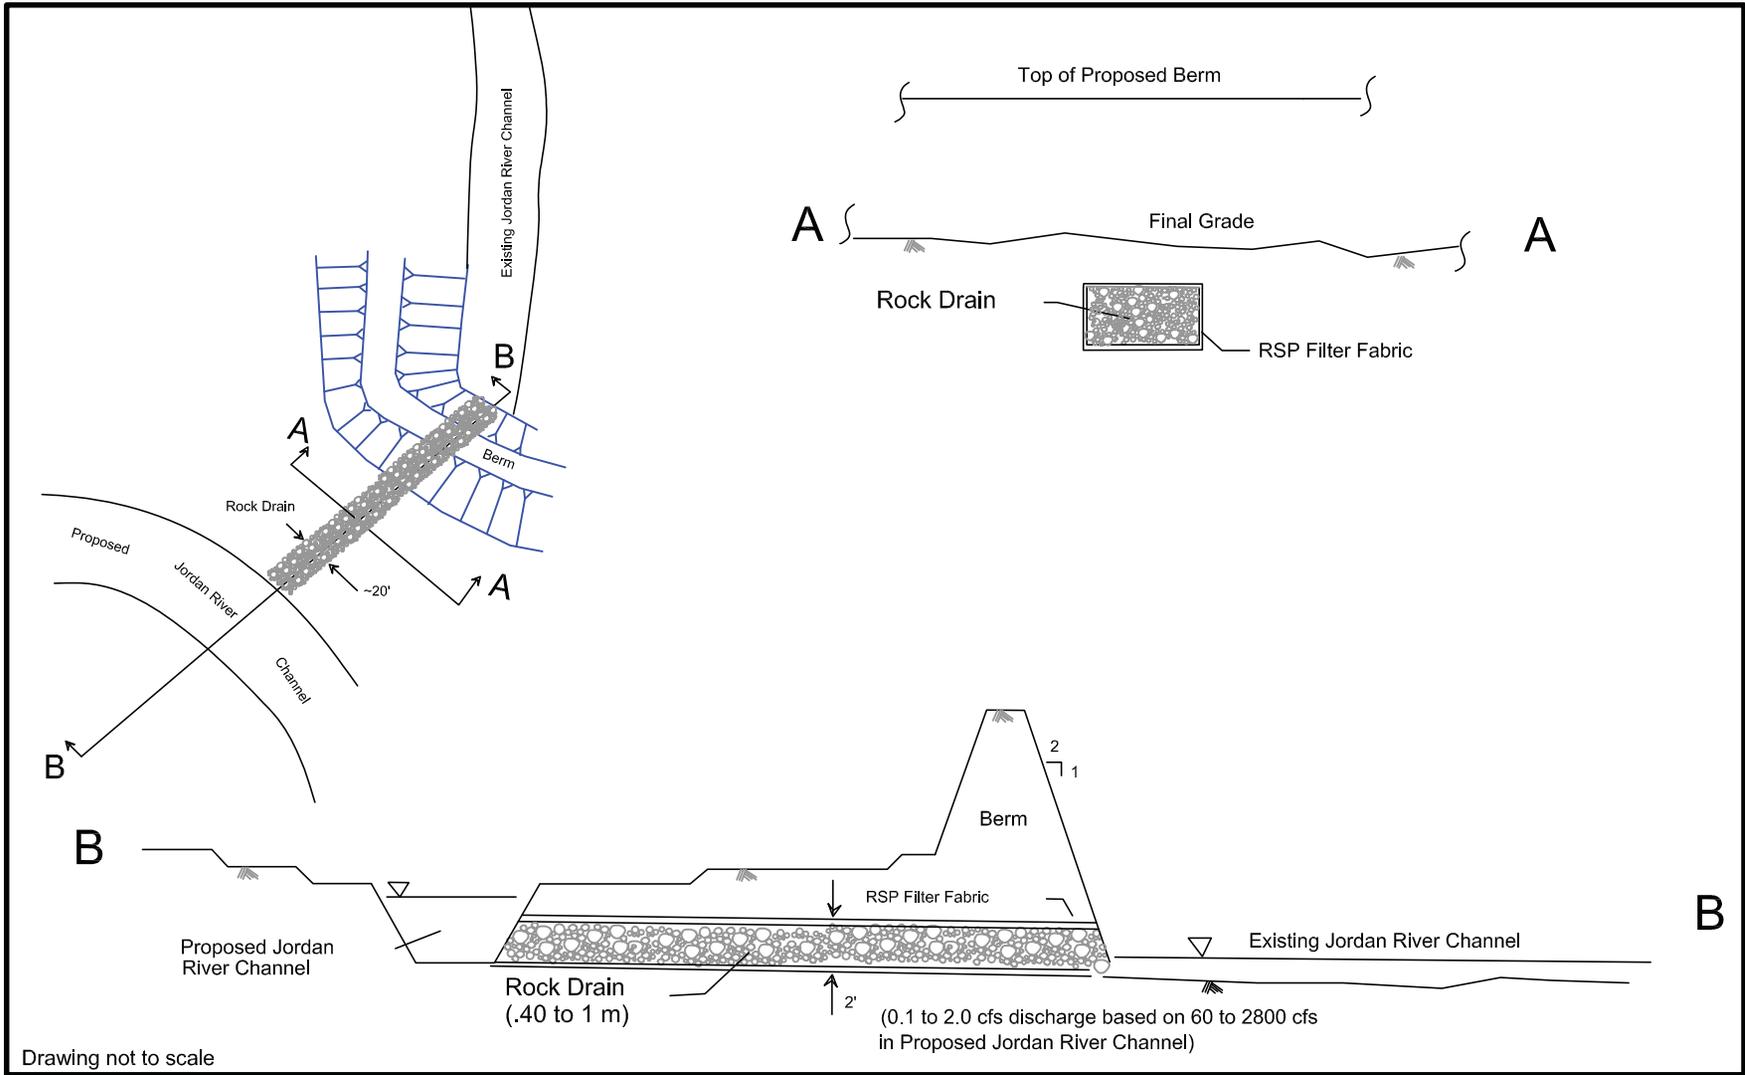
Plate 33
**Semi-Permeable
 Rip-Rap Levee**

Figure 5. Proposed semi-permeable rip-rap levee.

The DDPR includes plans for a proposed semi-permeable riprap levee (Figure 5) that would allow water to drain from the new meander channel back into the old channel to maintain the riparian vegetation and to supply water for the Sharon Steel Wetland. This drain is likely not needed because the groundwater in the area will remain quite high and should keep the old channel filled with water at all

times. Recent groundwater studies of the Jordan River suggest that this reach is a gaining reach, meaning that groundwater levels slope toward the river channel. The proposed design appears to be adequate but has a 2-to-1 slope on the downstream side. Steep slopes like this one are far less stable than more gradual slopes which occur over longer distances. I recommend that the slope be reduced to 6-to-1 or more on the back side of the levee, if it is deemed to be needed. In addition, high flows should be allowed to overtop this levee, whenever they occur. During periods of extremely high flow, the entire floodplain will be inundated. It would be better to allow the water to overtop the levee and flow down the old channel rather than trying to prevent it from overtopping. Given the extremely low slope in the area, water will likely be ponded against the back side of the levee before it overtops. The high water on the back side of the levee helps limit any tendency to headcut as water flows over the top, especially if the slope on the back side is shallow.

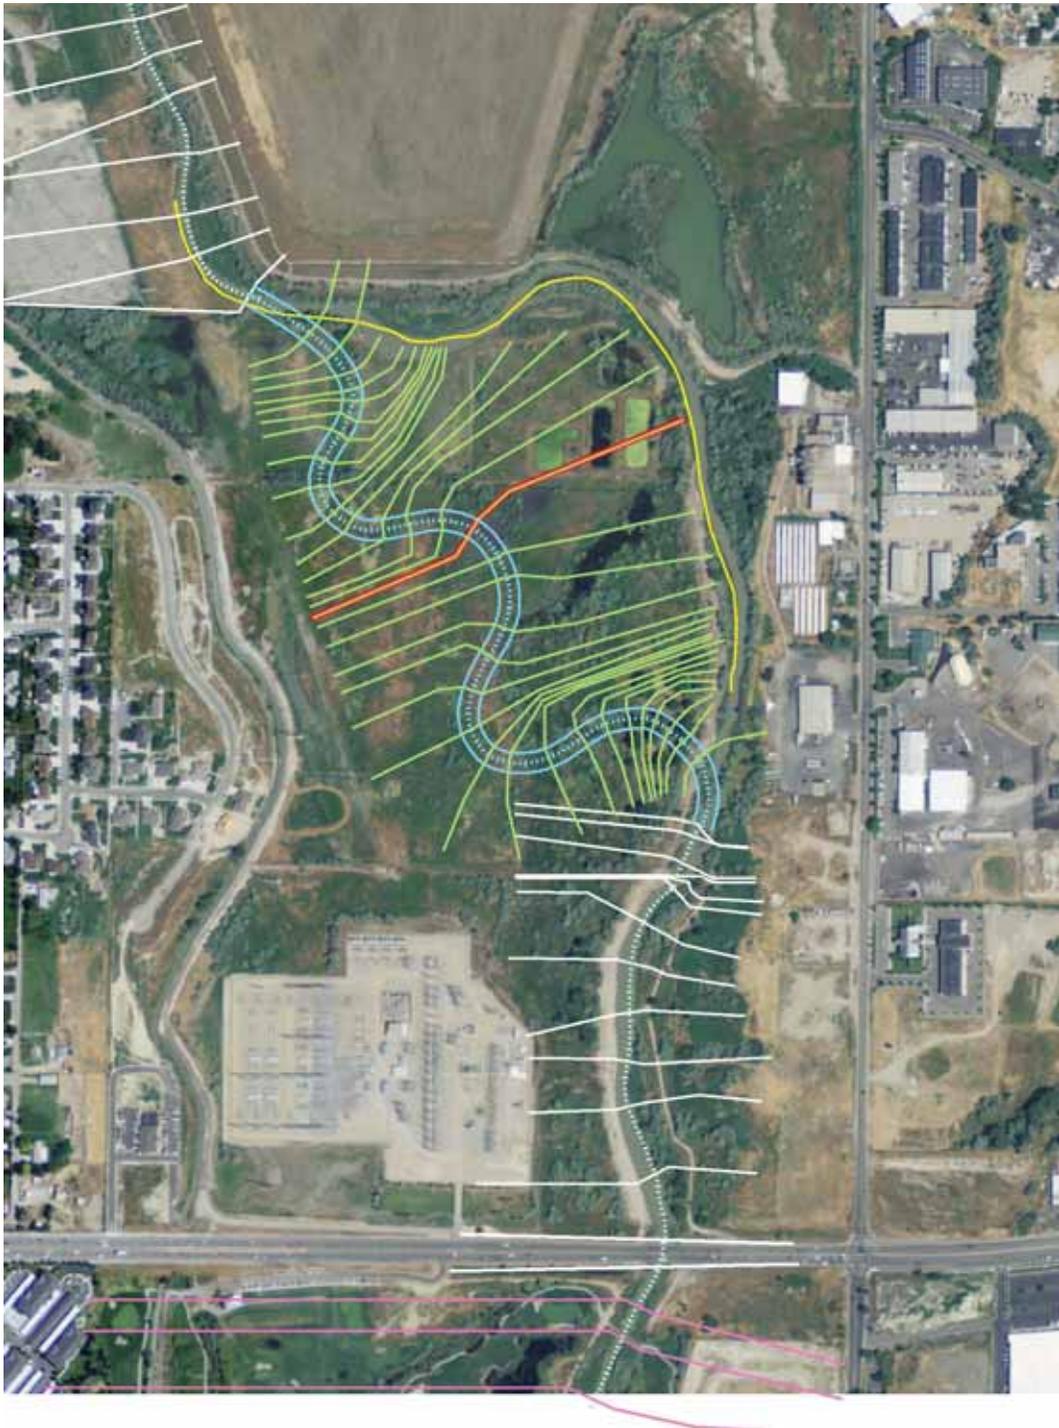
Figure 6. Aerial image showing the location of HEC-RAS cross sections for Alternatives 4 and 5. The cross section location highlighted in red was used to generate the cross section plot shown in Figure 7.

floodplain material will need to be removed to lower the floodplain to an elevation where overbank flooding can occur: a primary goal of the project (Figures 6 and 7). Much of the floodplain will need to be lowered by 4 to 5 feet in order to be accessible to the river during frequent flood events.

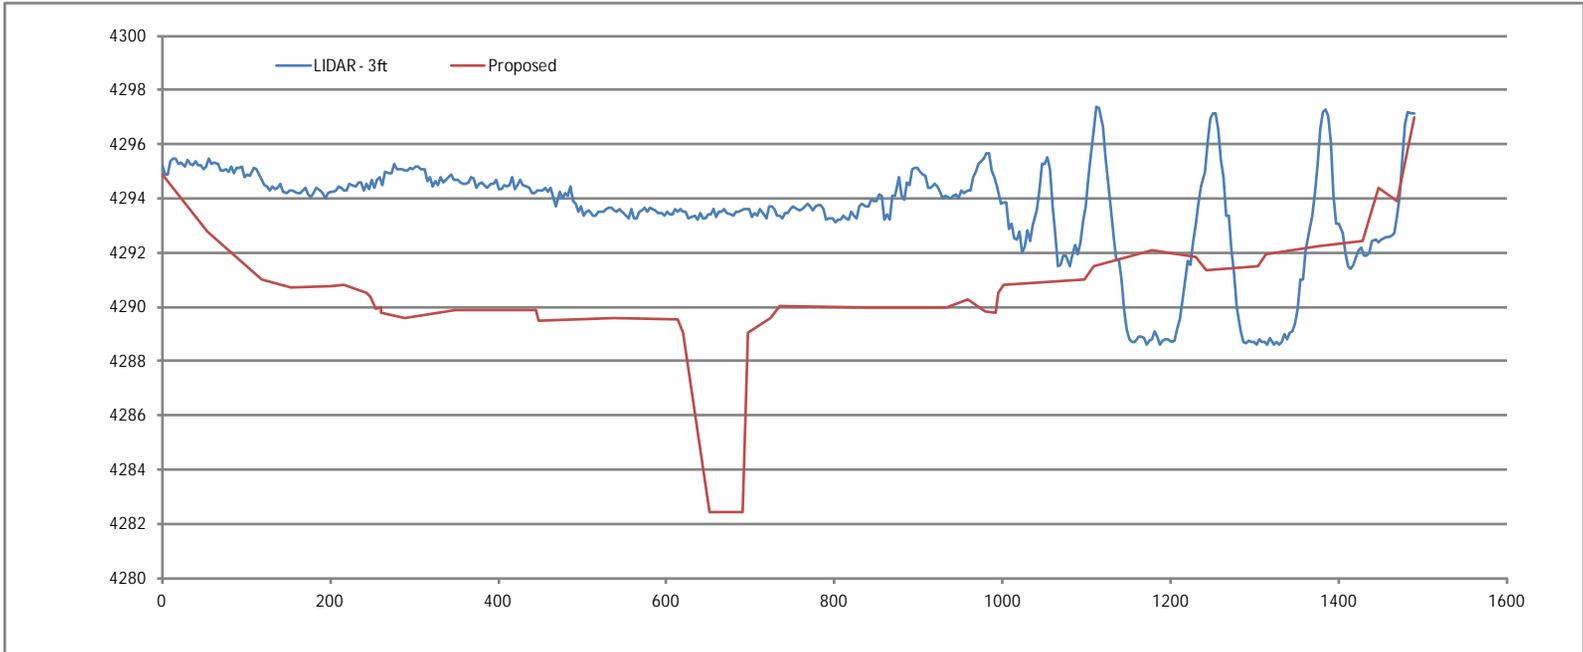
Figure 7. Plot of cross section from Figure 6, showing the existing ground surface from adjusted LIDAR data (blue line) and the proposed ground surface (red line). Note that much of the proposed surface requires between 4-5 feet of excavation and lowering of the existing ground surface.
