High Lakes Stabilization Construction Report

Kidney Lake

Uinta Basin Replacement Project

March 2010

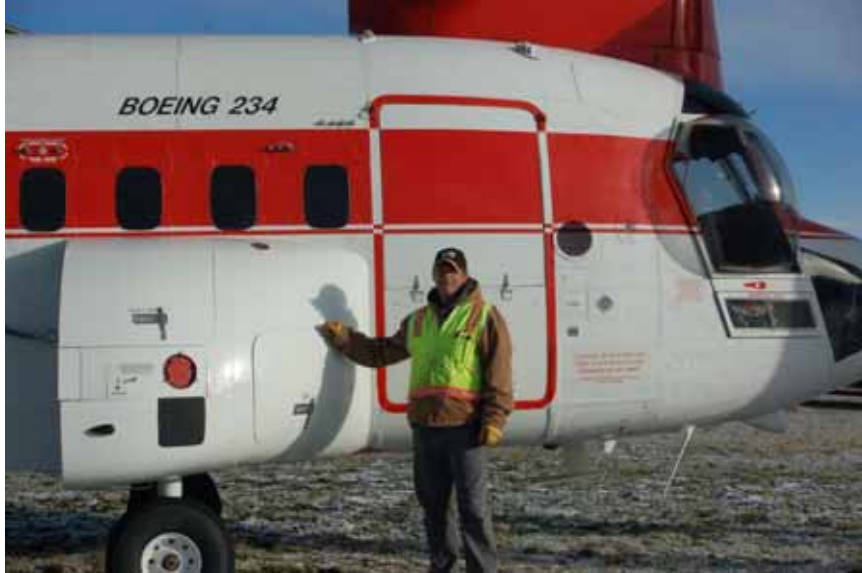
Figure 2: Reclamation Crew Manager Mike Talbot alongside the Helicopter used to transport equipment to worksite.

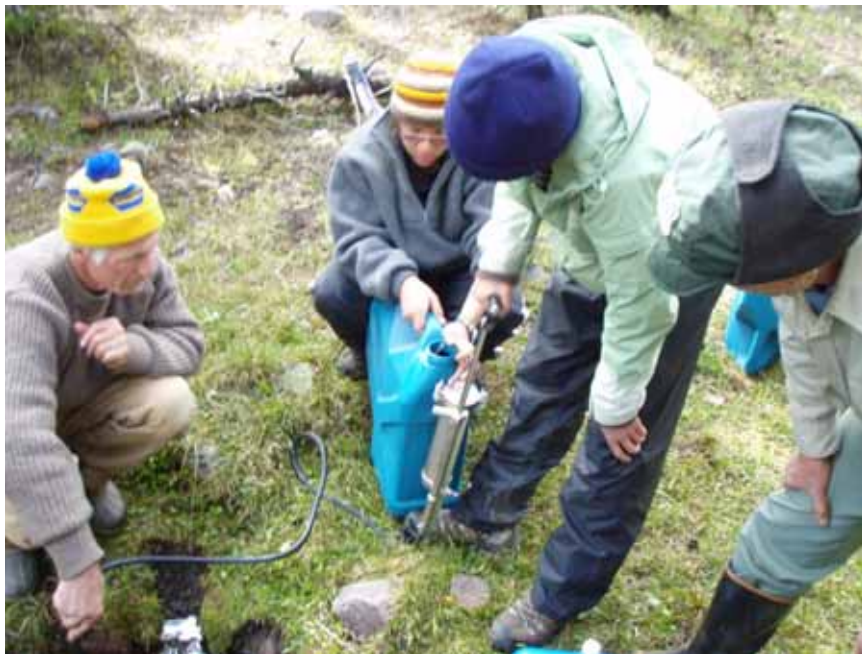
Figure 3: Some of the UCC crew that assisted with work at Kidney Lake getting instructions from Forest Service on proper use of water filtration equipment.

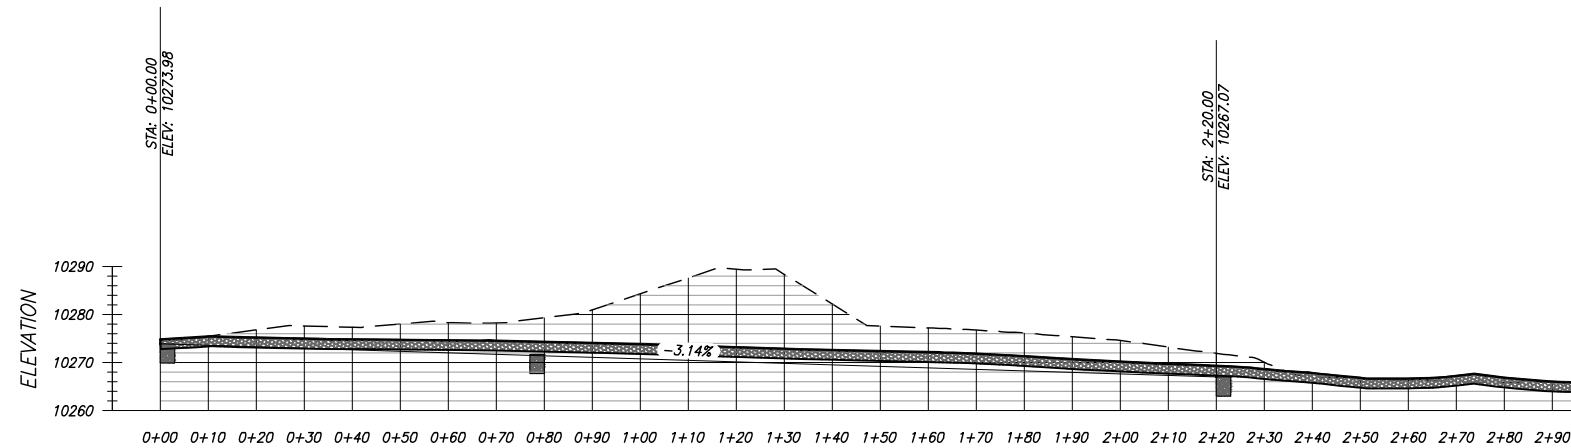
PROFILE: KIDNEY BREACH

Breach - 24" Riprap Thickness
15 ft. bottom width
2.5:1 Cut slopes

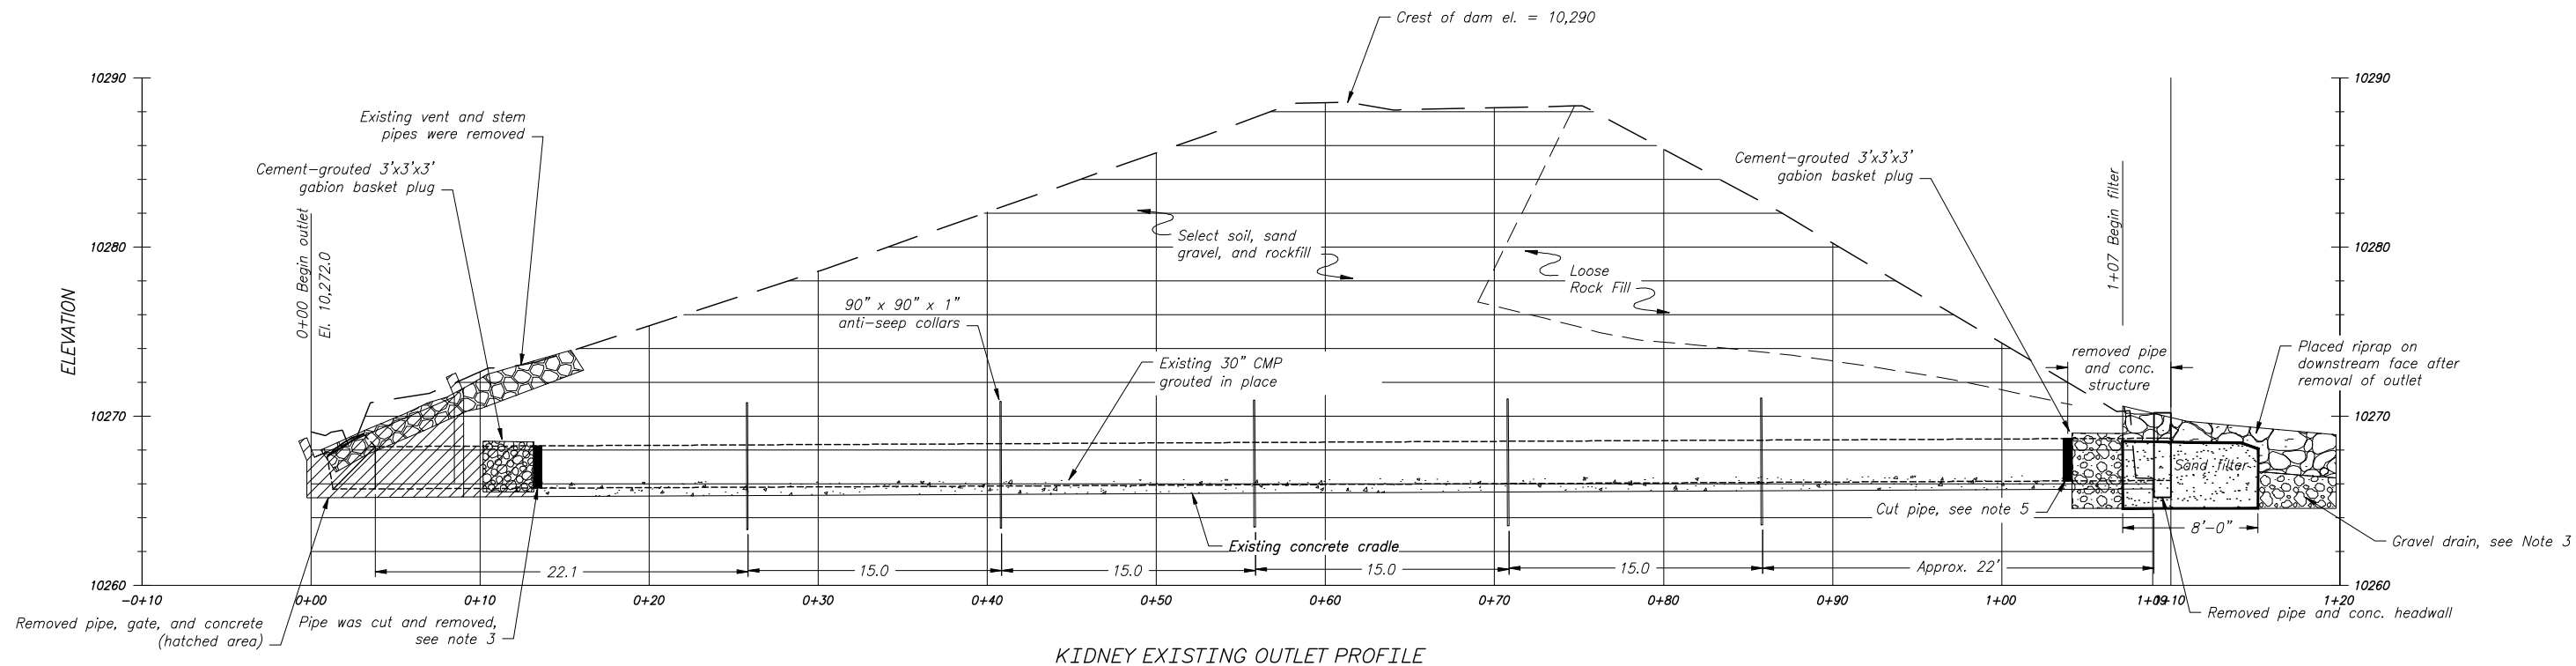
1. Compacted filter material was placed over last 8' of pipe removal trench.
2. Trench walls were sloped to allow adequate compaction between fill and natural ground.
3. Inlet area was filled with embankment material compacted to 95% maximum density.
