Dollar Ridge Fire Watershed Restoration Plan

Prepared by:
Eco Logical Research, Inc.
JW Associates
Martin & Nicholson
Environmental Consultants, LLC
for
The Utah Division of Wildlife
Resources

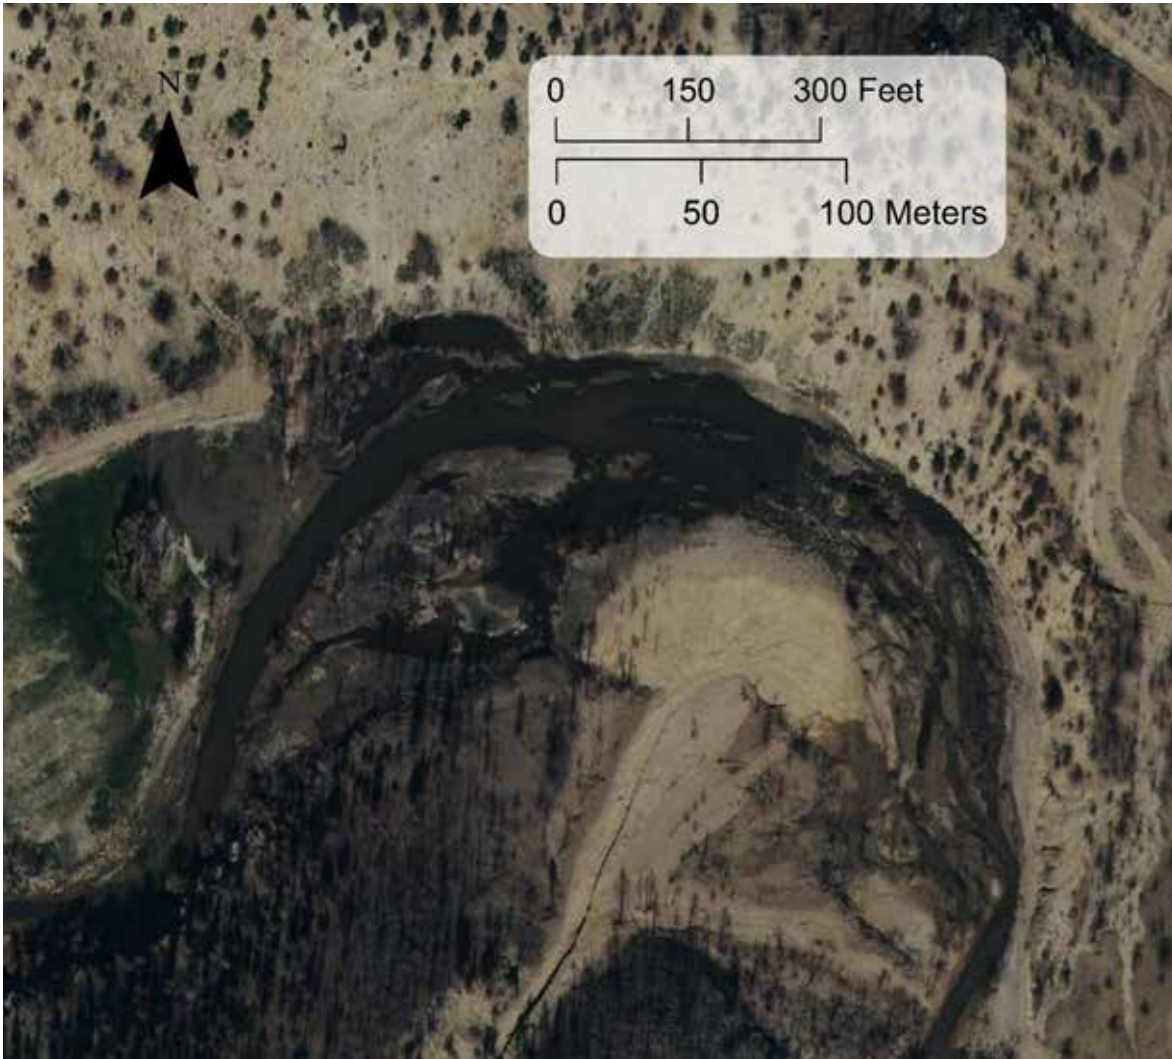
Figure 3.14. Alluvial fan forcing formation of upstream backwater at Timber Draw

We recommend a policy of no action in these areas. These areas are currently providing both important habitat and environmental benefits and acting as a natural buffer to flow, sediment and wood delivery to downstream infrastructure and private property. They provide extensive surface water storage and deep water, low velocity habitat for instream species, support extensive riparian areas by maintaining a high-water table, attenuate high flows, and provide a storage zone for sediment and wood, limiting their transport downstream.

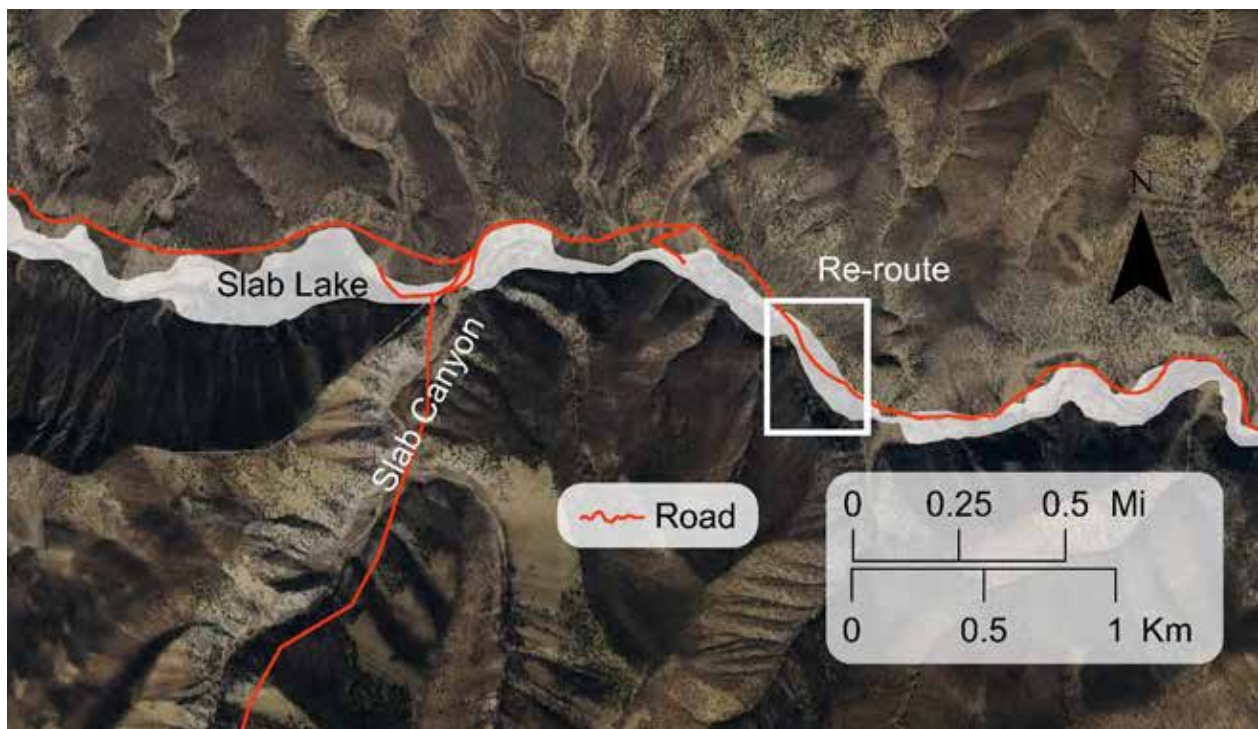
dissect the floodplain. In these instances, it has also been heavily protected using rip rap. As part of the EWP reconstruction of the road, portions were moved from the valley bottom onto the adjacent hillside, most notably upstream of Sulfur Draw near river km 18 (Figure 3.22).

Figure 3.22. Pre-fire road location along the Strawberry River. The white polygon represents the valley bottom. The pre-fire road traversed the valley bottom as well as alluvial fans. The current road also traverses alluvial fans and the valley bottom, and was re-routed in one location to remove it from the valley bottom. Where the road is in the valley bottom, it is most often along the valley bottom margin.

The long-term health of the Strawberry River depends on its ability to maximize access of valley bottom. Furthermore, maintaining road accessibility is critical for landowners at Beaver Canyon and emergency responders. In addition to limiting the recovery potential and long-term health of the Strawberry River, sections of the road located in the valley bottom are more vulnerable to high flows that result from high-intensity rain events. Where possible, we advocate moving the existing road out of the valley bottom and onto either alluvial fans or hillslopes as was done near Sulfur Draw. In many places it may be impossible to move the road out of the valley bottom due to cliff walls. In these areas, we recommend moving the road adjacent to the valley bottom margin.

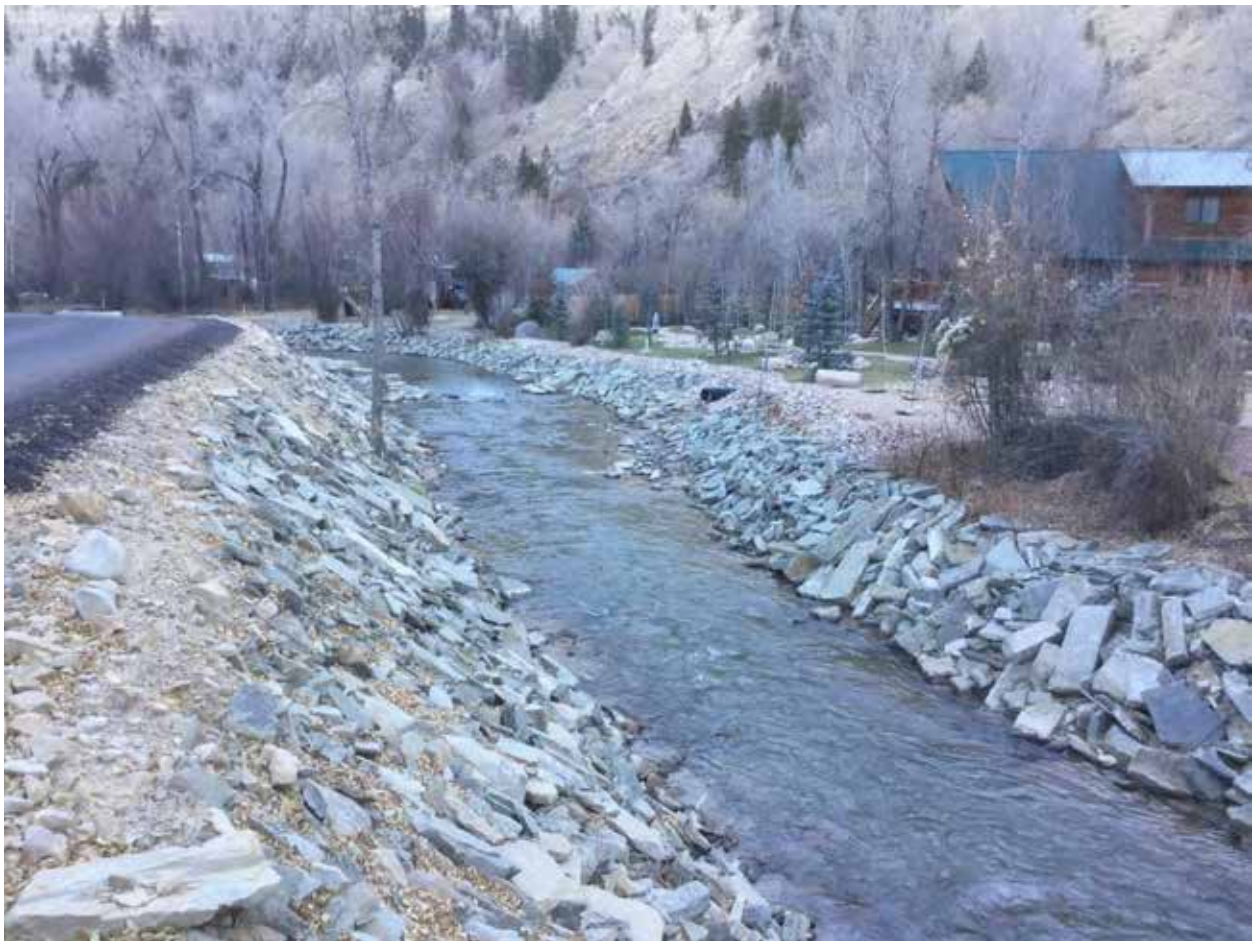
We identify this area based on location alone, due to its proximity to Pinnacles and significant infrastructure that includes both bridges and recreational residencies that is built immediately adjacent to the current channel. The current channel has been extensively stabilized by rip rap in this area (Figure 3.23). We do not suggest any work within the private lands at Pinnacles. We also recognize the hazards posed by clogged bridges or flooding of adjacent buildings. As such, we recommend structural additions are limited to higher elevation surfaces (e.g., bars, floodplain) downstream of the debris catchers located at river km 28.5.

Figure 3.23. Strawberry River at Promised Land Resort at Pinnacles. No restoration is recommended here.

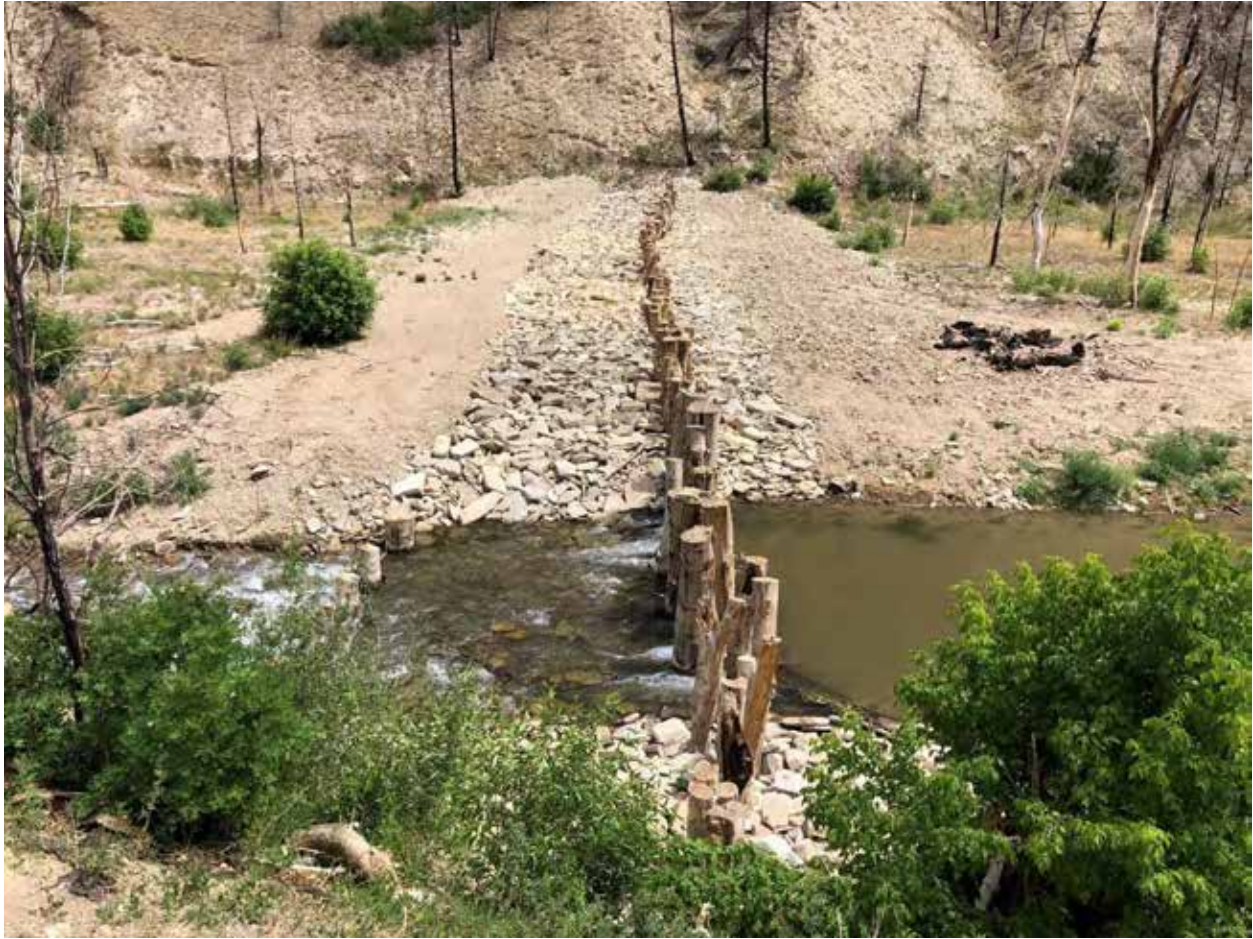
Figure 3.24. Debris catcher near River km 28.5. This structure extends laterally across the valley bottom and can capture wood mobilized from upstream reaches, protecting downstream infrastructure.

However, rather than a policy of ‘no action’ we recommend maximizing the buffering capacity of the section below the debris catchers (Figure 3.24). These actions will address two different objectives. First, increasing the buffering capacity of this reach will attenuate high flows, reducing their capacity to cause flooding. This is important both in the context of monsoon driven flows, which are likely to continue to occur, as well as important in any restoration that includes high flows to improve riverscape health along the full length of the Strawberry River. Increasing the buffering capacity also applies to sediment and wood delivery and storage. Buffering capacity with respect to sediment means creating conditions to facilitate deposition in either the active channel and floodplain so it is not delivered and stored in the reach near Pinnacles. Similarly, increasing the buffering capacity means changing this reach from a reach that is likely to transport wood to a reach that will store it, thereby decreasing its delivery to areas with significant infrastructure.

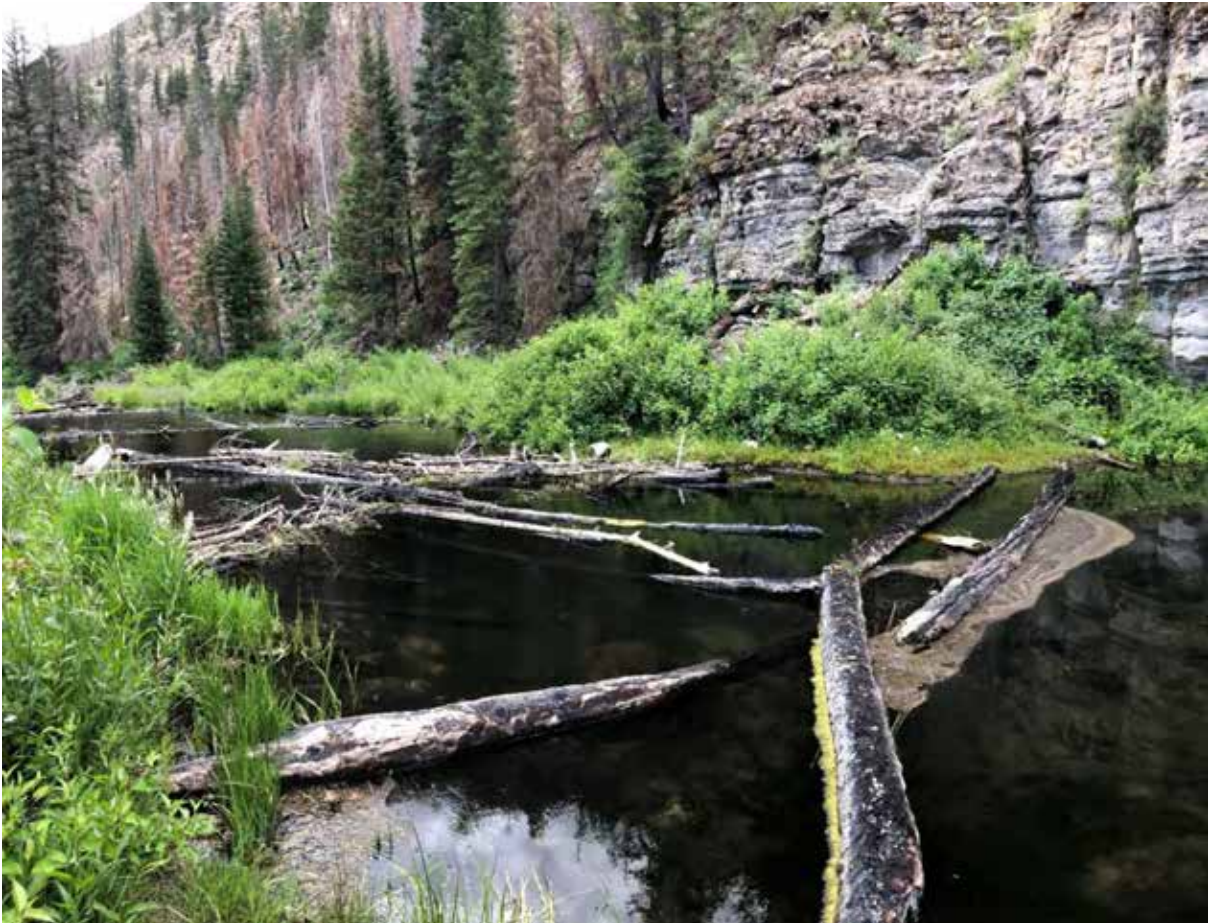
Figure 3.29. Geomorphic Reach 1. Large wood, some of which is from past restoration efforts, found in a beaver dam complex.

We do not recommend any instream restoration in reaches 1 and 2 because they are in good condition and unlikely to benefit significantly from direct interventions such as construction of instream woody debris structures, which are already abundant as are beaver dams (Figure 3.29), as shown in the Geomorphic Assessment. While these areas would likely benefit from greater channel-floodplain connectivity, we believe this is most likely to be achieved by restoration of the flow regime rather than direct manipulation of channel geometry which would be harmful to the existing riparian area and channel and difficult to access.

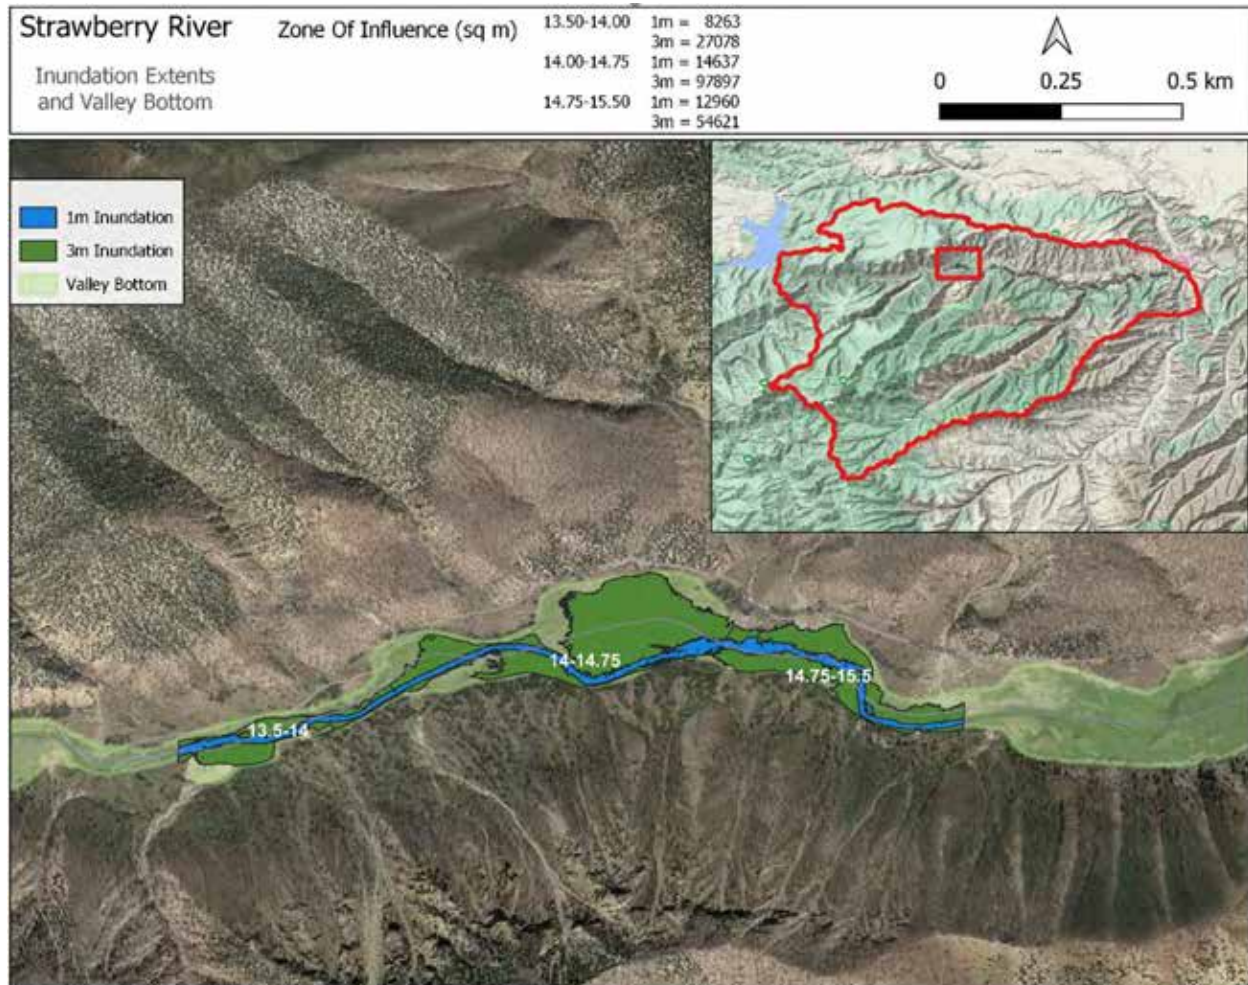
Figure 3.33. Restoration reaches 13.5-15.5. ZOI assumes 1 m of inundation during augmented flows, and 3 m for hydrological influence on riparian vegetation following restoration. The valley bottom was delineated using LiDAR data.

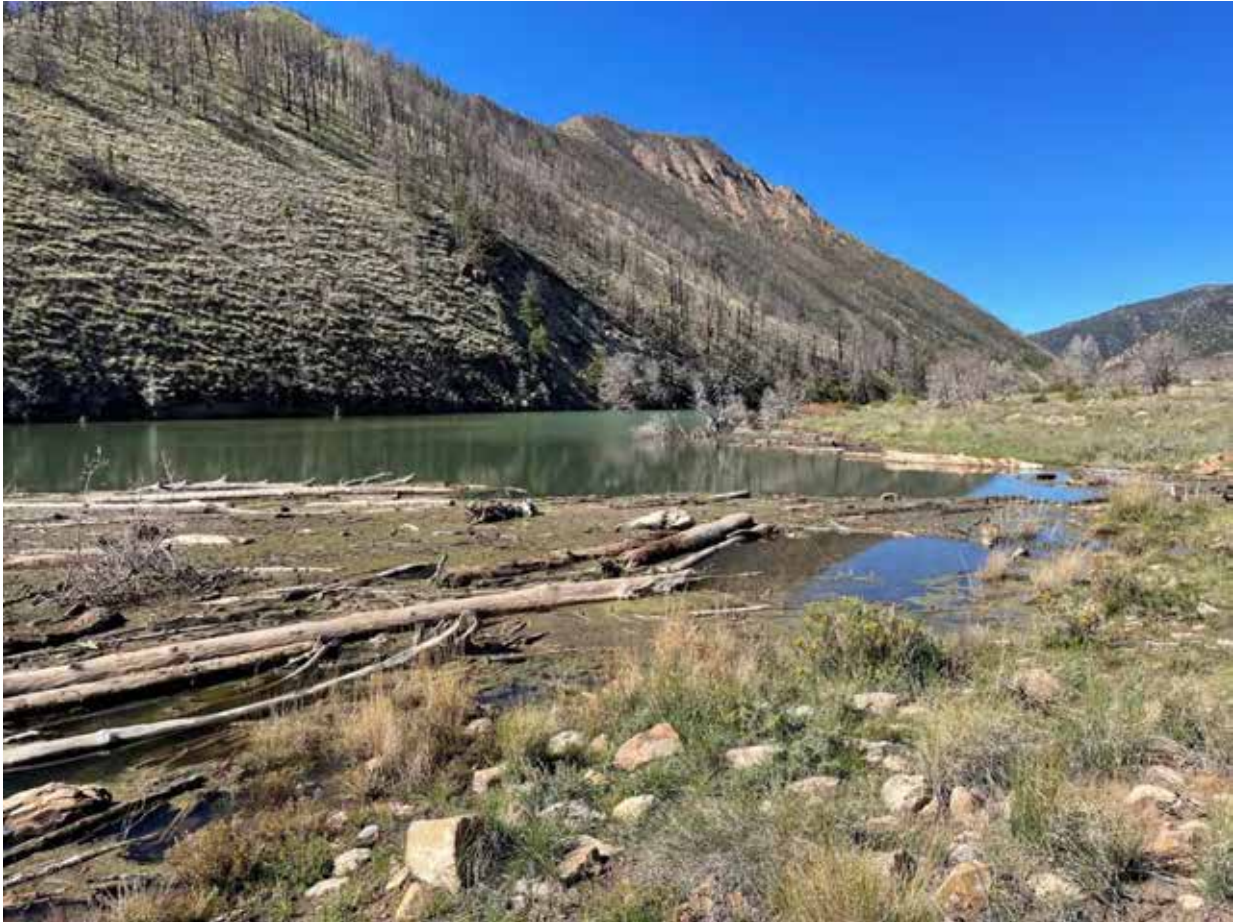
Figure 3.34. Slab lake was formed by a debris flow from Slab Canyon creating a large alluvial fan that dammed the river.

River Km 15.5 – 16.5: No action. This section is currently Slab Lake, the backwater formed by the damming of the Strawberry River by the alluvial fan at the outlet of Slab Canyon (Figure 3.34). Slab Lake is a unique habitat feature along the length of the Strawberry River, providing extensive surface water storage and deep-water habitat. The lake can also buffer flow, sediment and wood delivery to downstream reaches. Any wood that is mobilized and transported from LTPBR instream structures is likely to be stored at Slab Lake. In other words, the mobilization of unanchored instream wood structures above Slab Lake (e.g., PALS and BDAs) pose no threat to infrastructure downstream of Slab Canyon.

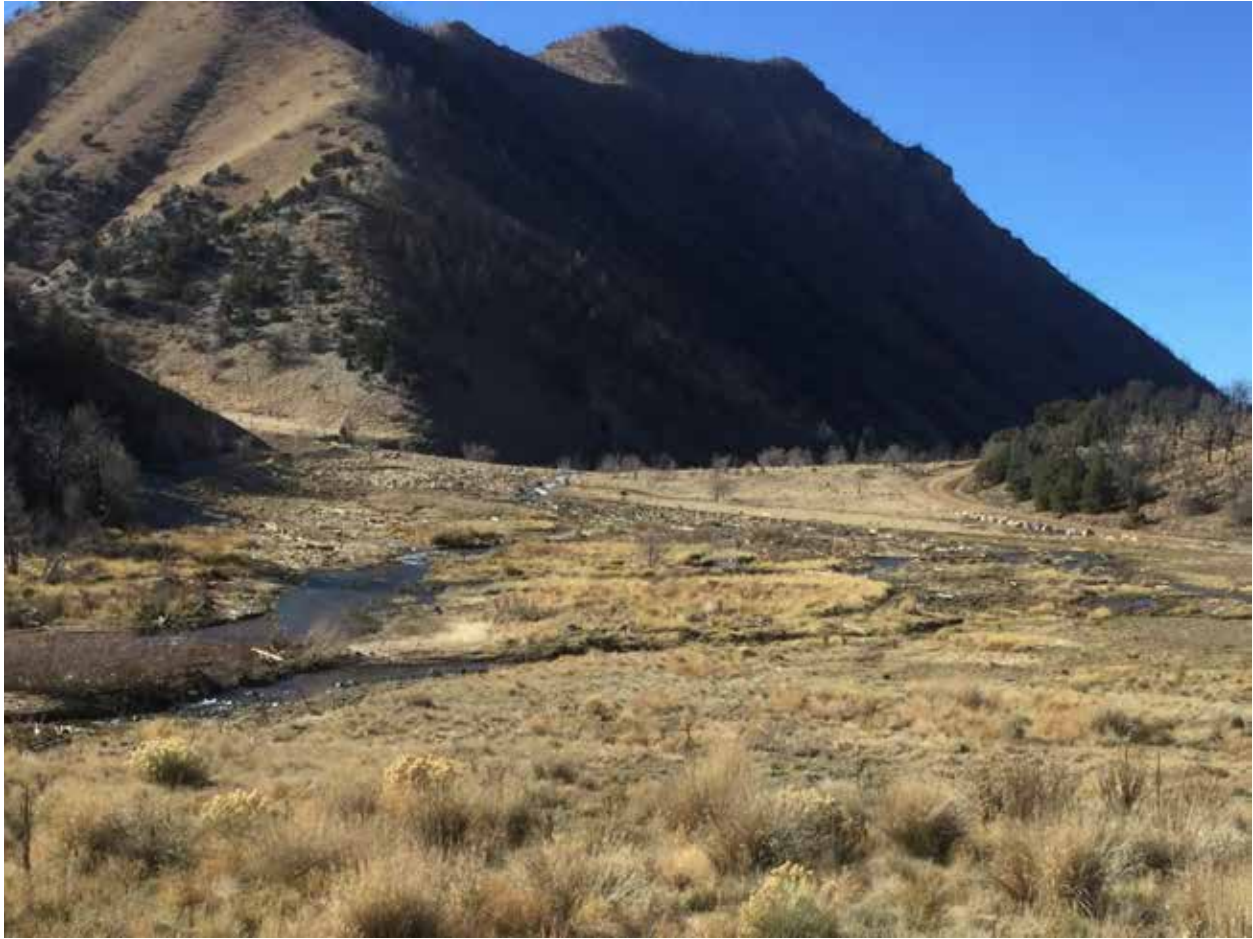
Figure 3.35. River Km 16.5-17. Water cresting the alluvial fan on the downstream side of Slab Lake formed a multithreaded system. Structure addition can maintain the multi-threaded system and increase lateral connectivity to increase riparian vegetation.

River Km 16.5 – 17: LTPBR structure addition. This reach is immediately downstream of the Slab Lake and currently supports a multi-threaded planform (Figure 3.39). LTPBR structures here will maintain a multi-threaded planform, increasing channel complexity and hydraulic diversity (Figure 3.35).

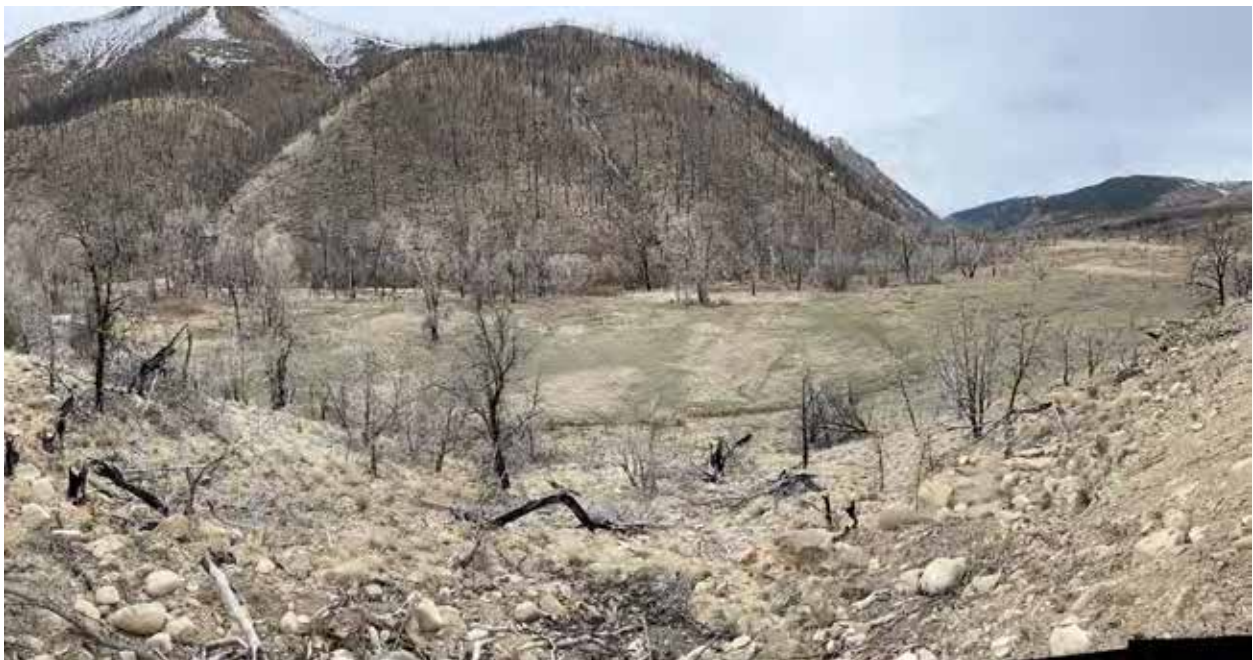
Figure 3.38. River Km 17.5-18. Old irrigation ditch might be used to aid in the recruitment of riparian plantings.

Figure 3.37). Heavy machinery can be used to create additional channels across the valley bottom and create more significant immediate connectivity. Irrigation infrastructure (irrigation ditch) might be repaired to deliver water to floodplain surfaces and allow for riparian planting (Figure 3.38).

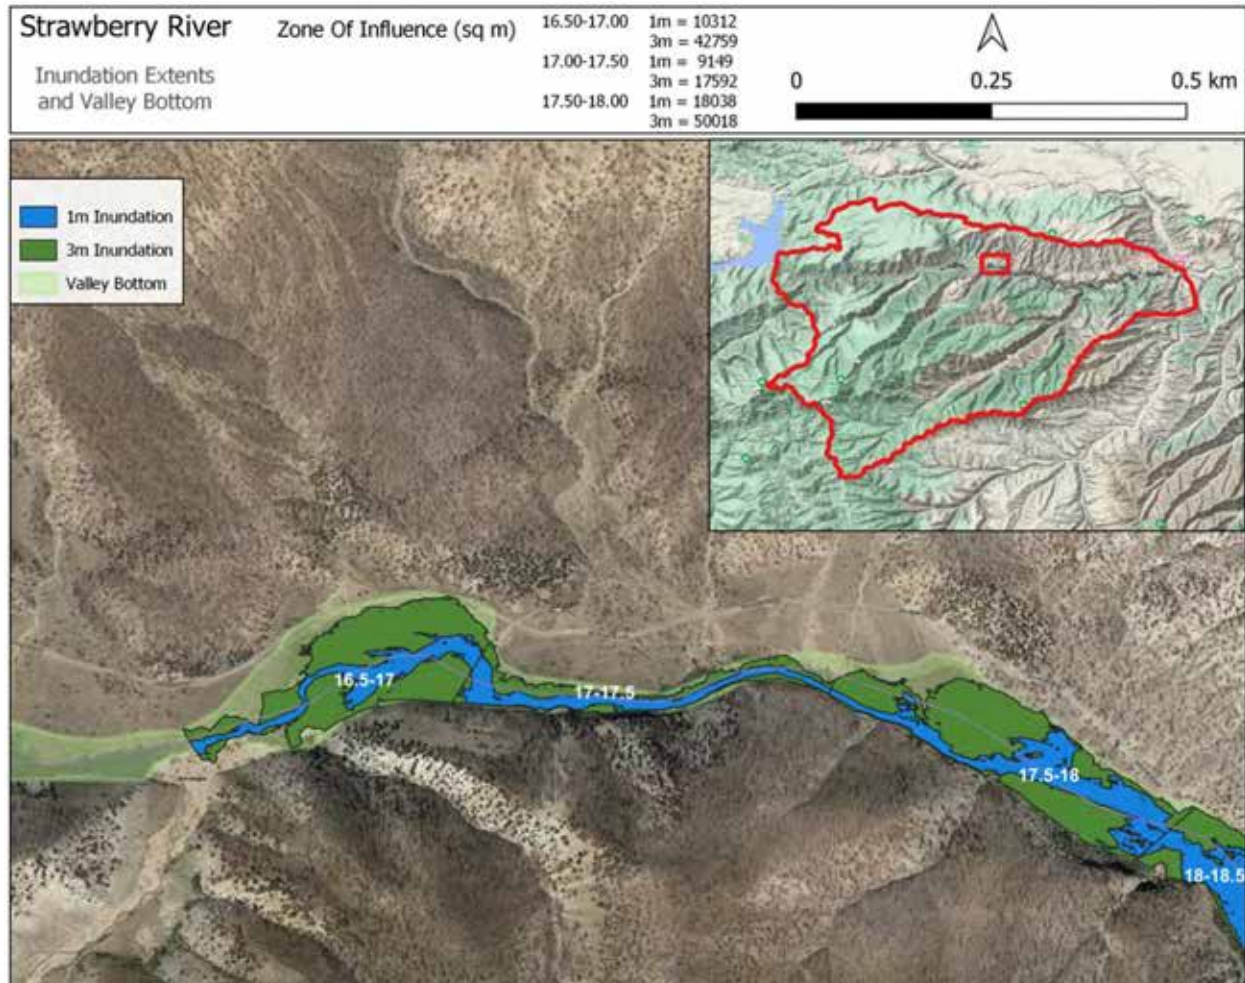
Figure 3.39. Restoration reaches river km 16-18. ZOI assumes 1 m of inundation during augmented flows, and 3 m for hydrological influence on riparian vegetation following restoration. The valley bottom was delineated using LiDAR data.

River Km 17.5 – 18.0: LTPBR instream structure addition, channel modification, riparian planting, and irrigation. This reach has a wide valley bottom (Figure 3.39). Structures can be used in this reach to increase instream complexity and improve habitat; however it is unlikely to significantly increase channel-floodplain connectivity or the formation of additional channels characteristic of Stage 0 conditions as channel is incised in some areas (

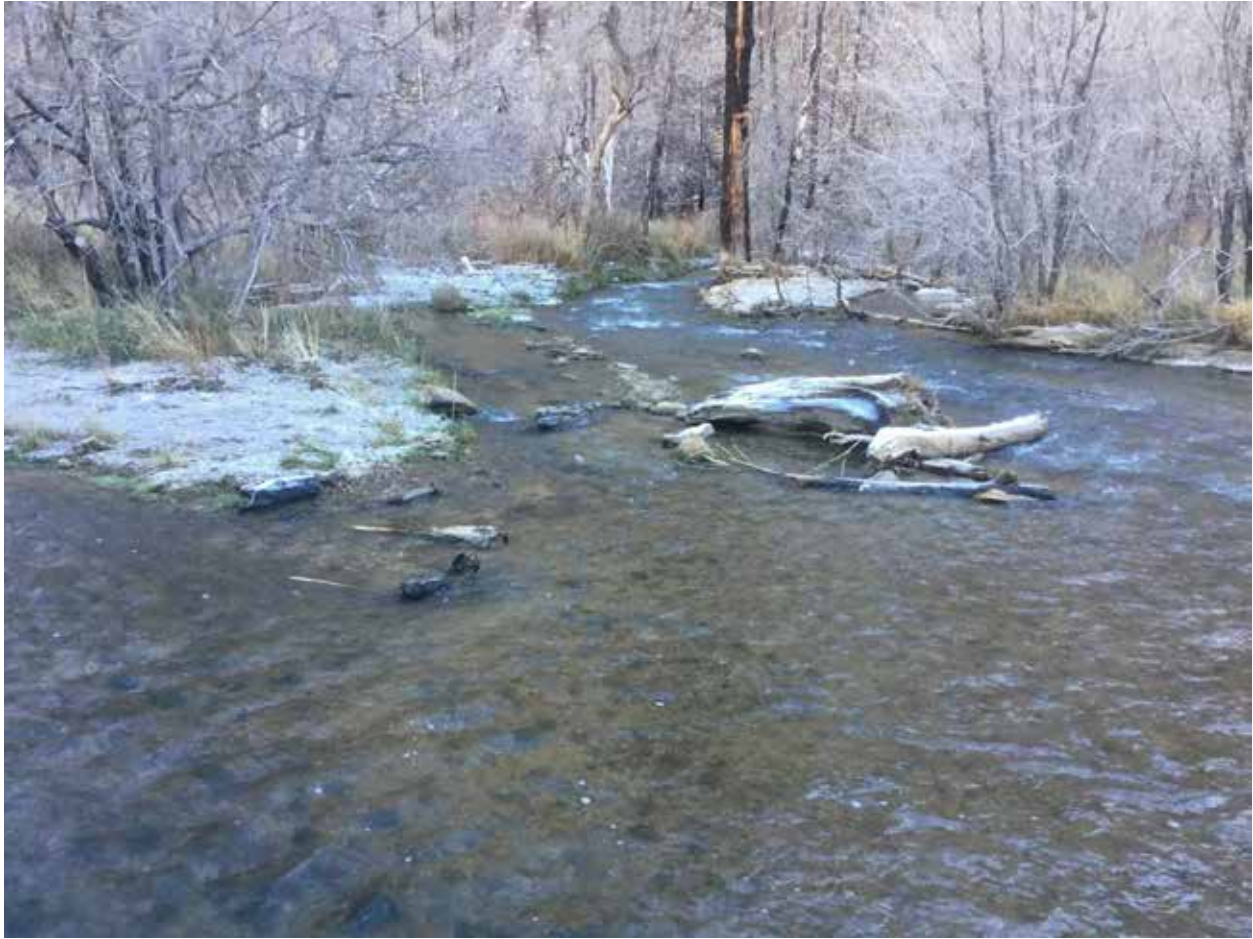
Figure 3.42. River Km 18.5-19.25. A multi-threaded low entrenchment reach. The addition of LTPBR structures will increase habitat complexity and force water onto the floodplain.

River Km 18.75 – 19.25: LTPBR instream structure addition. This section has low entrenchment and is characterized by multiple channels (Figure 3.42, Figure 3.43). LTPBR instream structures can be used to maintain multiple channels and increase instream complexity.

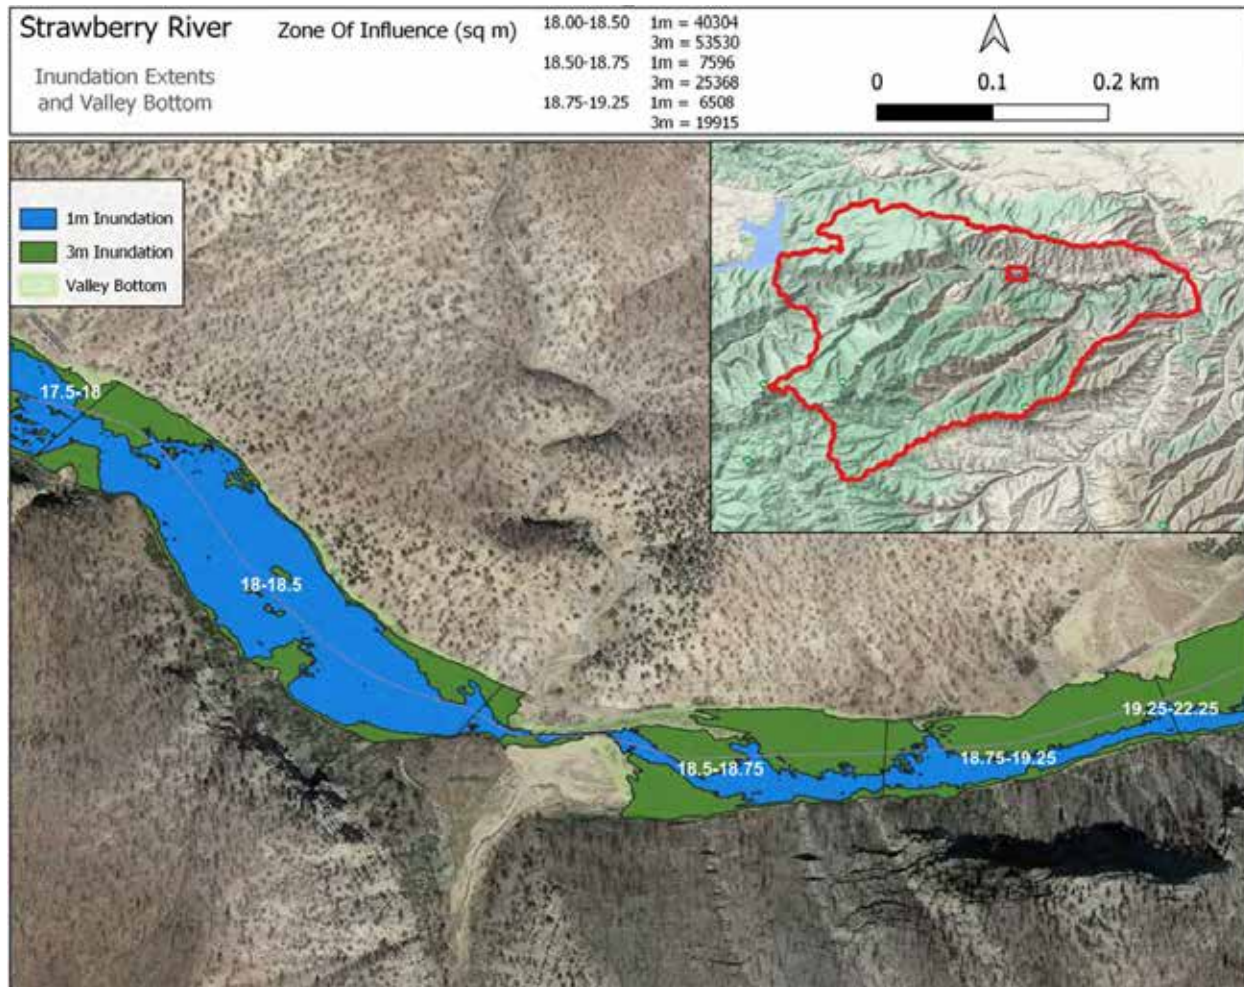
Figure 3.43. Restoration reaches river Km 18-19.25. ZOI assumes 1 m of inundation during augmented flows, and 3 m for hydrological influence on riparian vegetation following restoration. The valley bottom was delineated using LiDAR data.

River Km 18.5 – 18.75: Channel modification, LTPBR structure addition, and riparian planting. This section is at and immediately downstream of the confluence with Sulfur Draw and was the site of extensive EWP work (Figure 3.43). The EWP actions produced a narrow, straight, single-thread channel that had large angular boulders added. This channel has little instream habitat and the large boulders are unlikely to be transported even during high flow events. This reach has limited riparian vegetation and easy access for heavy equipment. Removal of the levees can immediately increase floodplain access at moderate flows and allow for riparian planting (Figure 3.41).

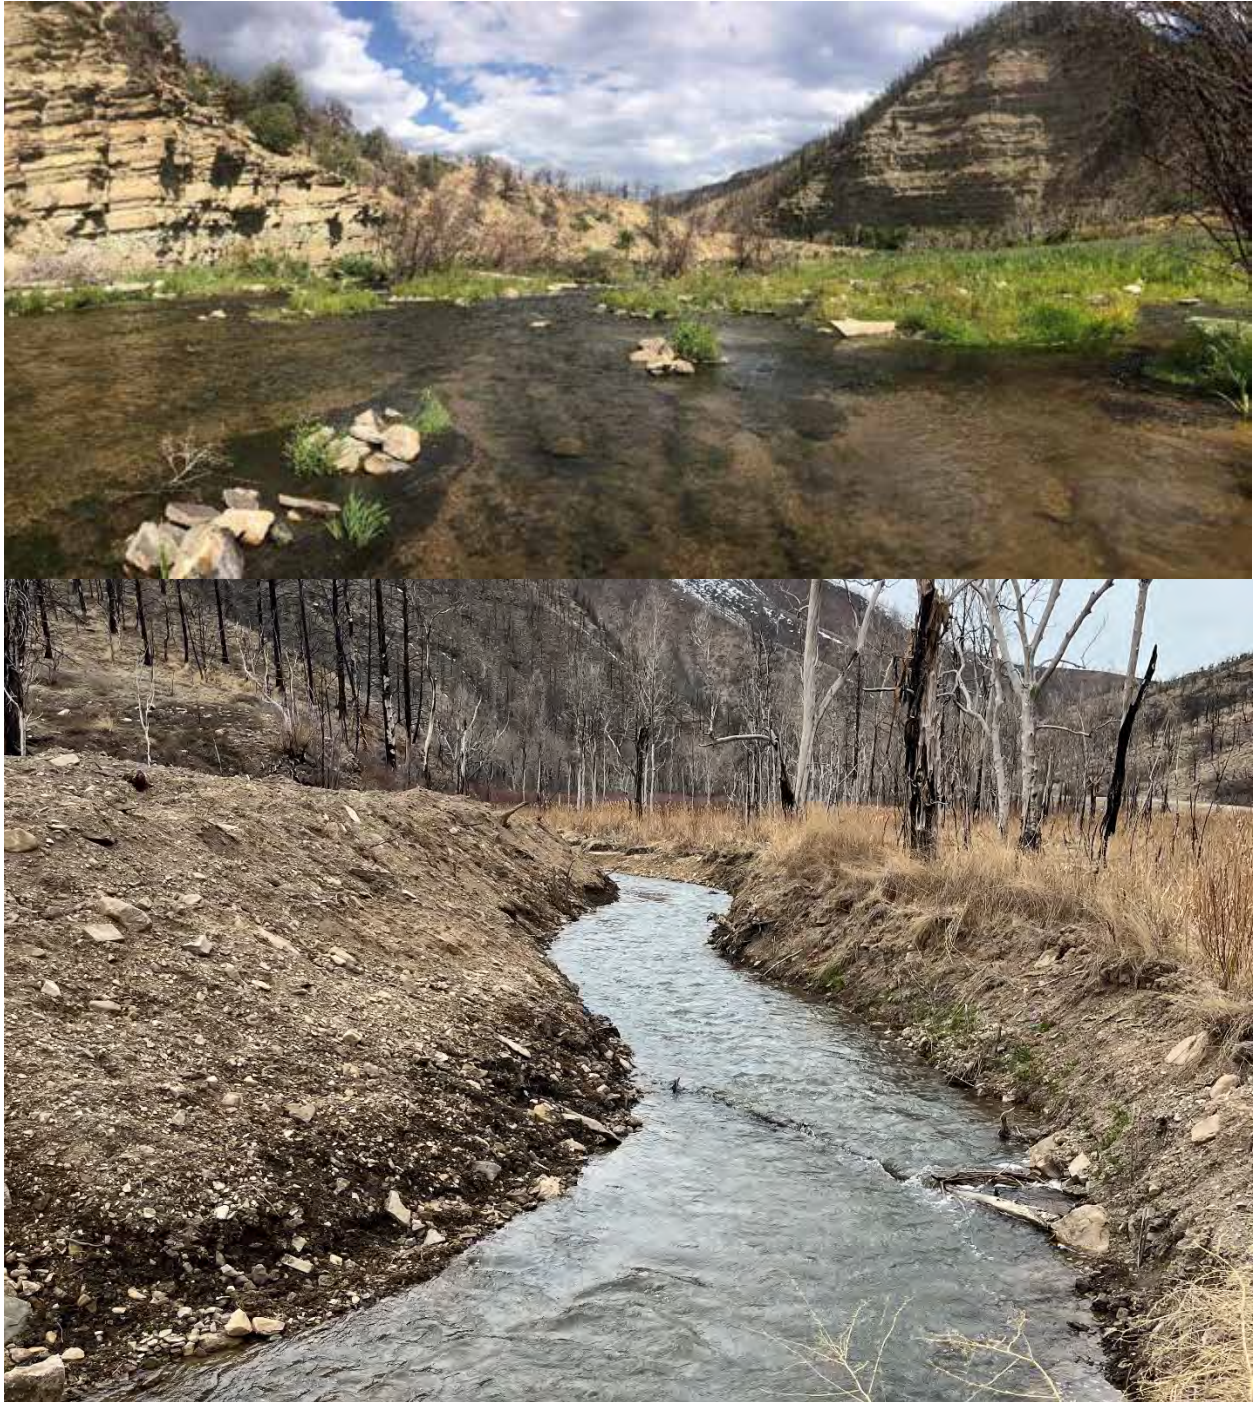
Figure 3.44. River Km 19.25-22.25. A debris flow out of Timber Draw created an alluvial fan that dammed the mainstem Strawberry resulting a complex multi-threaded channel (top photo). The channel was simplified to a single-threaded highly entrenched channel (bottom photo) as part of the EWP work created to drain the large pond above the alluvial fan. Structures will need to be added to the channel to increase complexity.

River Km 19.25 – 22.25: LTPBR structures. This section has variable valley bottom widths and is influenced by multiple alluvial fans (Figure 3.47). EWP actions converted multi-threaded planforms and backwaters to single thread channels at several points within this reach (Figure 3.44). The most notably impacted area is immediately upstream of Timber Draw where a debris flow created an alluvial fan that dammed the river creating a massive pond that supported wetland vegetation such as cattails. A channel was constructed to drain the pond leaving wetland vegetation no longer viable (Figure 3.45). Several sections of this reach are a low-entrenchment single-threaded channel where LTPBR instream structures will increase channel-floodplain connectivity and instream complexity (Figure 3.46). We do not recommend heavy equipment in areas that already support significant riparian vegetation, or in areas where they are likely to be overwhelmed in the event high intensity summer storms. EWP also implemented numerous instream structures in this section.

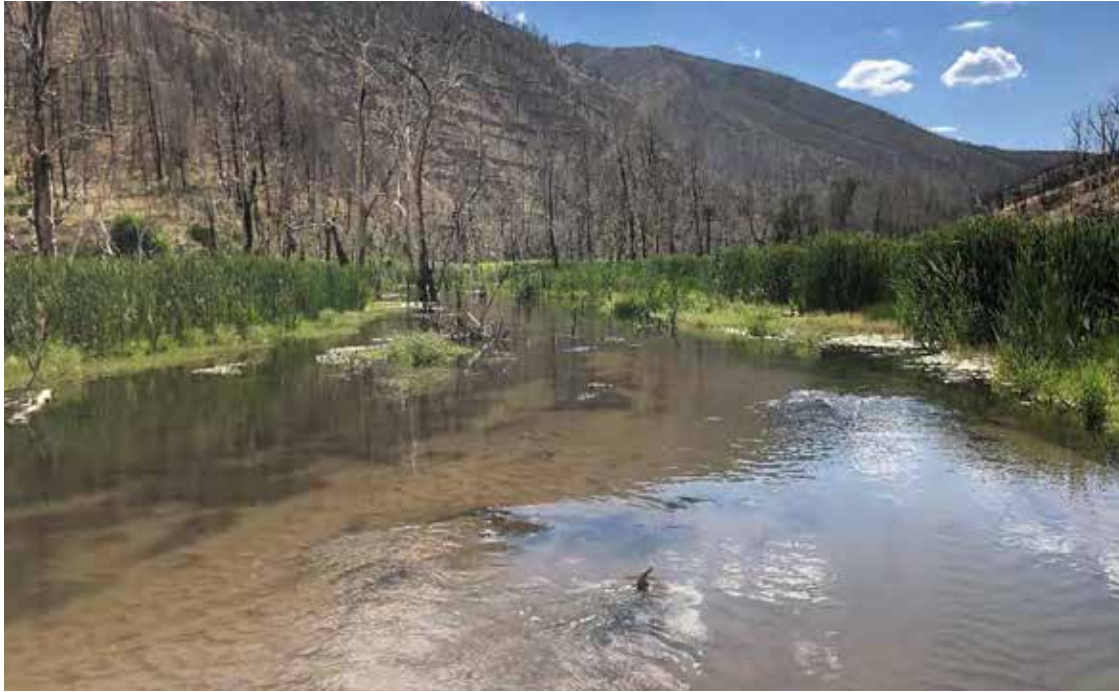
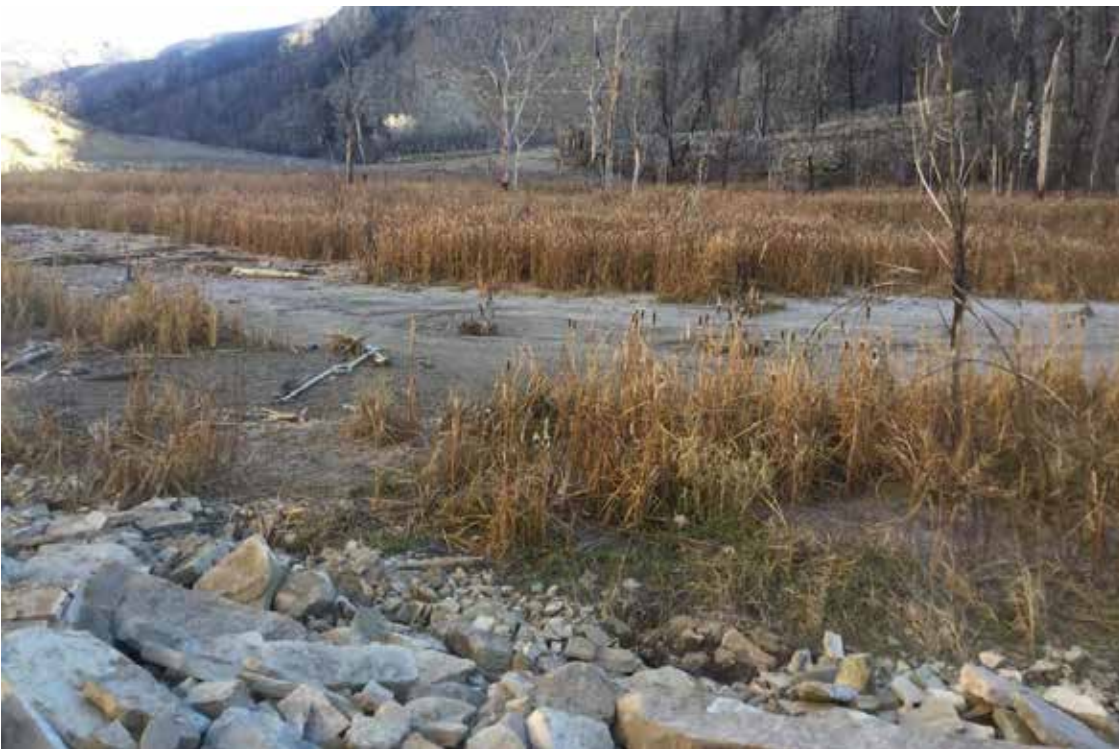
Figure 3.45. River Km 19.25-22.25. Before and after a channel was created to drain the backwater behind the alluvial fan formed by a debris flow out of Timber Draw. Structures could be used to force water into these backwater channels to restore the lost wetlands.

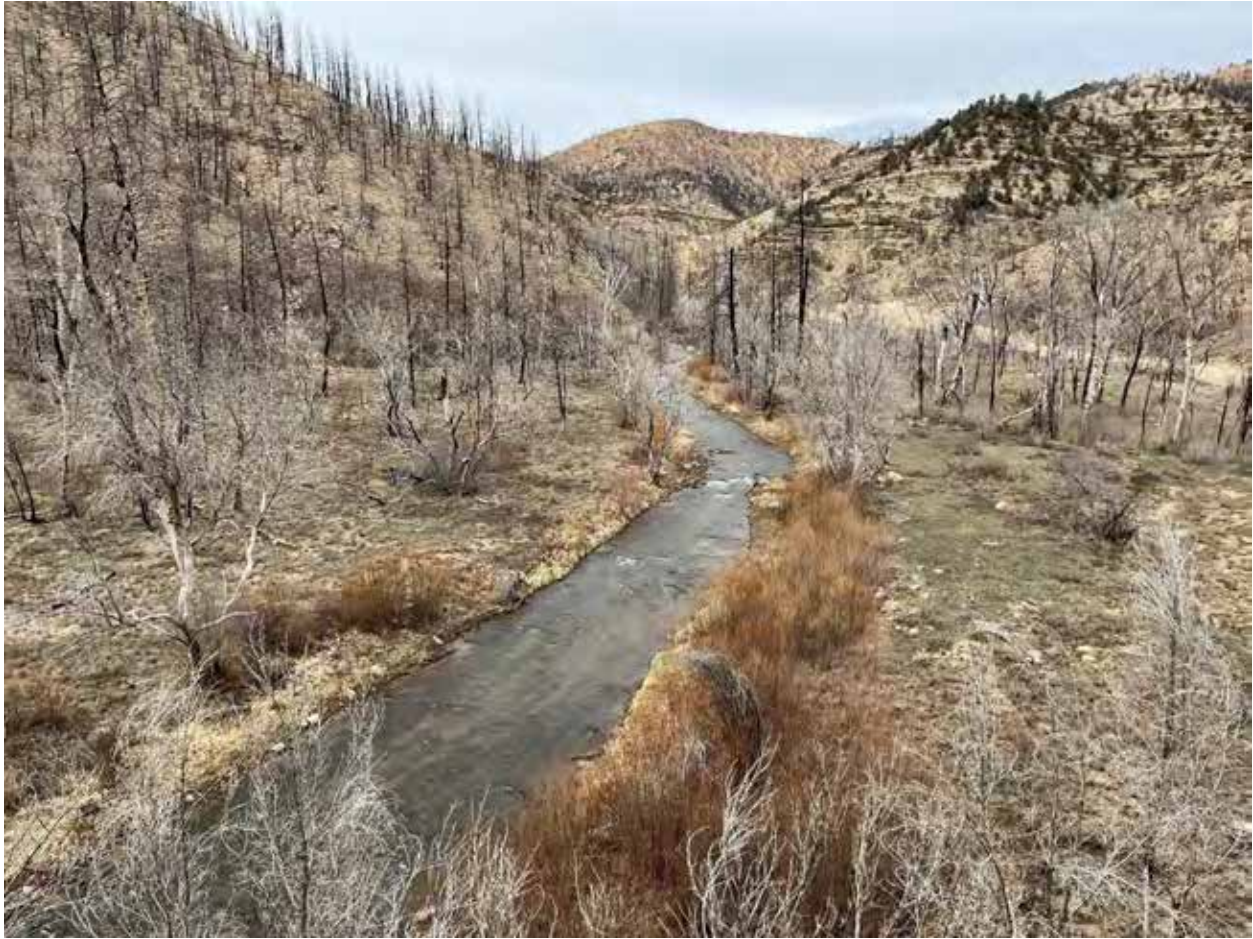
Figure 3.46. River Km 19.25-22.25. Several sections of this reach can be characterized by a low entrenched single-threaded channel. Structures could be used to increase floodplain connection potentially leading to new channels forming on the floodplain.

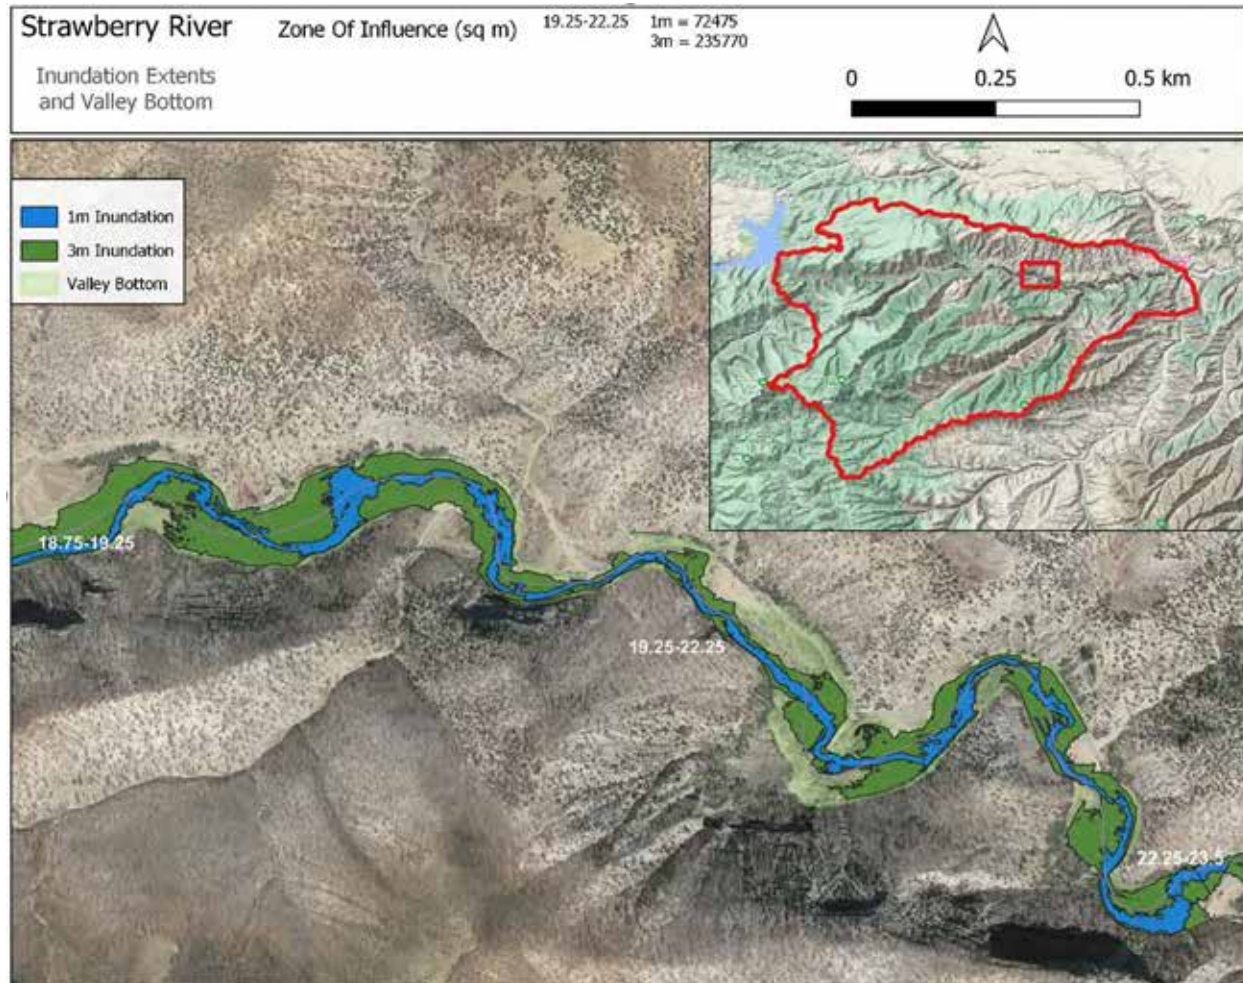
Figure 3.47. Restoration reach river Km 19.25-22.25. ZOI assumes 1 m of inundation during augmented flows, and 3 m for hydrological influence on riparian vegetation following restoration. The valley bottom was delineated using LiDAR data.
