Dollar Ridge Fire Watershed Restoration Plan

Prepared by:
Eco Logical Research, Inc.
JW Associates
Martin & Nicholson
Environmental Consultants, LLC
for
The Utah Division of Wildlife
Resources

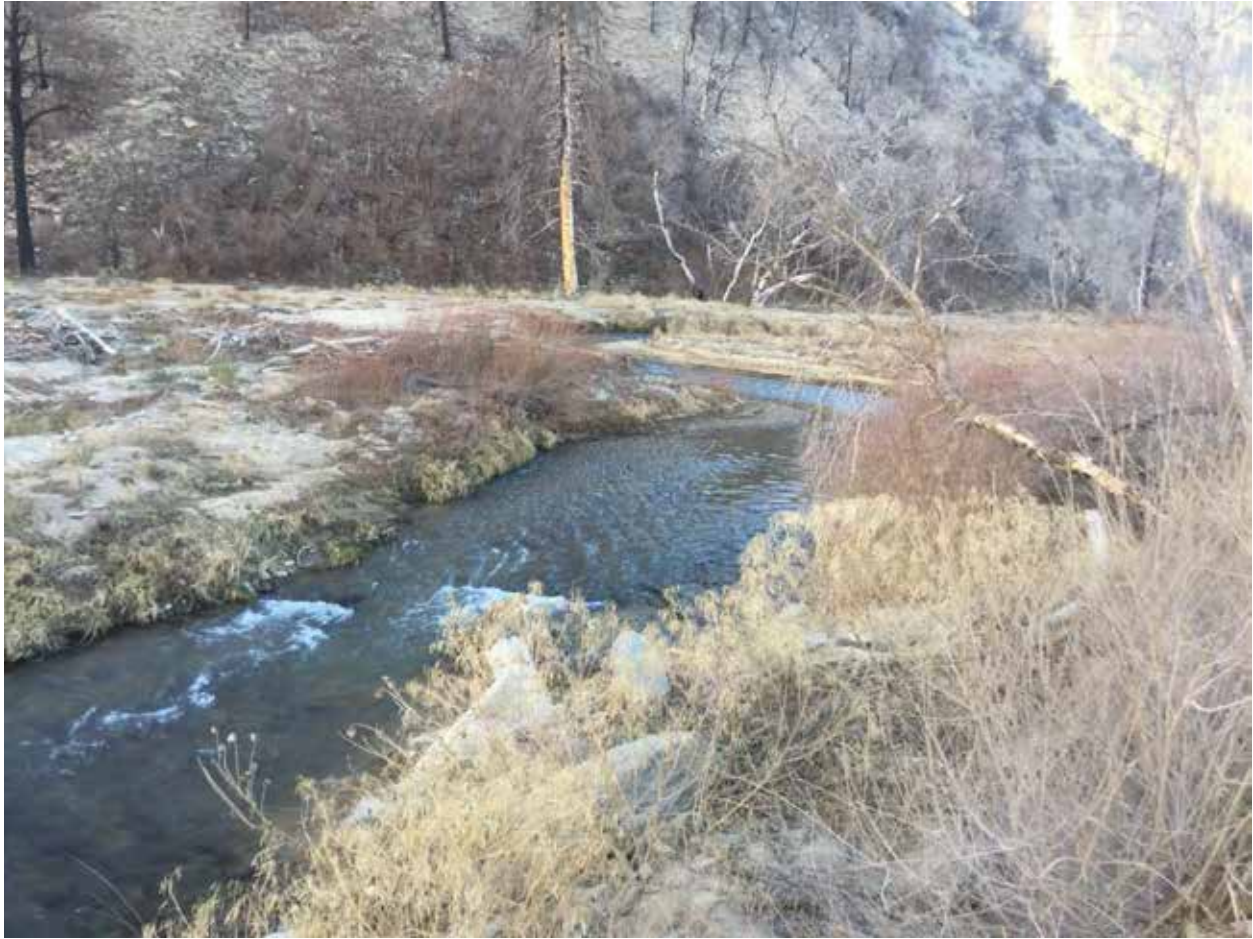
Figure 3.50. River Km 24.5-25.5. This reach is a moderately entrenched, planar, single-threaded channel. Structures can be used to increase complexity and floodplain reconnection, although heavy machinery may be necessary for short-term responses.

River Km 24.5 – 25.5: Structure addition and channel modification. This reach has limited entrenchment and a wide valley bottom (Figure 3.50 and Figure 3.51). LTPBR may be used effectively by itself, in this reach, to force channel-floodplain connectivity and increase instream habitat complexity, however to develop multiple channels heavy equipment may be required. The limited magnitude and expected duration of high-flow events (peak flows of 400 – 500 cfs are expected to last 3 days) mean that channel formation if possible at all, is likely to require multiple high flows (i.e., years). Therefore, heavy equipment may be useful in creating a multi-threaded reach.

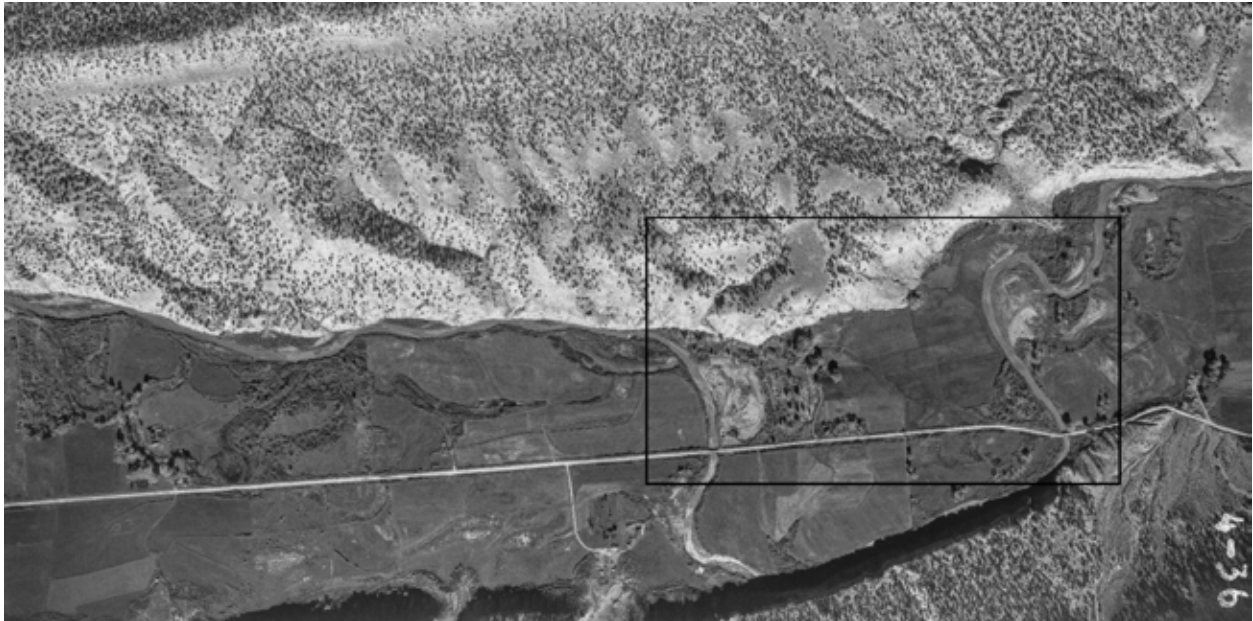
the current forms are different than those which would have been primarily responsible for those forms pre-flow regulation. For example, recent historic imagery shows an active channel 130 m wide, with significant bare alluvium (Figure 5.1 and Figure 5.2). This condition appears analogous to the current conditions found along the Strawberry River, with a wide active channel. However, the processes/drivers responsible for these two conditions vary. In the former (Figure 5.1 and Figure 5.2), modest spring runoff and a lack of full valley bottom land conversion, enable a wider active channel, and such conditions were more likely to be sustained by current flows and land use, while in the latter (Figure 5.3) a wide active channel only reflects changes wrought by a high magnitude, infrequent disturbance and the conditions are unlikely to be sustained given the current flow, sediment and wood regime.

Figure 5.1. 1961 aerial imagery of the Strawberry River downstream of Pinnacles. While outside of the project area, this image illustrates that in wide valley bottoms the Strawberry River was historically characterized by a wider active channel with exposed alluvium. By 1961, flow regulation had already been present for 50 years, but was not yet as affected as it would be following the construction of Soldier Creek dam in 1973. The black rectangle shows the extent of the magnified image shown in Figure 5.2.

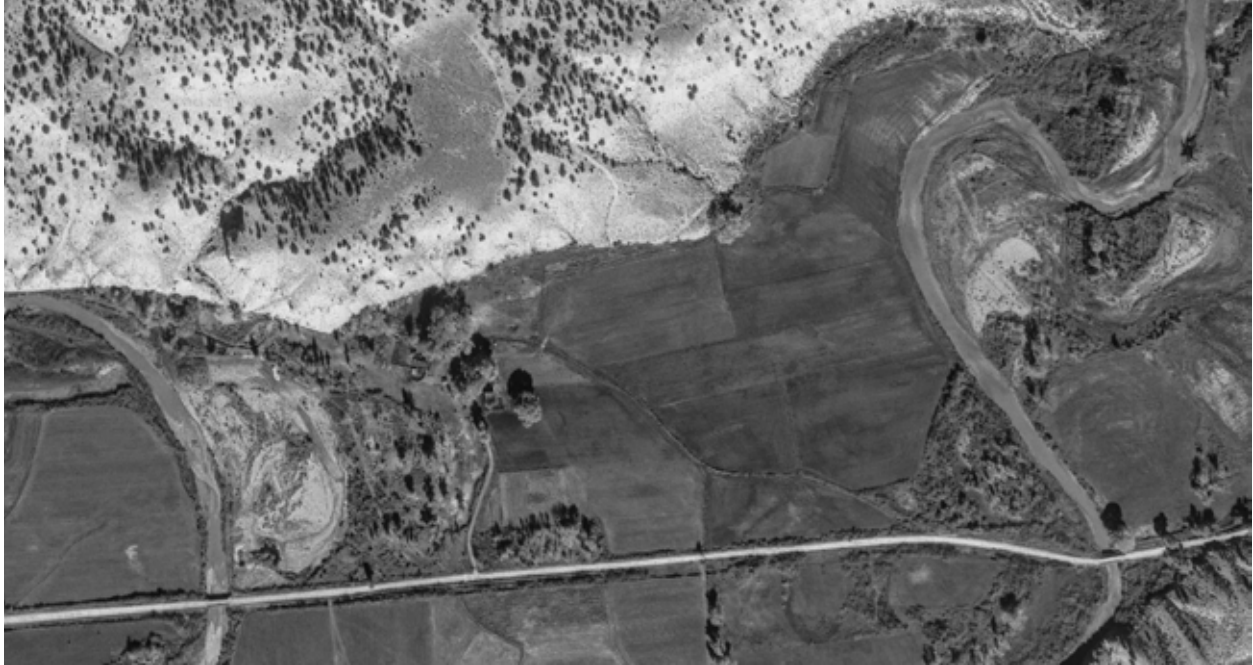
Figure 5.2. Magnified image of black rectangle shown in Figure 5.1. Despite significant development of the valley bottom for agriculture, the river shows localized areas where the active channel is approximately 5-10x the width of the low-flow channel, and there is evidence of significant areas of bare alluvium.

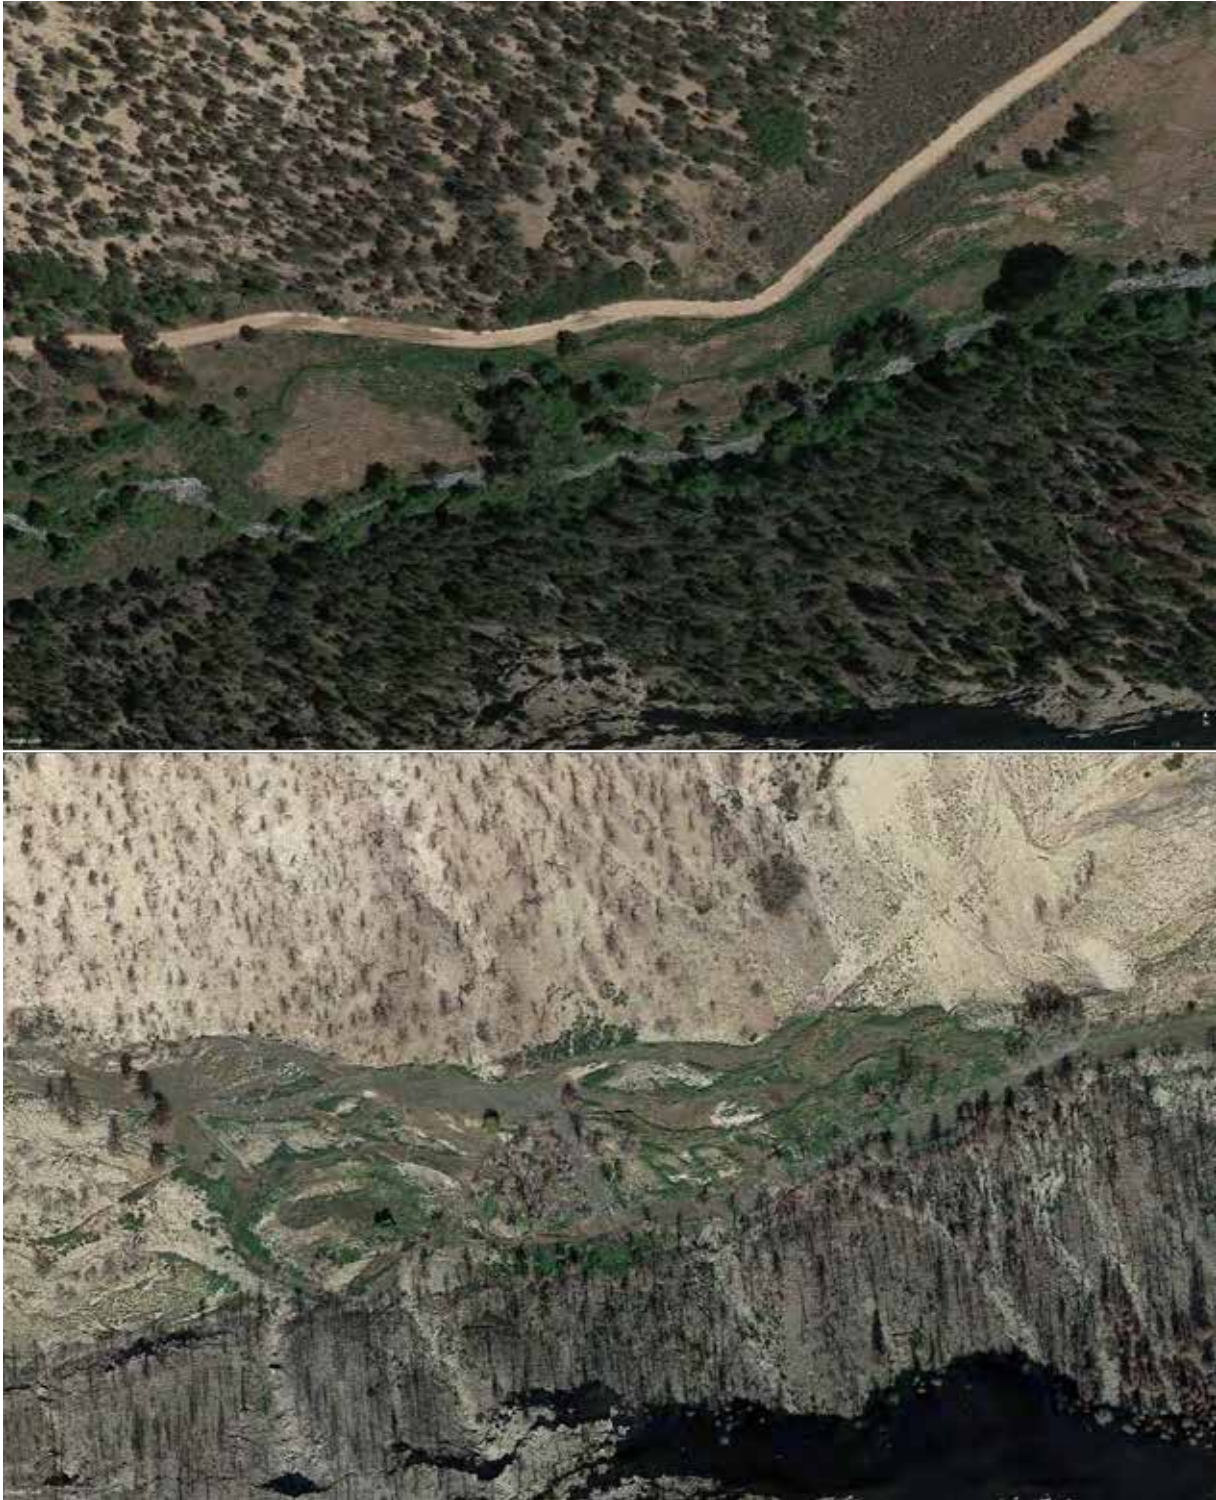
Figure 5.3. Pre- and post-fire on the Strawberry River immediately below Sulfur Draw (river Km 18). Assessing both pre- and post-fire conditions is critical to understanding the impact of post-fire changes and assessing recovery trajectory and potential. Flow is from left to right.

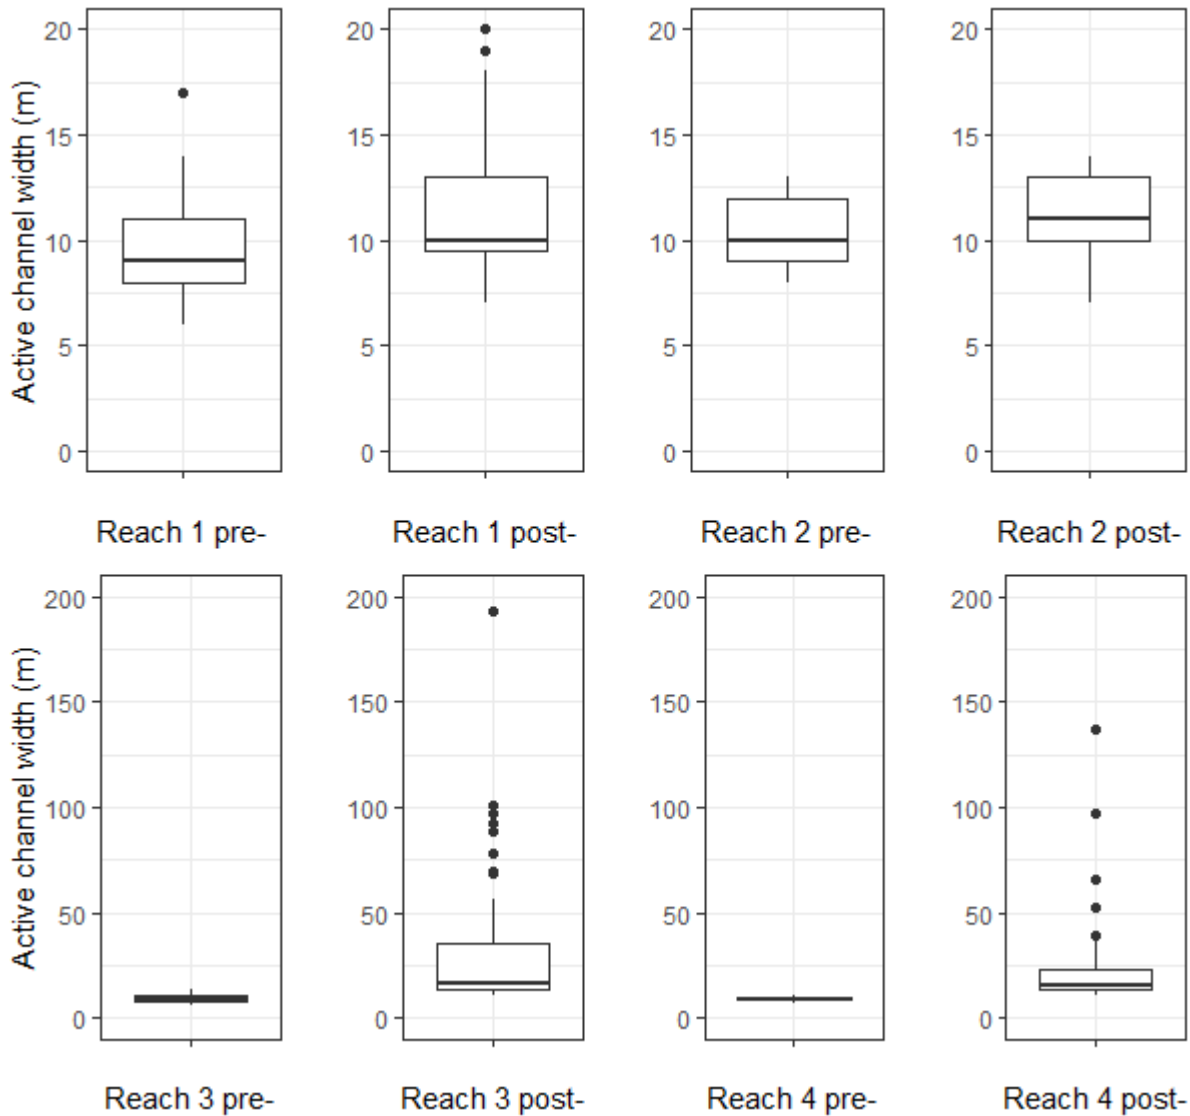
Post-fire, the active channel is wider than pre-fire and has a much greater width variability (Figure 5.4). These differences are most pronounced in reaches 3 and 4 where a wider valley bottom allows for a wider active channel.

Figure 5.4. Active channel widths pre and post fire. Mean active width and width variability increased in all reaches post-fire. Beaver dam activity and extensive backwaters are likely responsible for the highest active channel widths observed in Reach 1. Note that reaches 1 and 2 have different y-axis values than reaches 3 and 4.

Interpretation: The post-fire active channel increased in mean width in all reaches. These changes were most pronounced in reaches 3 and 4 where a wider valley bottom encouraged significant deposition and allowed for the active channel to increase significantly. In reaches 1 and 2 aerial imagery indicates these changes were associated with alluvial fans and significant wood jams. In reaches 3 and 4, the mean width of the active channel increased significantly, as did width variability. The most notable features include extensive backwaters and multi-threaded and braided reaches that occupied the full extent of the valley bottom post-fire. These changes were most pronounced at or adjacent to tributary junctions. Reaches that were outside of the influence of tributary junctions generally experienced very little change. Wide valley bottoms and low gradients in reaches 3 and 4 promote deposition in these reaches. By contrast, narrower valley bottoms and higher gradients in reaches 1 and 2 resulted in more limited zones of widespread deposition, even in areas influenced by alluvial fans. We suggest that the post-fire active channel in reaches 3 and 4 superficially resembles pre-flow regulation conditions in reaches 3 and

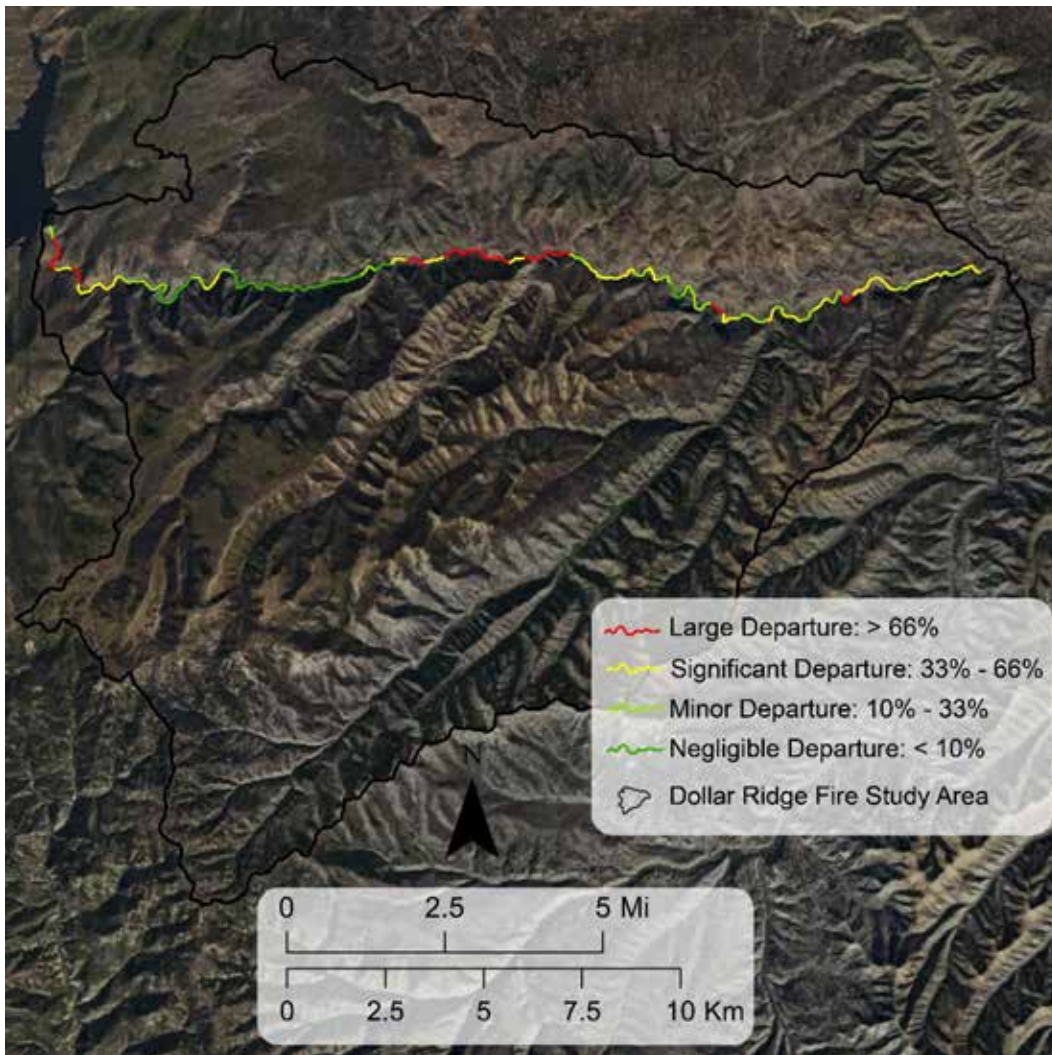
Figure 5.5. Riparian vegetation departure pre-fire, along the mainstem Strawberry River. Reaches 1 and 2 have experienced a significantly low-moderate riparian departure, except for immediately below Soldier Creek Dam. Reaches 3 and 4 have generally experienced moderate to significant departures from historic conditions.

Interpretation: Reaches 1 and 2 are in good condition. Their higher elevation, shade, and valley setting, and lack of land use conversion or infrastructure have rendered them less impacted than downstream reaches where land use conversion is more prominent and the importance of fluvial processes to regeneration and survival. RVD may also overestimate riparian vegetation departure in narrow valley bottom settings such as the upper most extent of Reach 1. Reaches 3 and 4 are in poor-moderate conditions due to the higher sensitivity of riparian areas to flow conditions and wider valley bottoms that supported conversion of land use to agriculture. There remain some pockets of good condition riparian areas reaches 3 and 4, but they are limited in extent.

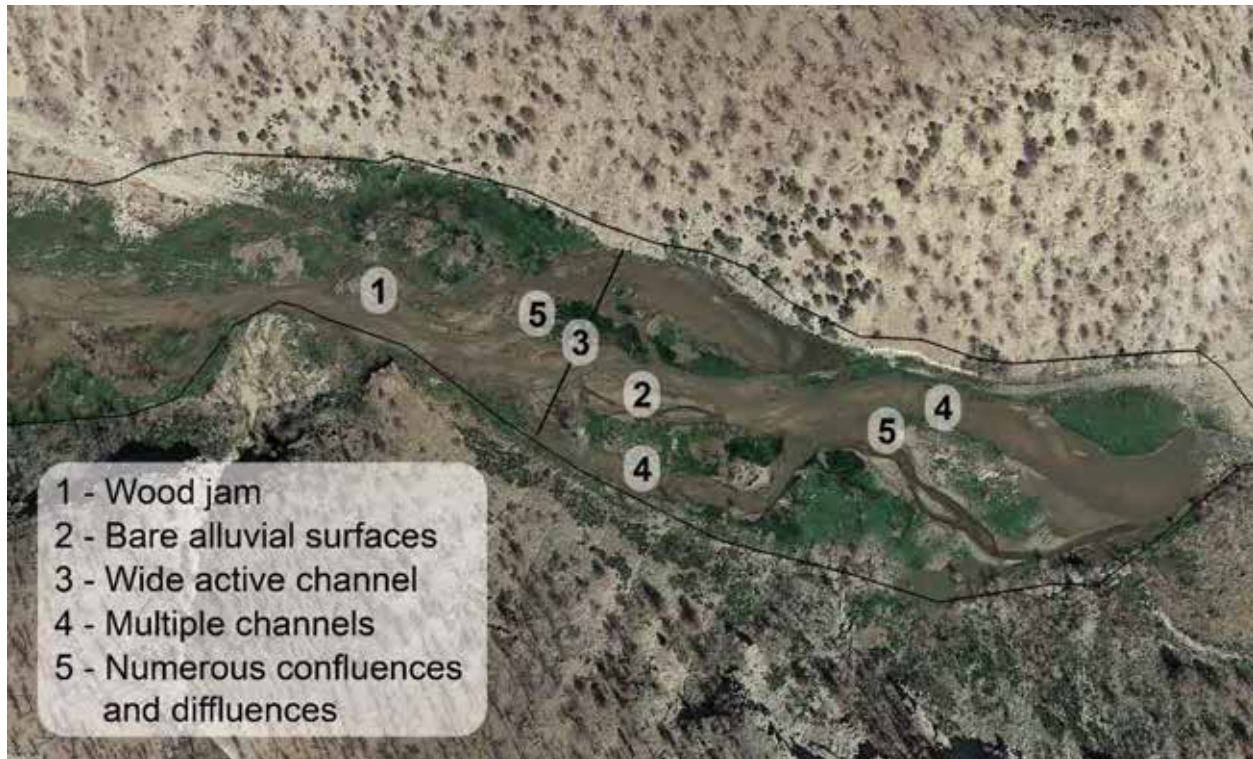
Figure 5.6. Post-fire conditions along a section of reach 3

Figure 5.6 and Figure 5.7 show a common post-fire response in the partly-confined alluvial fan influenced reach 3. We bring special attention to it here because this condition is characterized by a number of important attributes that were absent pre-fire that can be maintained through restoration. This section of stream was significantly influenced by sediment delivered from upstream and downstream tributary canyons. Post-fire it is characterized by a wide active channel that occupies the full valley bottom. It has multiple confluences/diffluences and multiple channels. It has both vegetated islands that split flow as well as multiple bare alluvial surfaces. These characteristics both represent and enable numerous processes that are critical to riverscape health. Perhaps most importantly, the conditions represented here have the capacity to buffer the delivery of water, sediment and wood to downstream reaches, providing protection related to excessive sediment deposition, flooding and wood delivery to areas with infrastructure. A wide active channel reduces unit stream power by spreading flow over a much greater width, reducing flow energy; wood is more likely to be trapped across such a wide area, specifically at diffluences where it may form jams. A wide active channel and highly connected floodplain create the hydrologic conditions for riparian reestablishment and multiple channels increase the quantity of habitat for aquatic species.

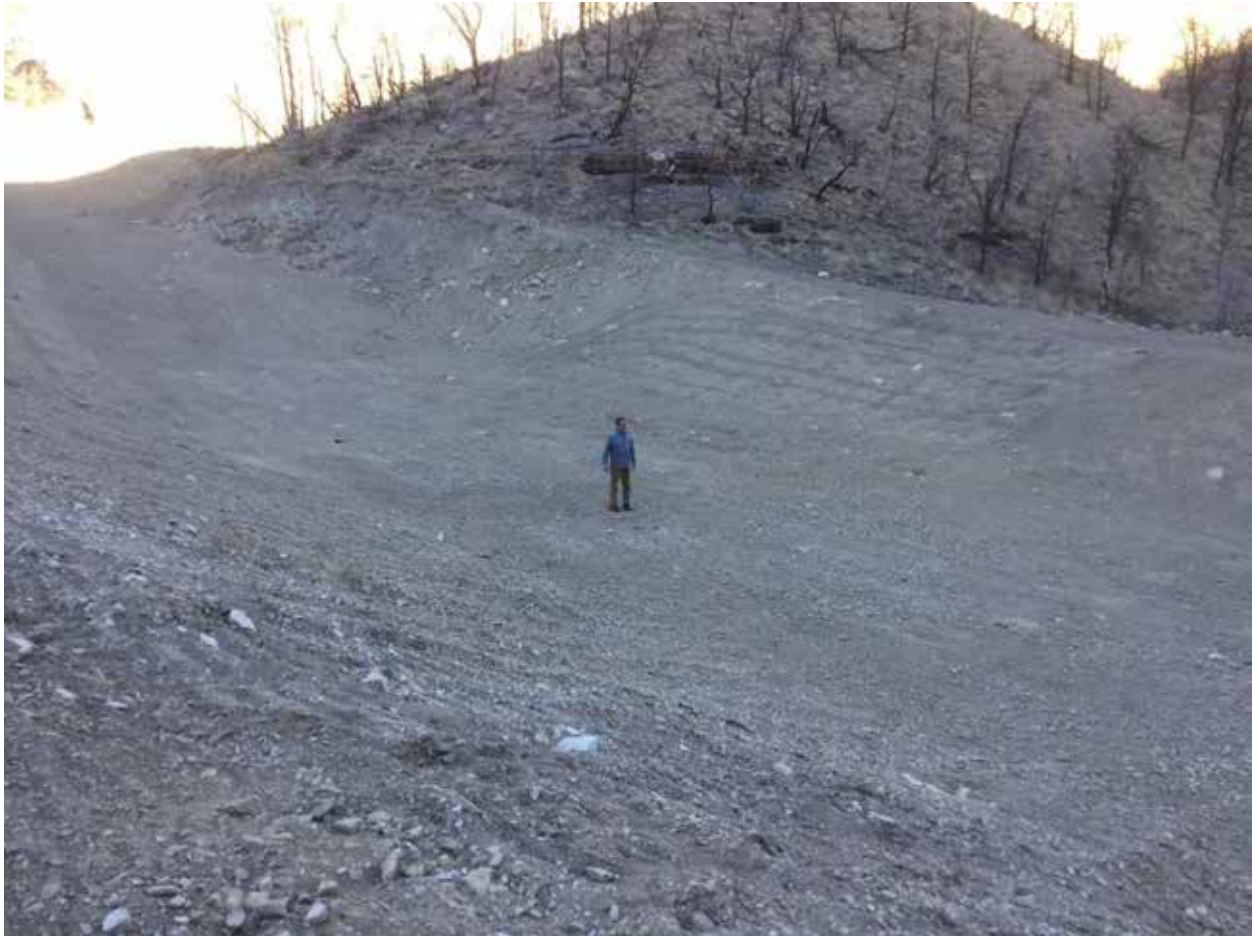
Numerous alluvial fans were excavated a part of post-fire EWP actions (Figure 10.1). This action both removed significant sediment, creating basins within the alluvial fans, and berms, which act to disconnect the fan from the mainstem Strawberry River. Tributaries, whether ephemeral, intermittent or perennial, are important sources of wood, water, and sediment to the Strawberry River. Especially on the Strawberry River where upstream flows are reduced, tributaries may deliver much needed sediment and wood inputs to the mainstem that have been completely shut-off by Soldier Creek Dam. Furthermore, tributary junctions, due to their higher frequency of disturbance often provide critical habitat for instream species. The complete disconnection of these tributaries from the mainstem, therefore, is likely to negatively impact the Strawberry River by eliminating important wood and sediment inputs that create high-quality instream habitat.

Figure 10.1. Excavated alluvial fan along the Strawberry River. The basins excavated from alluvial fans range in size. The one pictured here is approximately 40 yards wide and 50+ yards long and excavated to depth of roughly 5 yards.

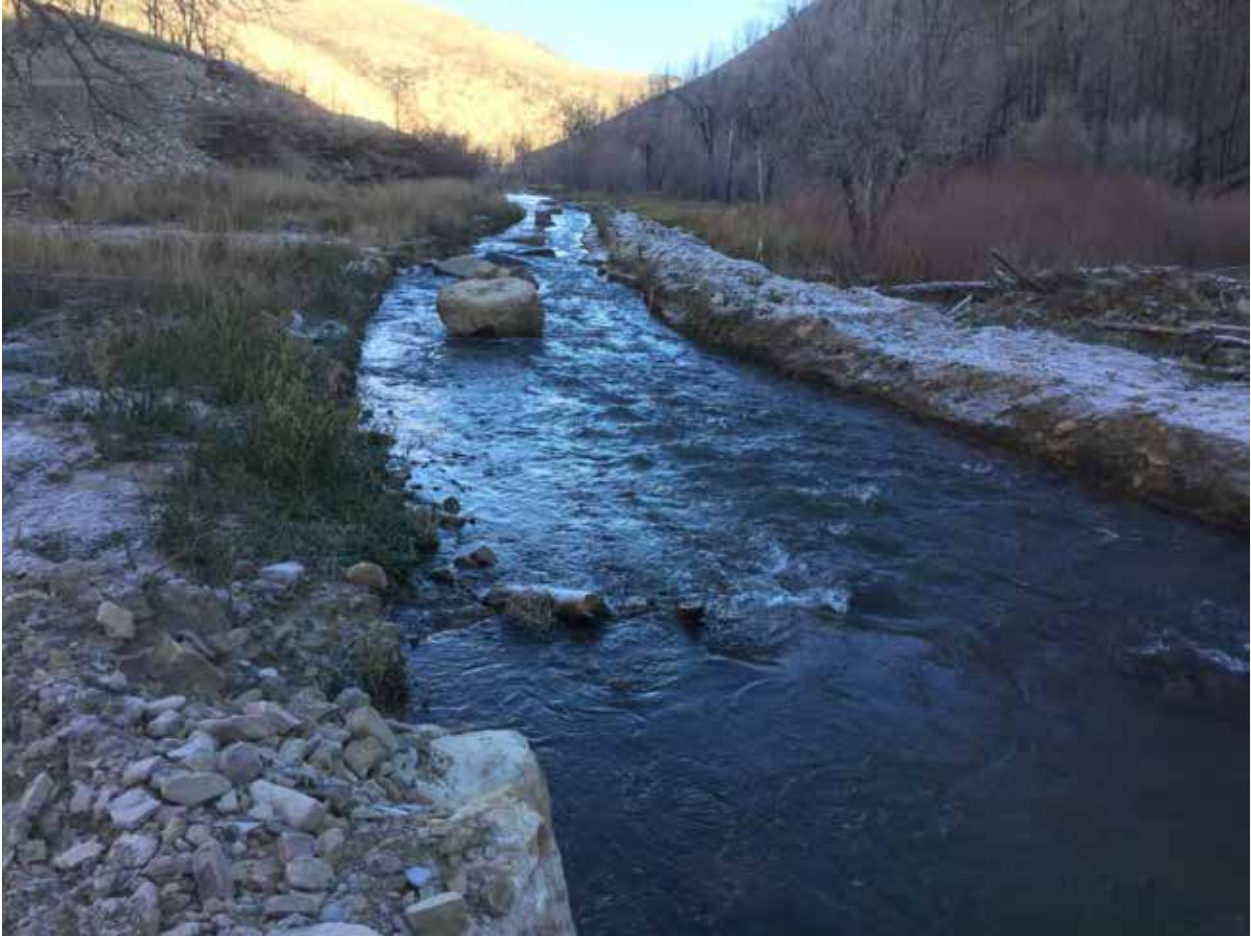
To rebuild the road along the Strawberry River, certain sections of the valley were drained and the channel reconstructed. While necessary to ensure access to private landowners near Beaver Canyon, the reconstructed channel appears, in many cases, to be a homogenous and simplified stream characterized by planar geomorphic features and high banks. In some cases, instream structures were emplaced, including single large boulders, or rock steps, neither of which are likely to be entrained under the current flow regime (Figure 10.2). These features are likely to remain, and while creating some minimal hydraulic diversity are unlikely to lead to improvements in either in-channel habitat or riverscape health.

Figure 10.2. Narrow channel characterized by plane-bed, high banks, and large boulders unlikely to be mobilized. These boulders, while creating some minimal hydraulic diversity, are unlikely to lead to improvements in riverscape health.

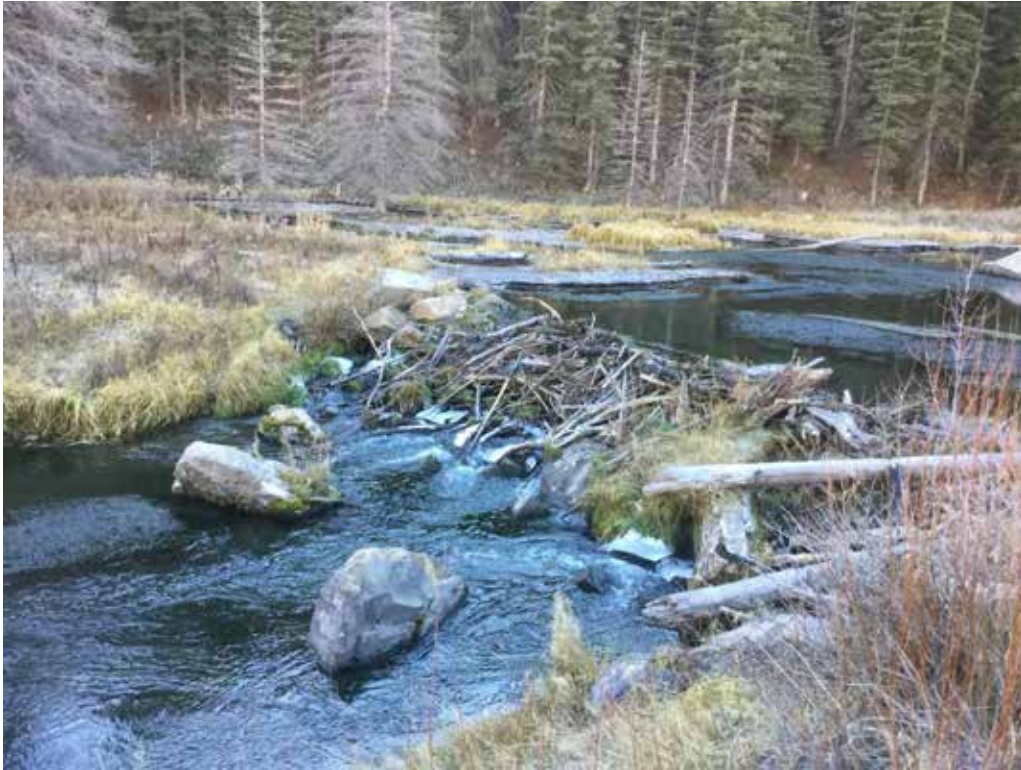
Figure 12.3. Beaver dam in approximately 1.5 km downstream of Soldier Creek Dam. Prior to the flow regulation on the Strawberry River, beaver dams were likely uncommon due to high annual spring flows. Under the current flow regime, beaver dams are forcing extensive ponding and lateral connectivity in the upstream reaches of the Strawberry River. A challenge to restoration is balancing the downstream needs of high-flows with promoting beaver dam activity in the upstream reaches.

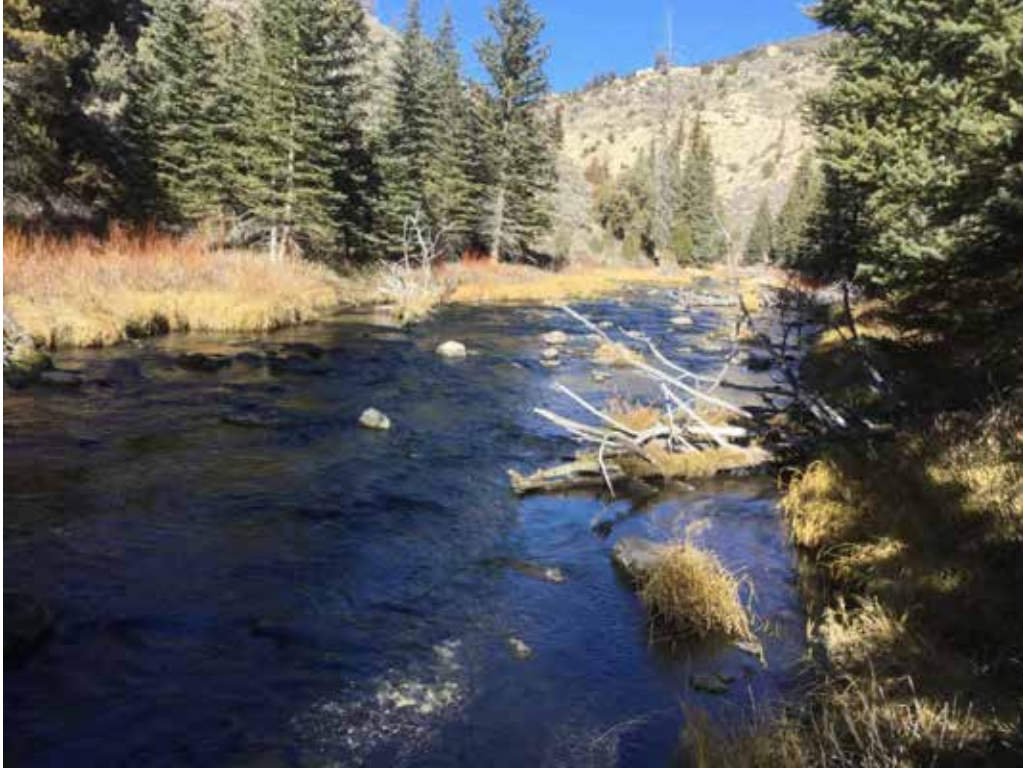
Figure 12.4. Strawberry River below Soldier Creek Dam. The river is dominated by planar geomorphic features and limited large wood. The wood that can be seen here was part of previous restoration work and is anchored to the bank. The reduction in peak flows has limited the recruitment of trees adjacent to the stream, reducing wood inputs. The dam upstream has cut off all delivery of wood from upstream reaches.

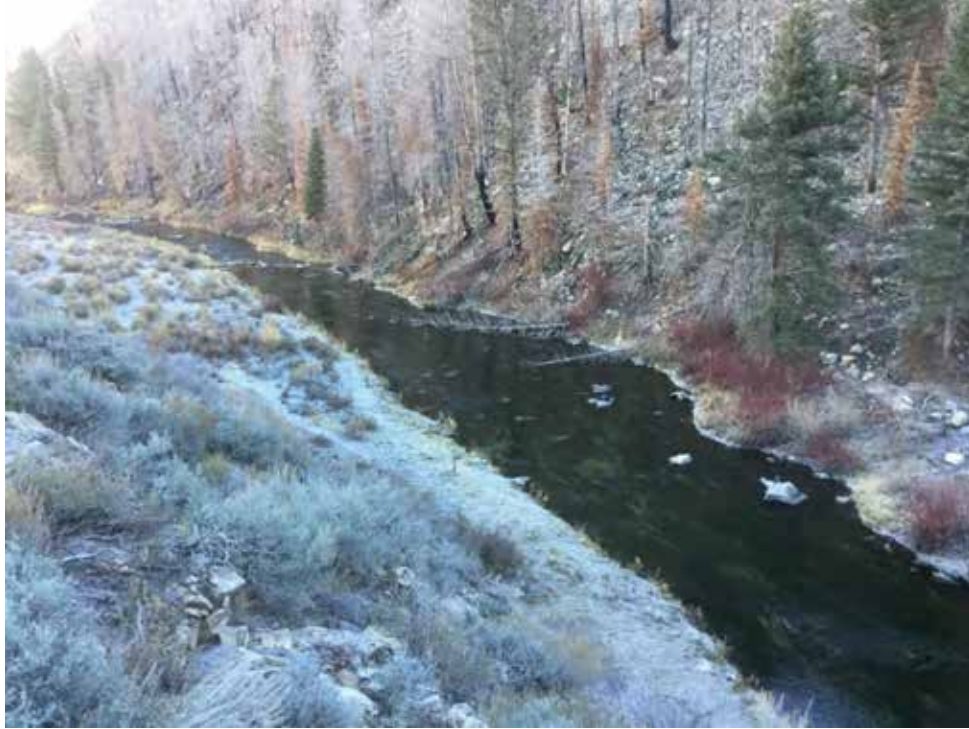
Figure 12.5. Strawberry River in upper reach near river Km 2.5. The channel is dominated by planar features and limited instream wood. This photo shows the river highly connected to the hillslope on river right, emerging from a constricted section. A floodplain pocket is visible on the left.

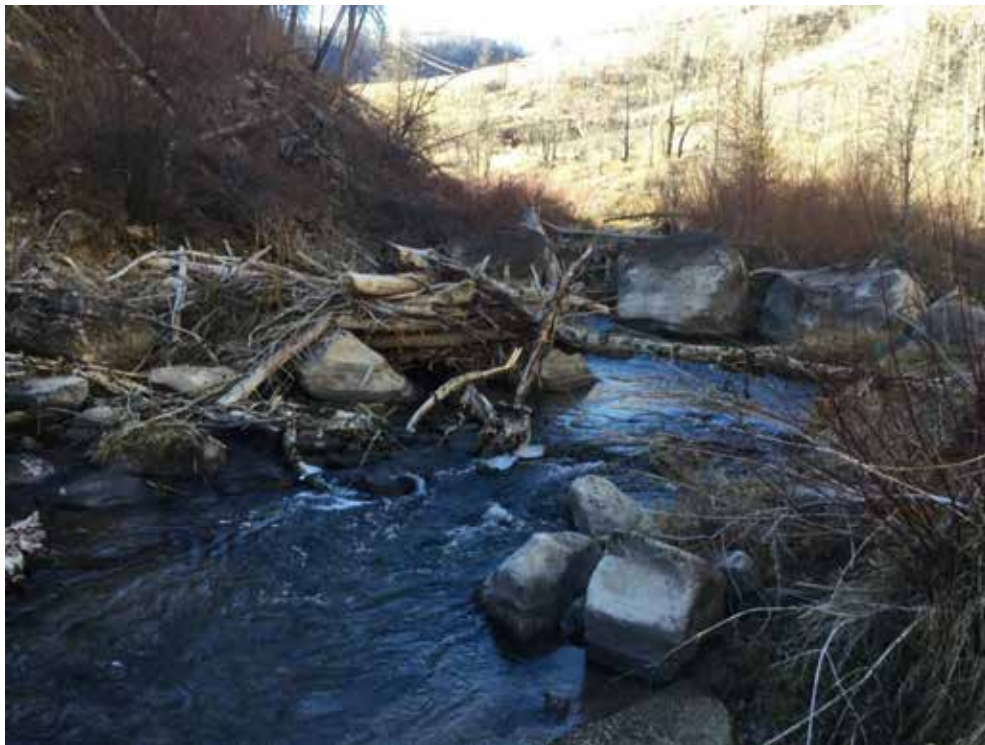
Figure 12.6. Coarse material delivered from hillslopes and alluvial fans. Alluvial fans often result in local zones of higher gradient. The reduction of peak flows has likely reduced the ability of the Strawberry river to move coarse boulders from these locations.
