High Lakes Stabilization Construction Report

Uinta Basin Replacement Project

Garfield Basin

Five Point Lake, Bluebell Lake, Drift Lake, Superior Lake

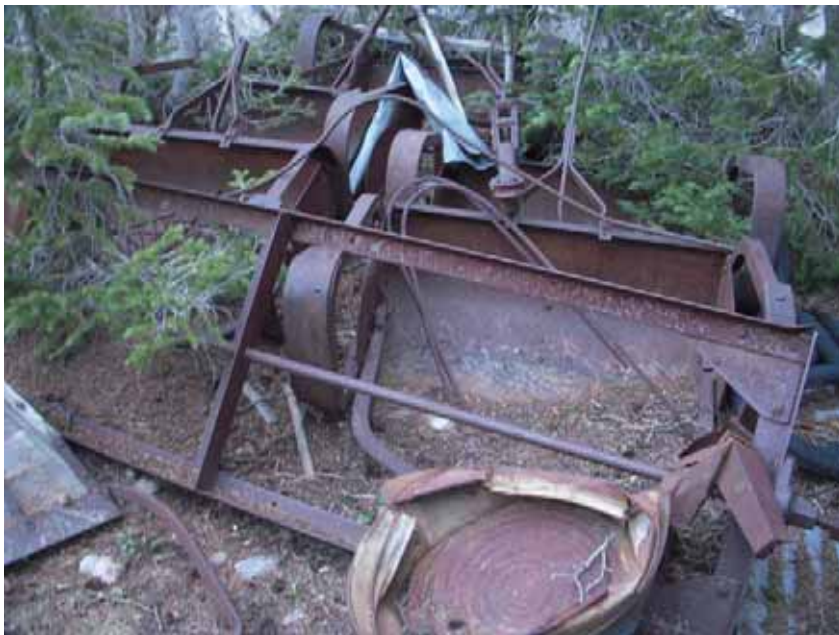
Figure 13: Old equipment to be flown out.

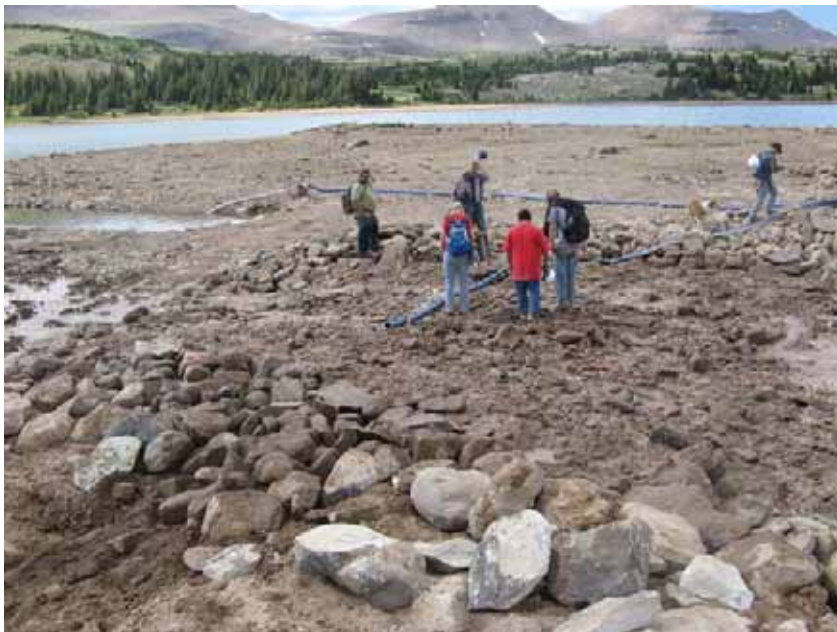
Figure 19: Hand crew washing fines into new outlet channel.

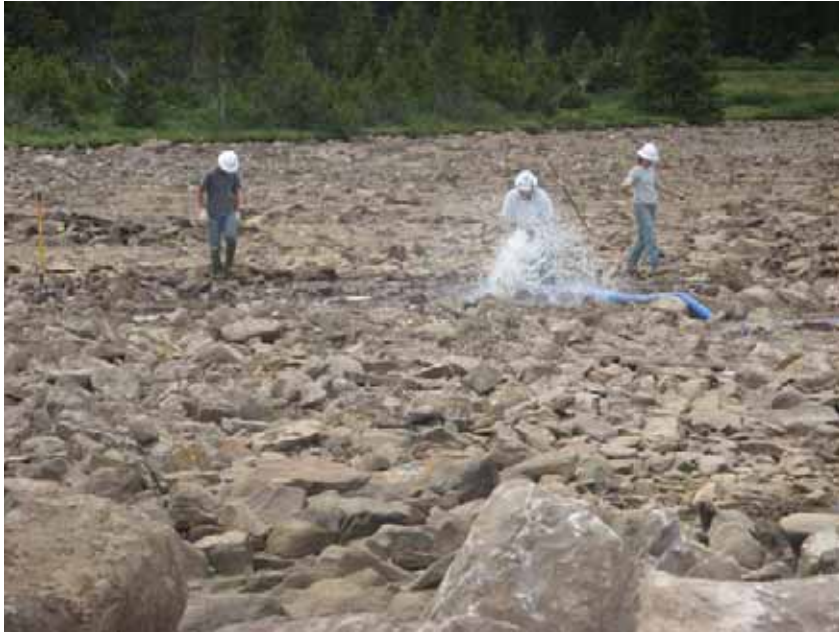
Figure 20: Rehabilitation of Five Point Lake.

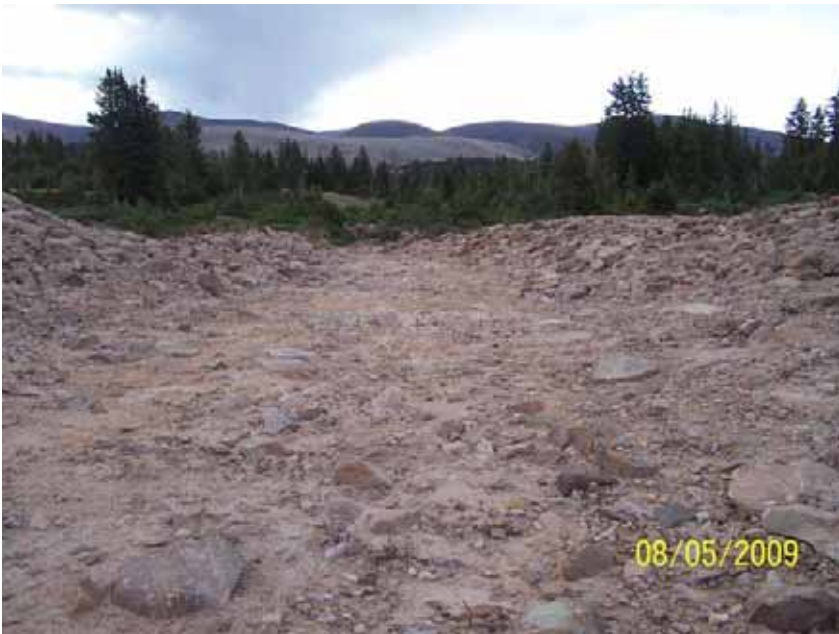
Figure 22: View of finished channel at Five Point from top gabion, looking downstream.

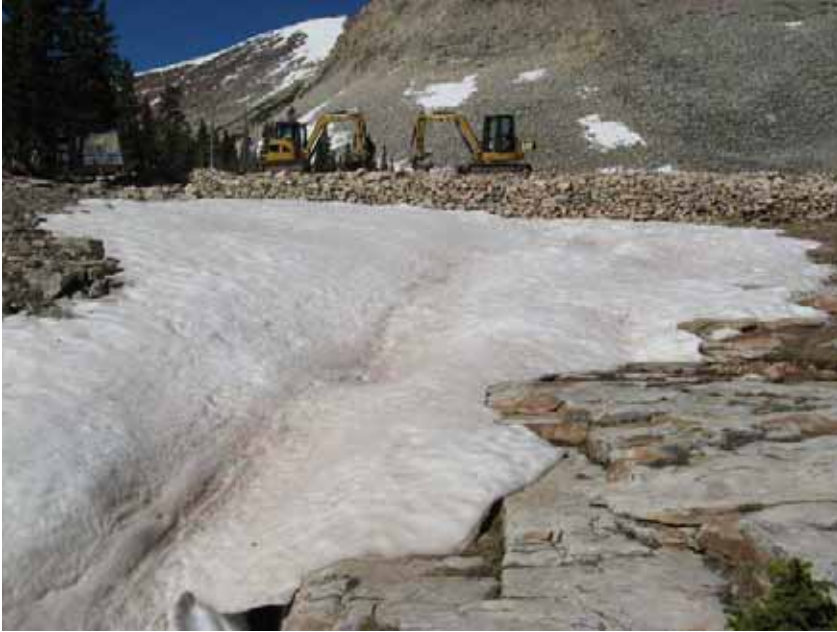
Figure 28: Crews working to remove the snow drift below dam at Drift Lake.

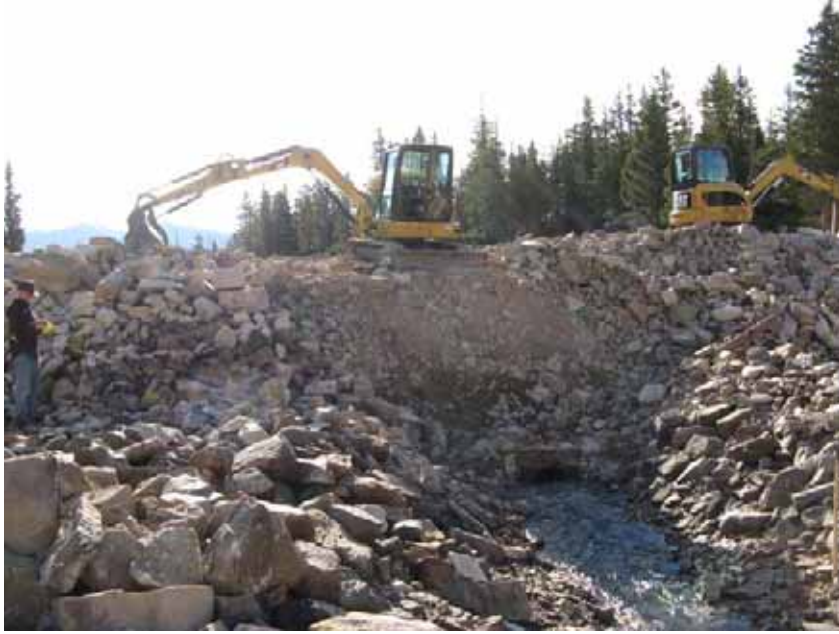
Figure 30: Crew working on removing riprap from existing channel.

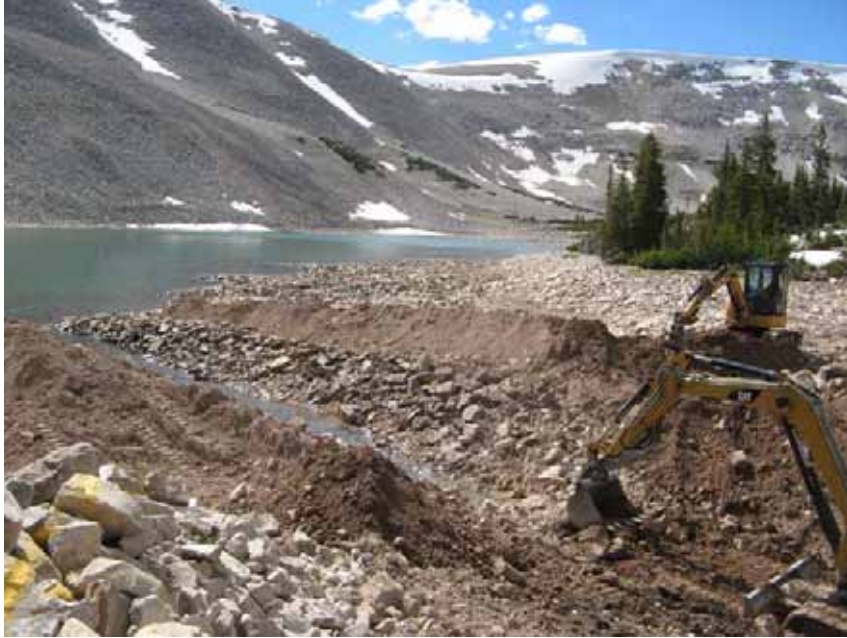
Figure 31: Crew cutting final grade.

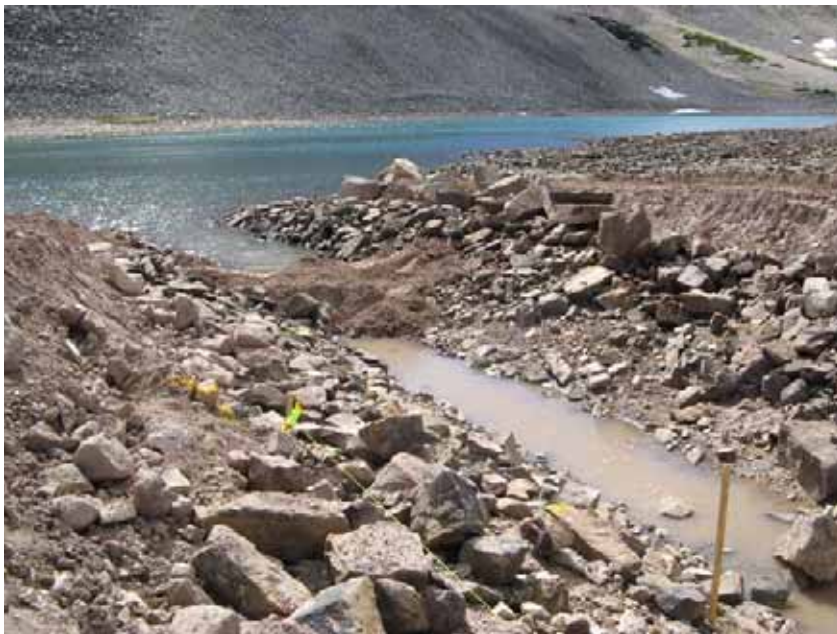
Figure 32: Temporary coffer dam put in place to control water flow.

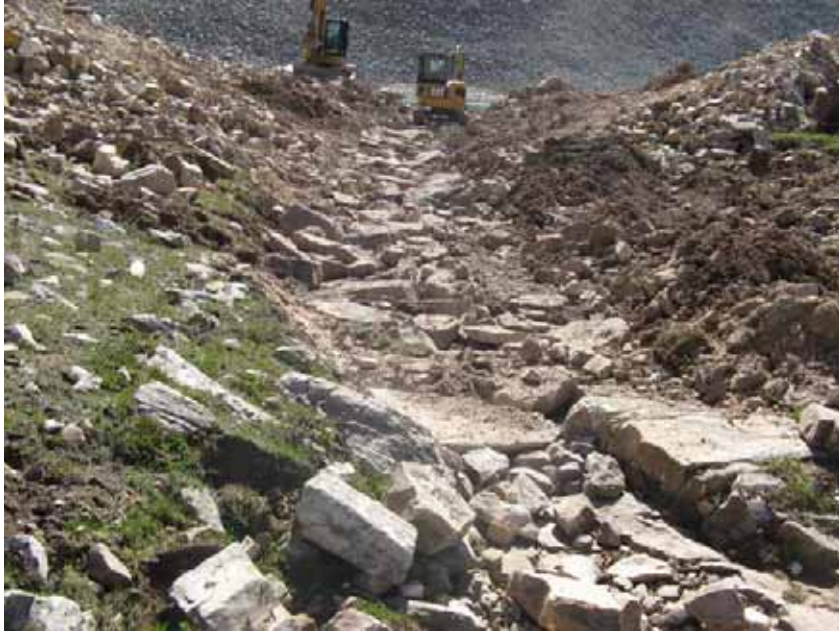
Figure 35: Rock sills in place.

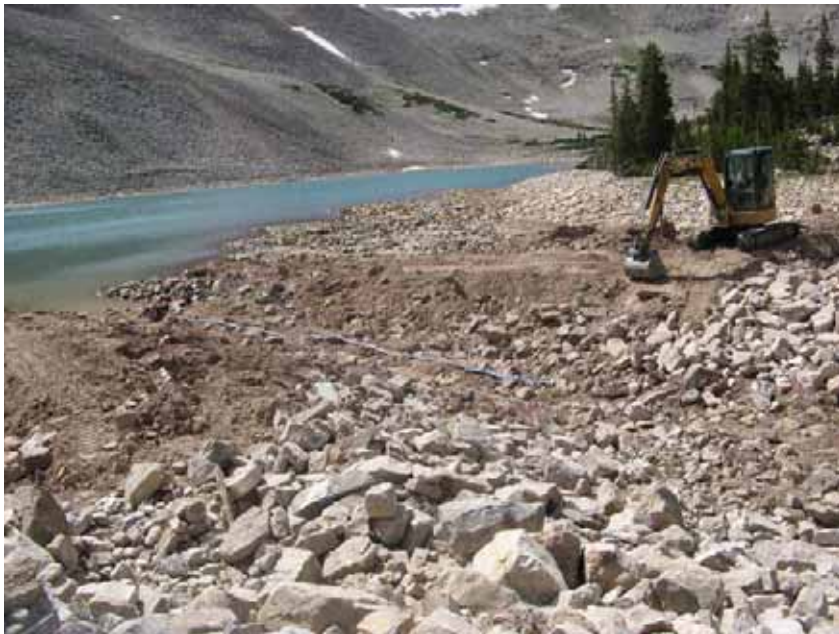
Figure 36: Crews continue to place riprap along the sides of the new outlet channel.

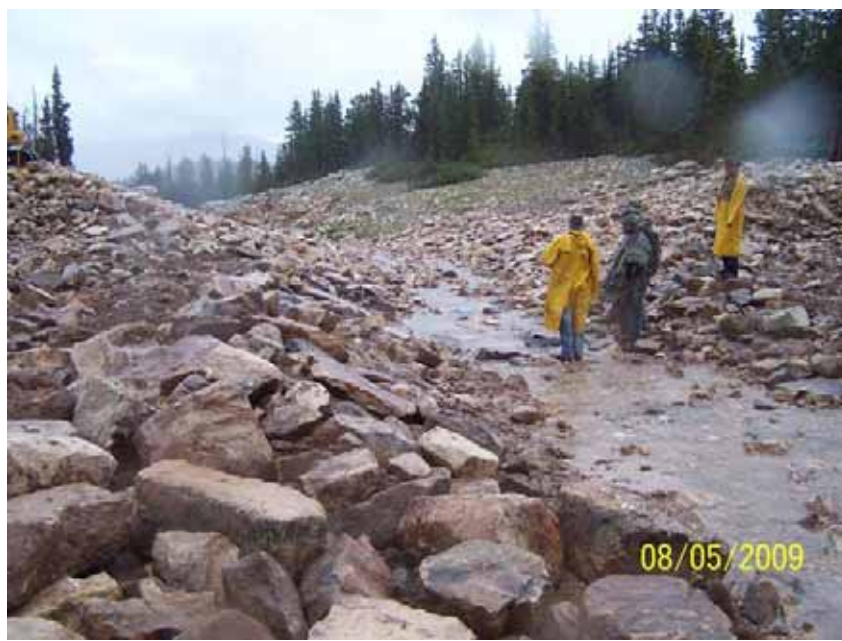
Figure 38: Looking downstream through the completed breach channel at Drift Lake.

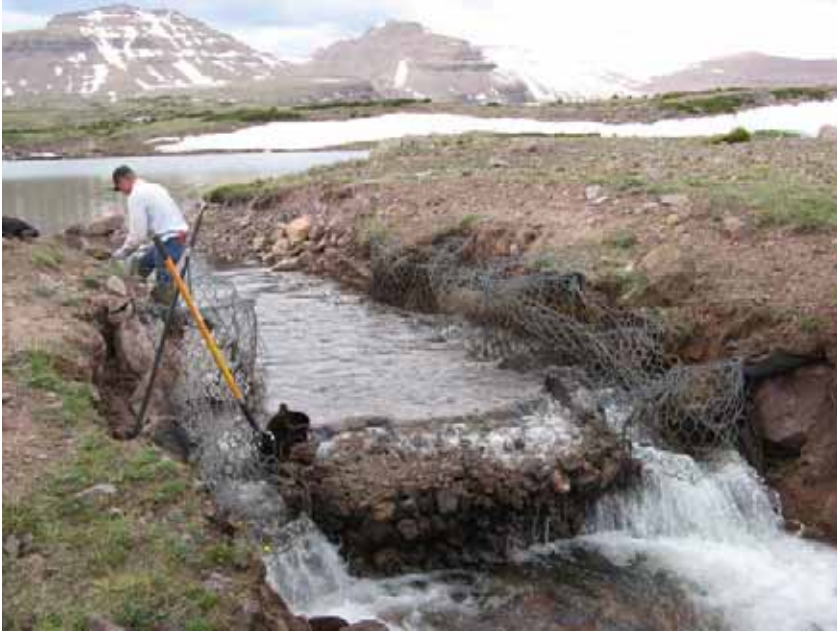
Figure 40: Hand crew removed gabions from old spillway.

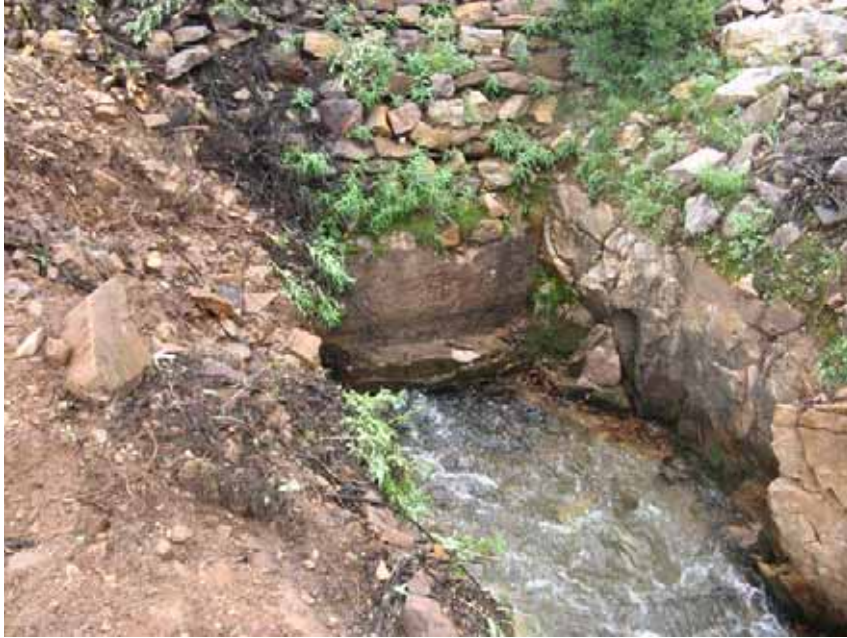
Figure 41: Outlet channel prior to construction.

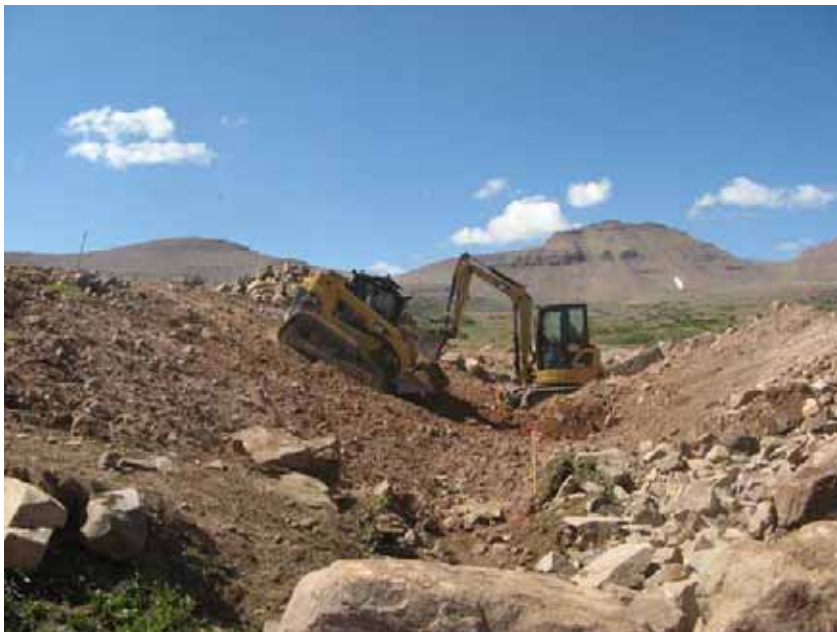
Figure 39: Crew cutting through dam at Superior Lake.

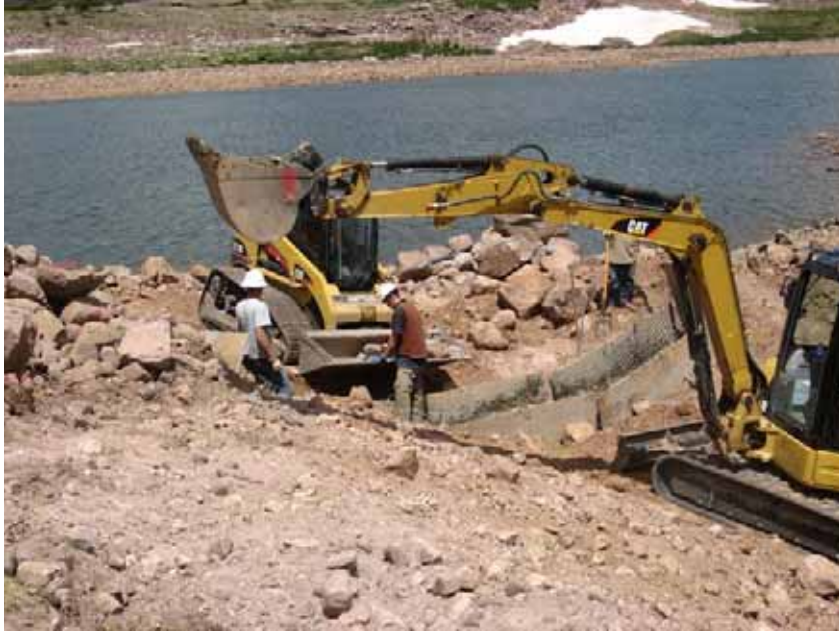
Figure 41: Placing of cutoff wall at top of breach.

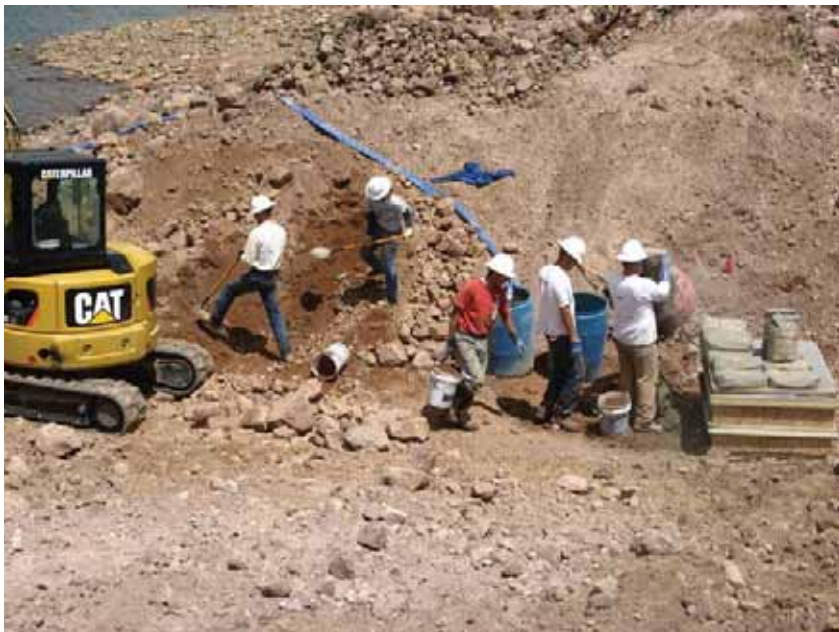
Figure 42: Grouting operation for the gabion cutoff walls.

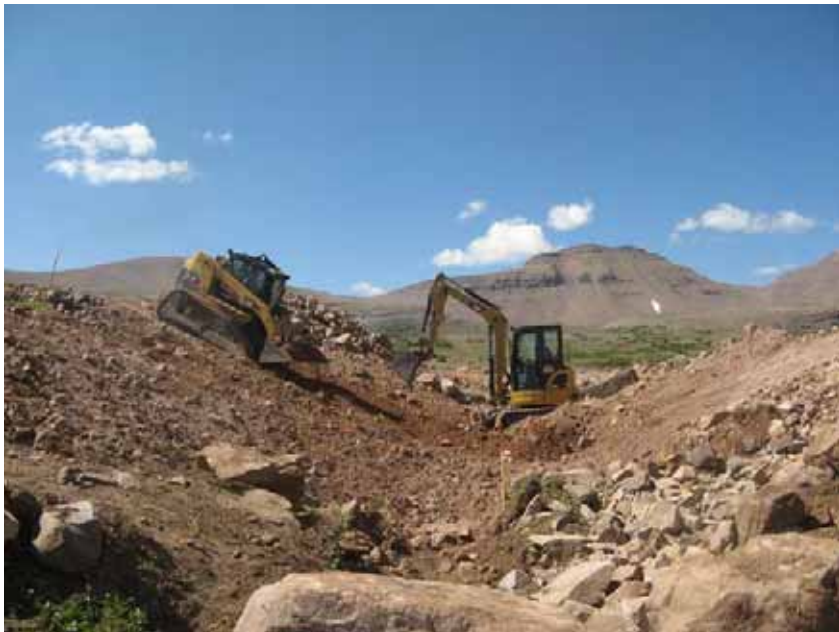
Figure 44: Placing riprap after cutoff walls were in place.

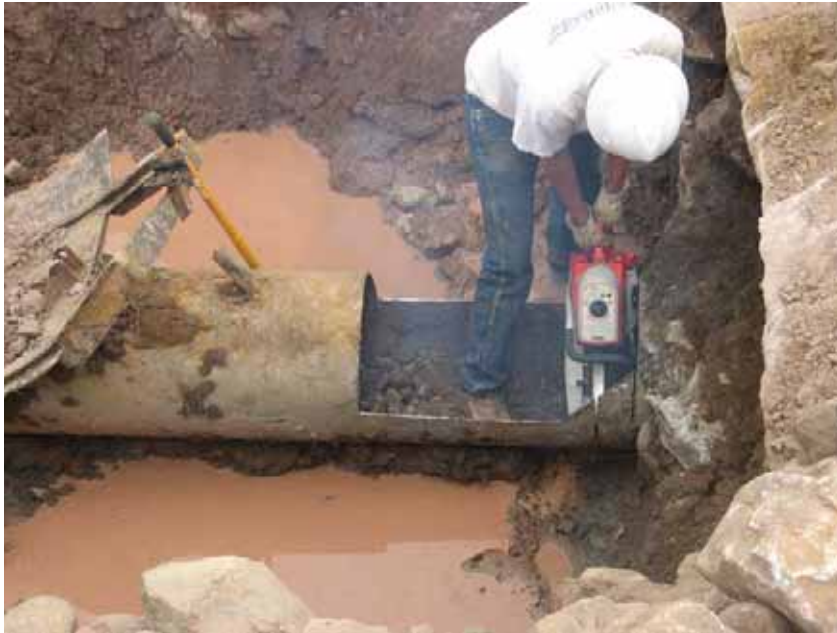
operation started on August 5th and the crew quickly learned that the outlet pipe had several holes in it which required extra cement bags to fill. Bob Leake and Brad Weber rode to Five Point to carry 40 leftover bags of cement back to Superior Lake using their pack horses, enabling the crew to fill the Superior outlet pipe. The calculated volume of cement needed to grout the outlet pipe was 140 bags, when all was completed the crew used 189 bags of cement (47 pounds each) to fully grout the outlet pipe. Filter sand and gravel was installed at the downstream side of the lower outlet gabion to bedrock.

Figure 45: Hand crew cutting off a portion of the outlet pipe prior to grouting.

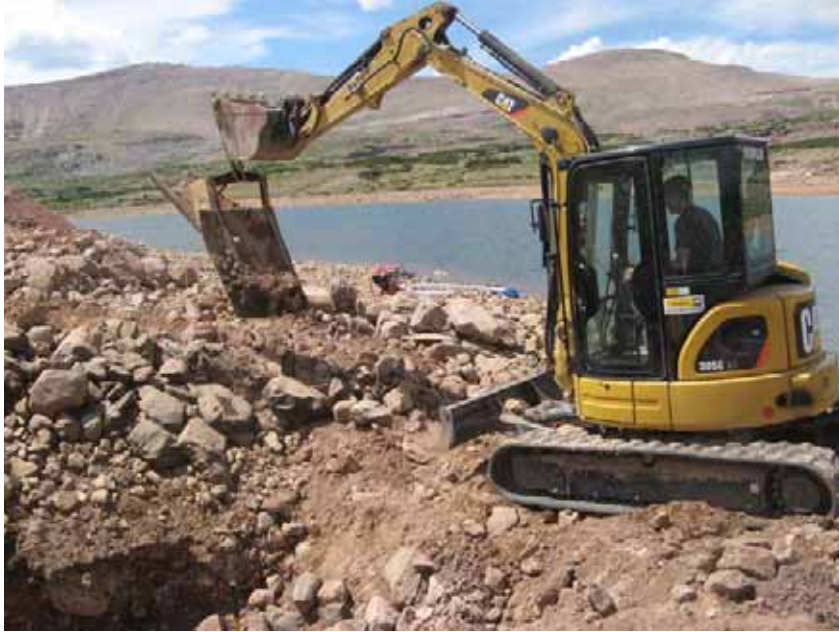
Figure 46: Removing the upstream portion of the outlet pipe.
