High Lakes Stabilization East Timothy Lake Construction Report

Uinta Basin Replacement Project

U.S. Department of the Interior
Bureau of Reclamation
Provo Area Office
Provo, Utah

November 2010

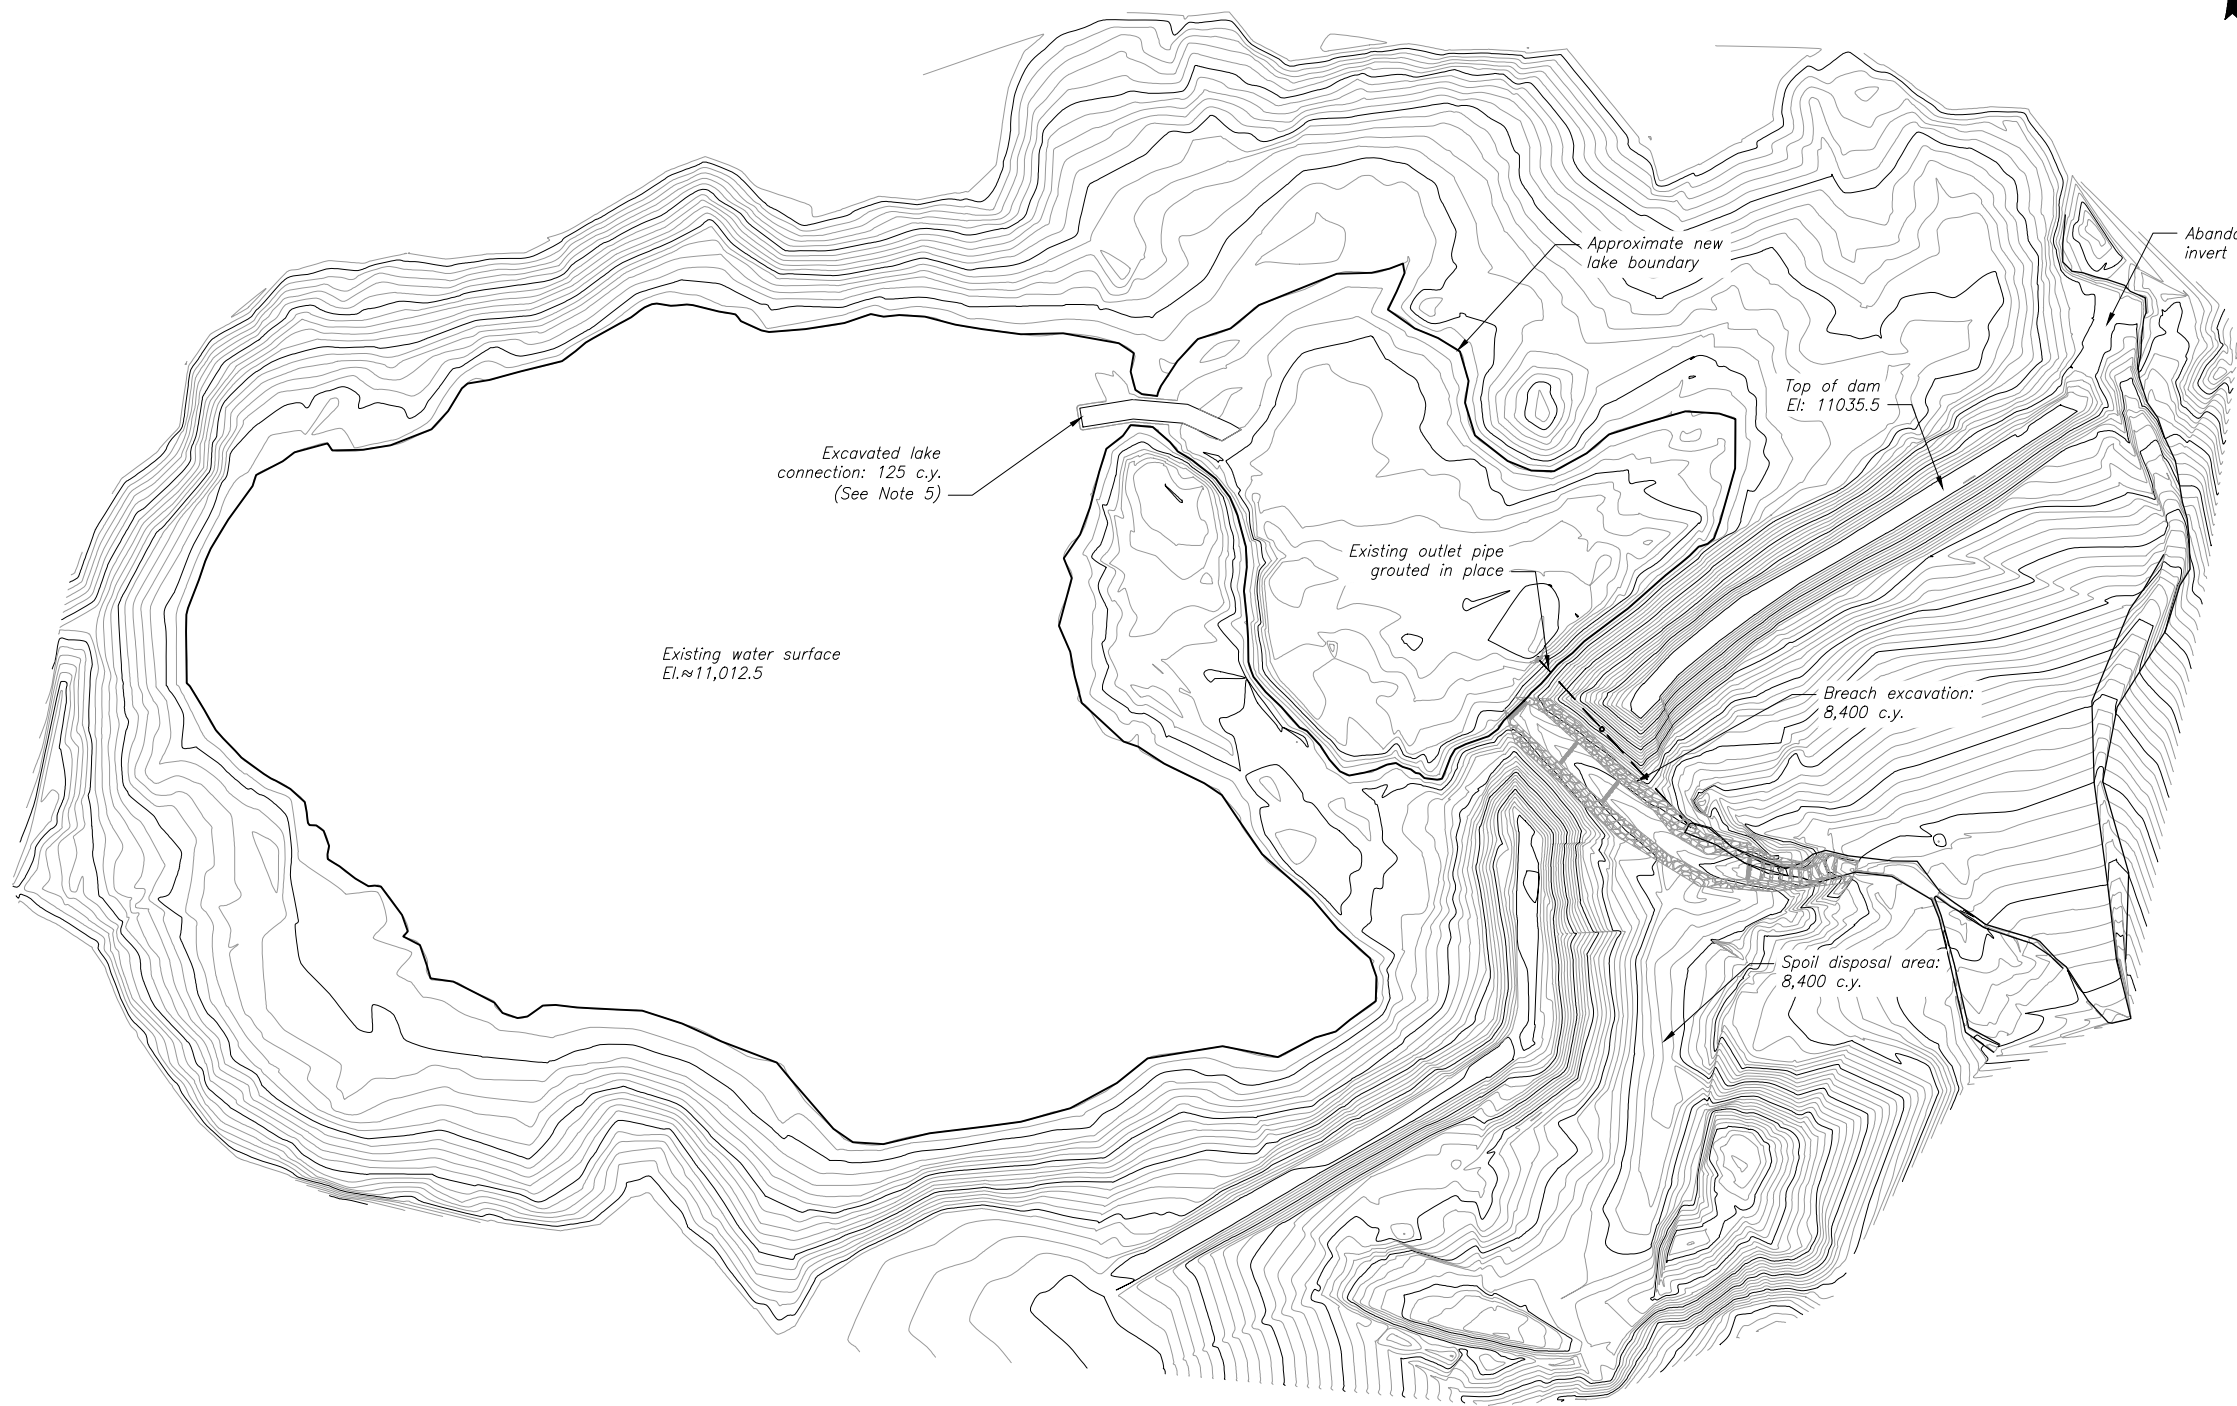
1. Contour interval is 1 foot.
2. Centerline alignment meandered along breach to create resting pools.
3. Top of riprap El. 11,012.57. Cut vol. = 8,400 c.y.
4. Grid factor = 0.99949466.
5. Lake connection was excavated to be 20 feet wide at El. 11,011.00 with 3:1 side slopes.
6. Existing drain wells were buried under spoil disposal area.

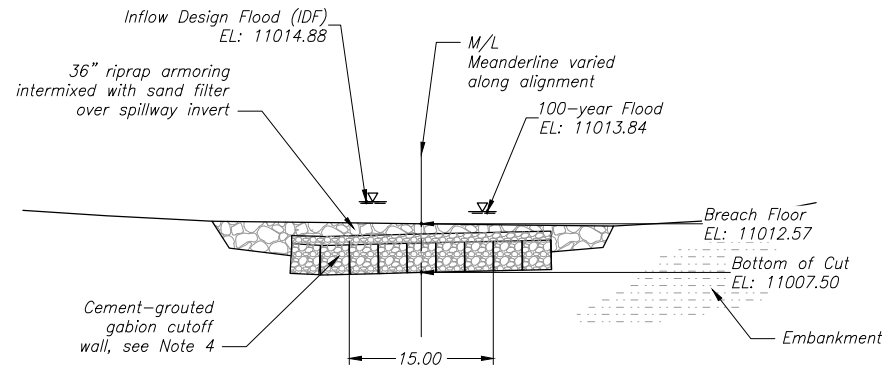
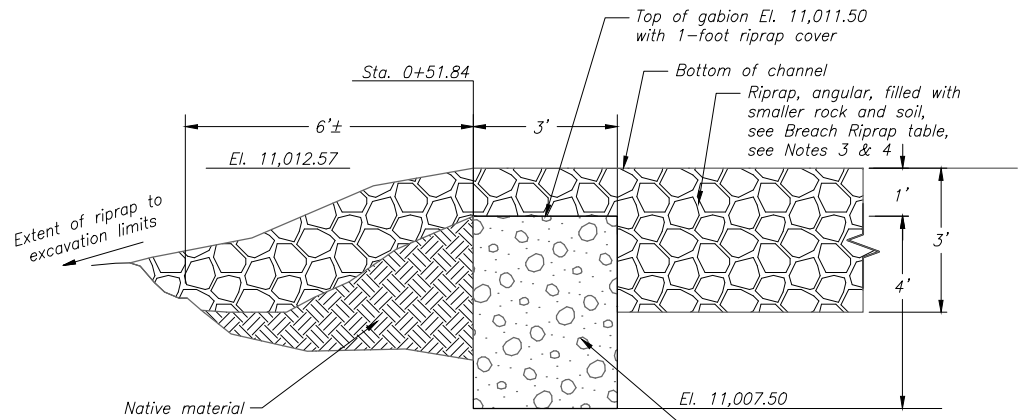
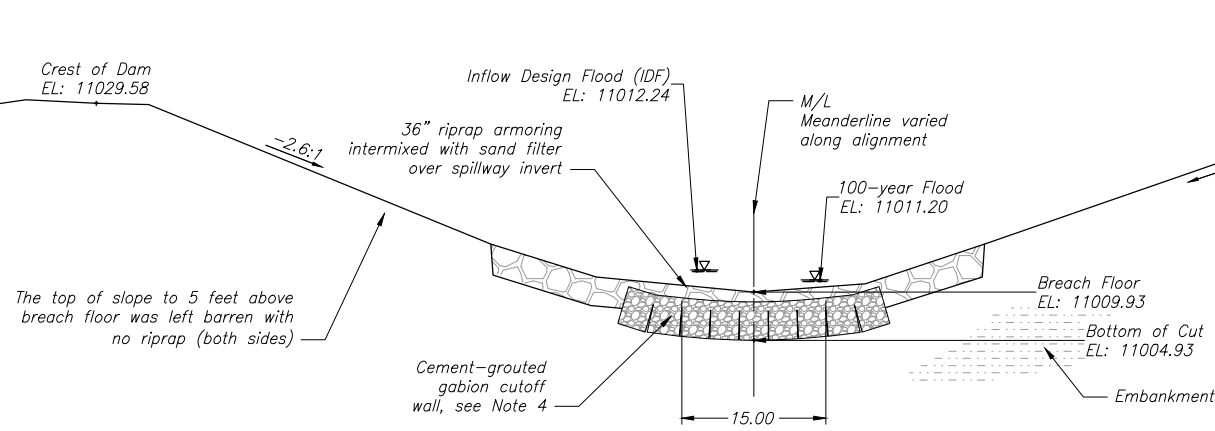
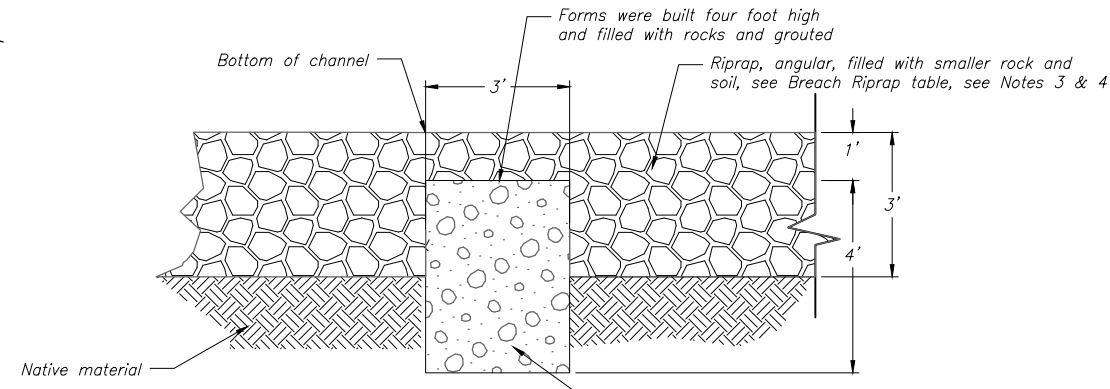
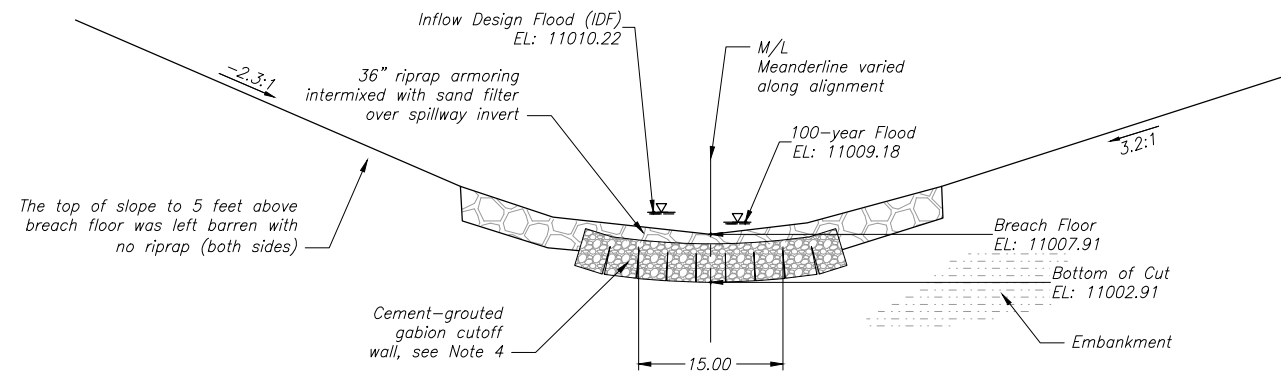
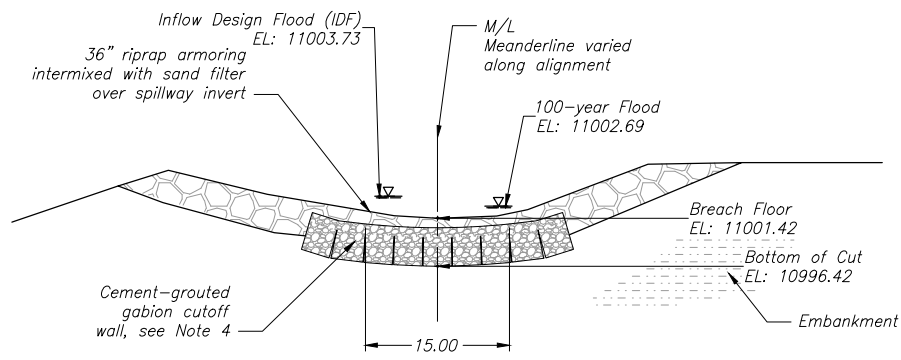
- NOTES**
- Flood elevations through the breach represent elevations as if the abandoned spillway does not operate.
 - Riprap was placed through breach in layers to maintain correct gradations.
 - Compacted backfill to the extent possible based on tools allowed for the job.
 - Gabion baskets were rock-filled, cement-grouted, angular rock. See Gabion Basket Rock Gradations table.

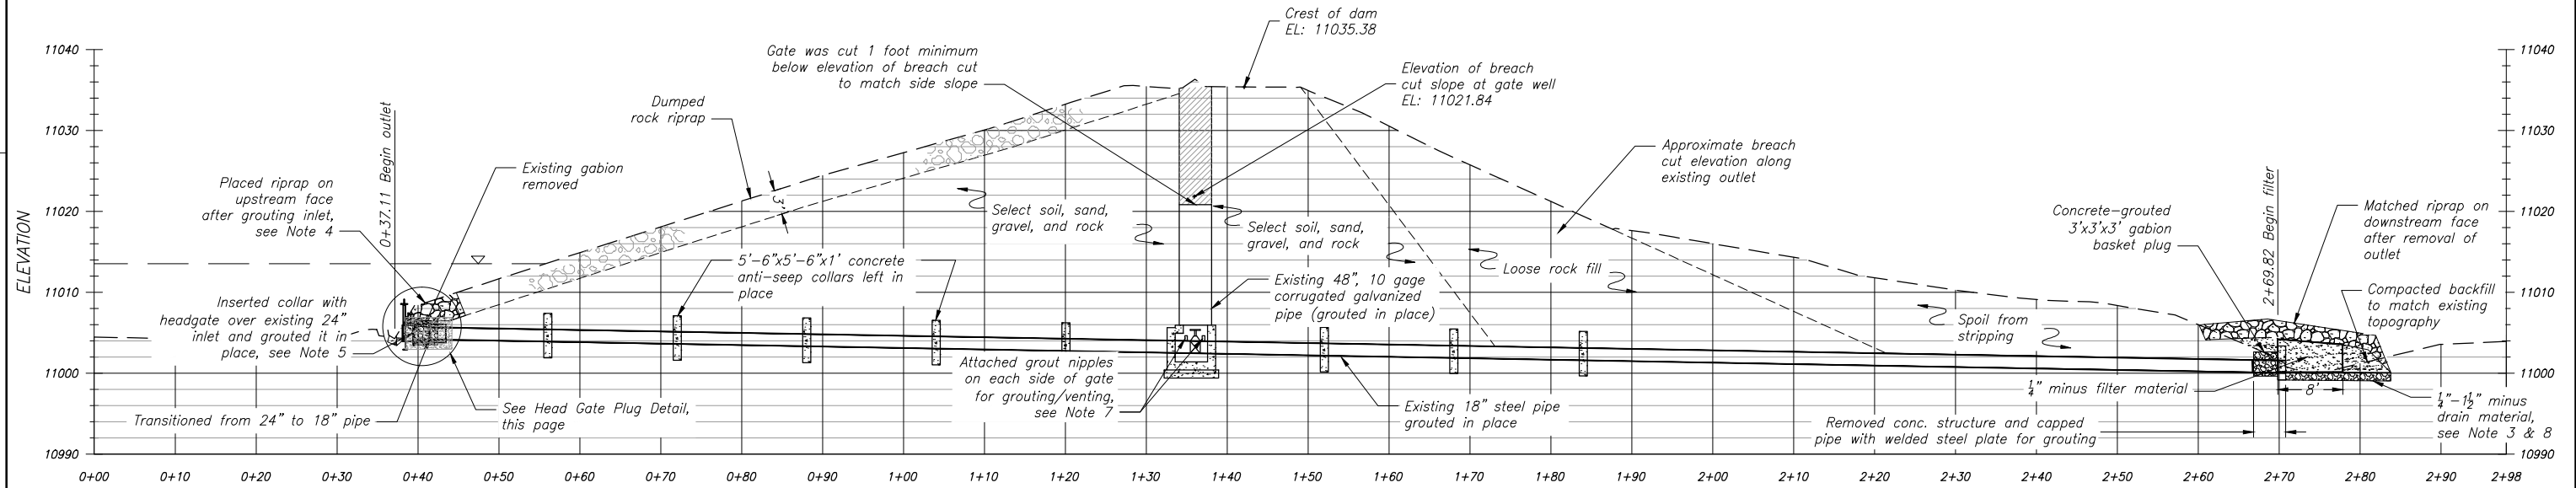
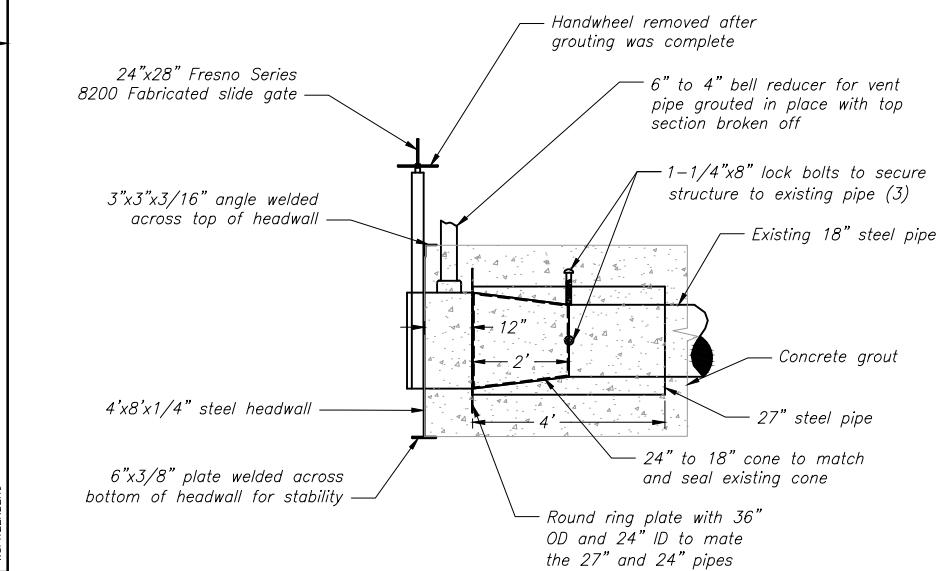
HEAD GATE PLUG DETAIL
(nts)

- NOTES**
1. Provided compacted filter material over end of pipe before grouting.
 2. Trench walls were sloped to allow adequate compaction between fill and natural ground.
 3. Extended gravel drain through compacted sloped material to discharge under riprap.
 4. Filled inlet area around vent pipe with embankment material compacted to the extent possible. Vent pipe was removed after completion of work.
 5. Installed collar and headgate at pipe inlet.
 6. Outlet anti-seep collars were left in place.
 7. Grout was pumped upstream in nipple upstream of gate. Nipple downstream of gate was used for venting for grout pumped from the downstream outlet.
 8. No testing was performed on sand filter and gravel drain.
