## High Lakes Stabilization Technical Memorandum

## Garfield Basin Lakes

Superior, Five Point, Drift and Bluebell

Uinta Basin Replacement Project

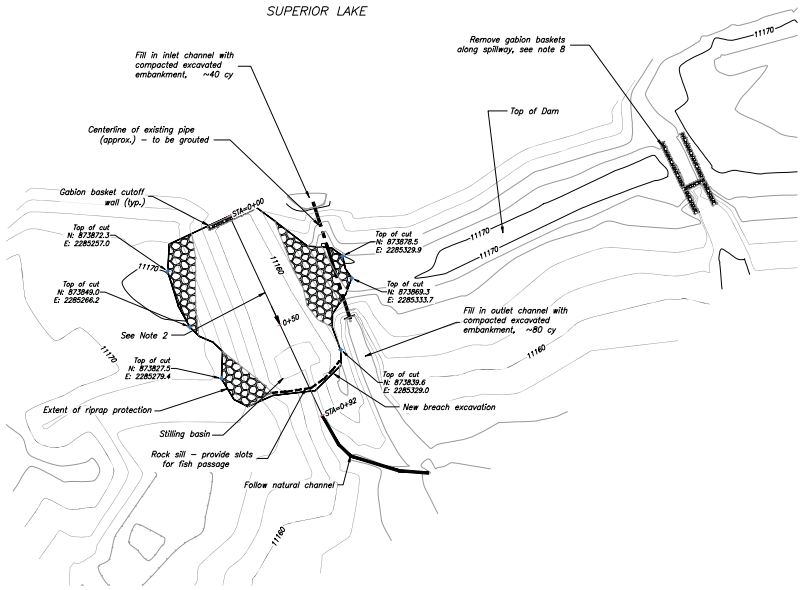
DATE: 08/26/08 04:00 PM  
 DRAWN BY: J. SPITZBERGER  
 CHECKED BY: J. SPITZBERGER  
 PROJECT: 0A58-418-87  
 SHEET: 0A58-418-87

UNITED STATES  
 DEPARTMENT OF THE INTERIOR  
 BUREAU OF RECLAMATION  
 PROJECT AREA OFFICE  
 PROVID, UTAH  
 GARFIELD BASIN LAKES  
 DAM STABILIZATION  
 SUPERIOR LAKE BREACH  
 SITE PLAN  
 DESIGNED - SCOTT J. SPITZBERGER, P.E. - CHECKED - M. P. SHAW, P.E.  
 DRAWN - J. SPITZBERGER - TECH. APPR. - J. SPITZBERGER, P.E.  
 APPROVED - J. SPITZBERGER, P.E.  
 PROJECT DATE: 08/26/08  
 PROJECT NO: 0A58-418-87

It is recommended that a design-build approach be taken to restore the flow to the natural channel below Superior Lake. Based on field reviews to date, we propose breaching three berms that were constructed to divert water into the canal. The first berm to be breached is directly below where a side channel re-enters the main channel and all the flow is combined in a single channel. This is the most critical berm to breach, and should restore all but the highest of flows to the natural drainage. Approximately 18 cubic yards (15'x 8'x4') of material need to be removed from the natural drainage channel (see Appendix B for plan view drawing).

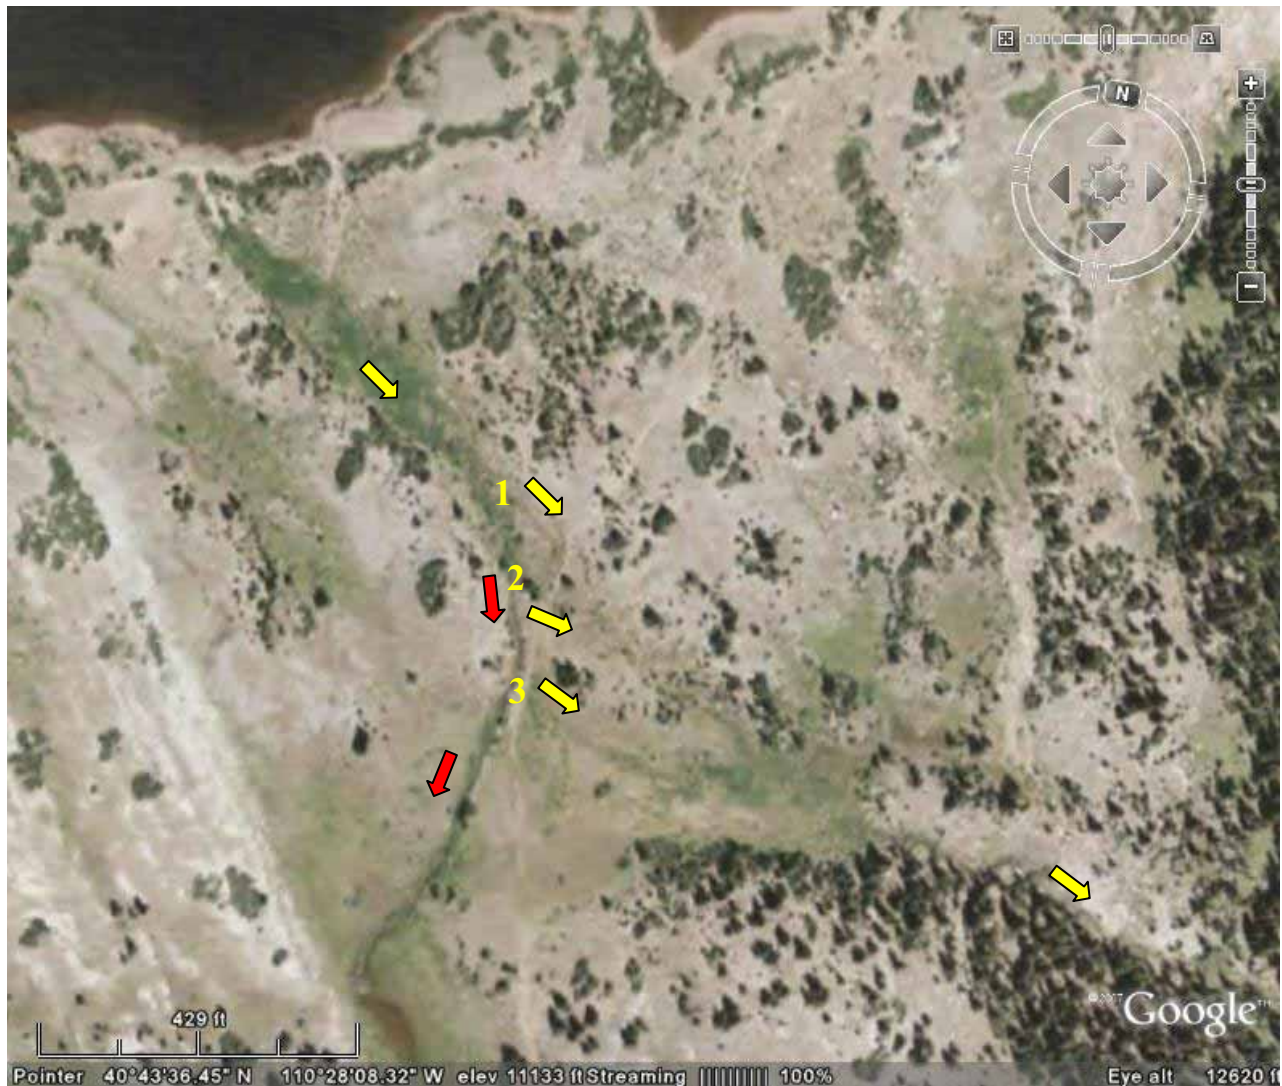
**Figure B-6. Plan view and cross section drawings of the proposed breach points below Superior Lake.** Survey equipment was not available during the September 9, 2008 field review, so these drawings are from field notes. Breach points 1, 2, and 3 are labeled in Figure B-1 of this report, which provides a larger plan view of the area.

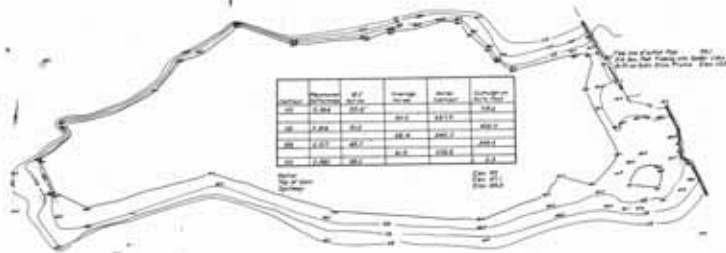
BLUEBELL LAKE  
Reference: Page No. 401, Page 274(27) Location: Bean Lake, Garfield Co., Utah  
Surveyed Sept. 27, 1928. Surveyed by U.S. Indian Service.

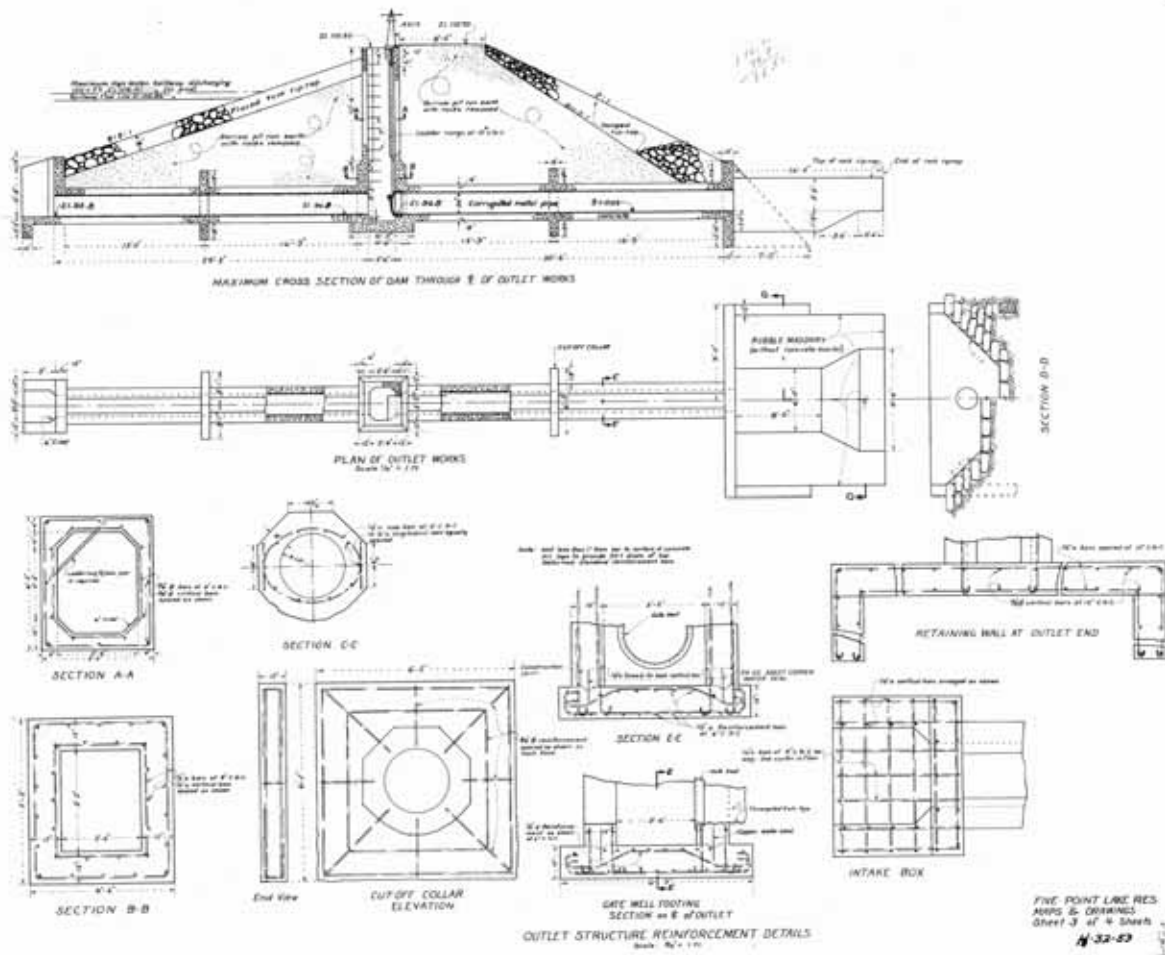
FIVE POINT LINE RES  
 WEIR & DAMS  
 Sheet 2 of 4 Sheets  
 H-32-52  
 Five Point Line Res.
